Masonry Inspection Report

Hereford Town Hall

Entrance Canopy

19th January 2016

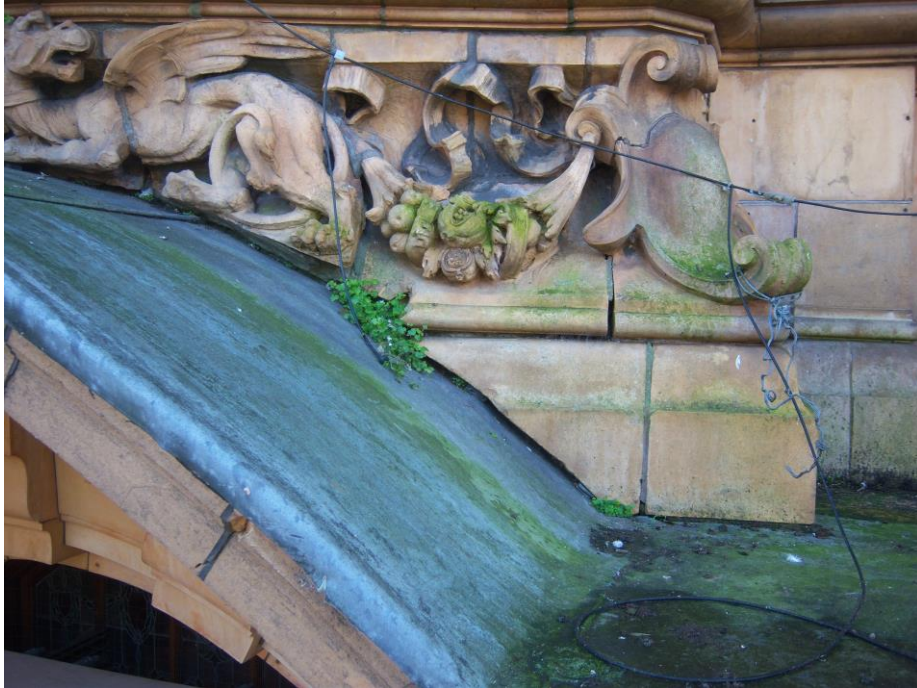
Lead covering to canopy appears sound apart from having no cover flashing or upstand of any kind where it meets the wall face above.

- Re detail the lead covering to the canopy to discourage water ingress where it abutts the balcony detail.
- Replace the lead covering to the balcony, re detail if necessary, and perhaps introduce a lead covering to the balcony capping.

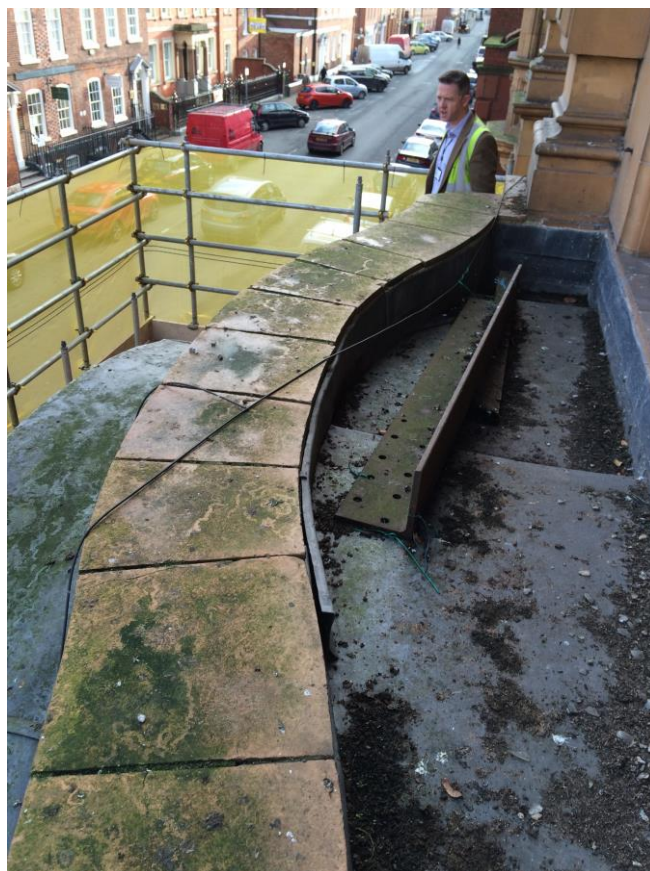
Lead flashings to the window balcony directly above the canopy were not secured.

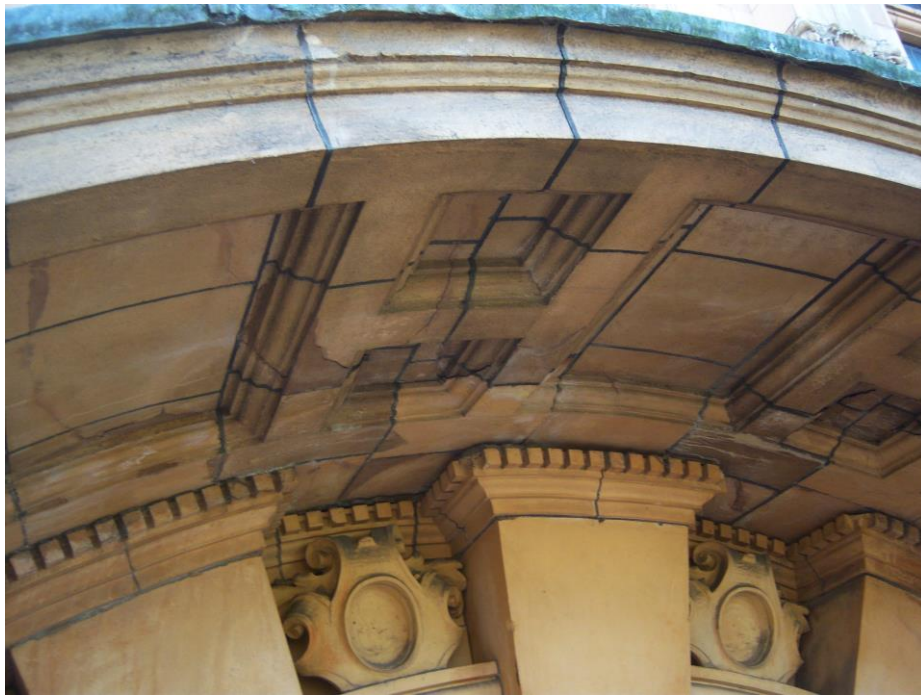
Where the soffit of the canopy meets the main building the joint has widened in general, but more so in several locations.

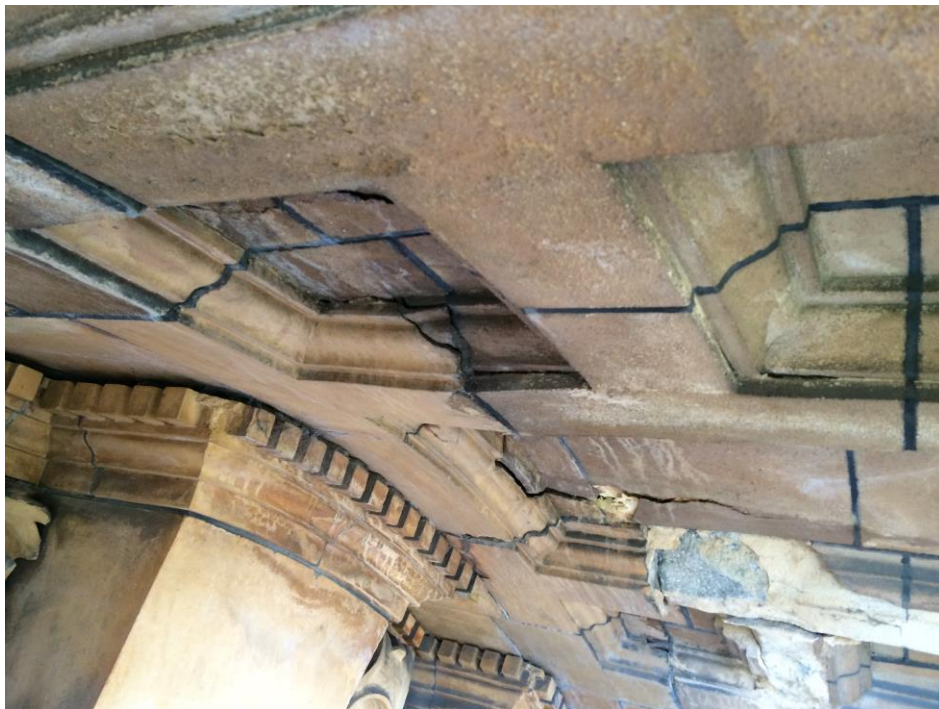
Considerable number of fissures and fractures visible throughout the soffit of the canopy, some appear recent and some historic, but all were hollow to a tap test.

- In my opinion it seems that with various opportunities water has ingressed into the terracotta construction promoting the corroding of the steels, which carry the weight of the canopy back into the main building.

- With the corrosion comes expansion and with the incredible force it exerts it fractures the weakest points around it.
- Without knowing the actual steel arrangements it's impossible to truly understand the extent of replacement support structure necessary to address the current issues.

- Dismantle the balcony above the canopy, the canopy and the corbels as necessary to remove all visibly damaged terracotta and fully expose the extent of problematic steelwork.

- Replace the steel as necessary with appropriate modern material/system.
- Have matching replacement terracotta sections manufactured to reconstruct around the new support system.

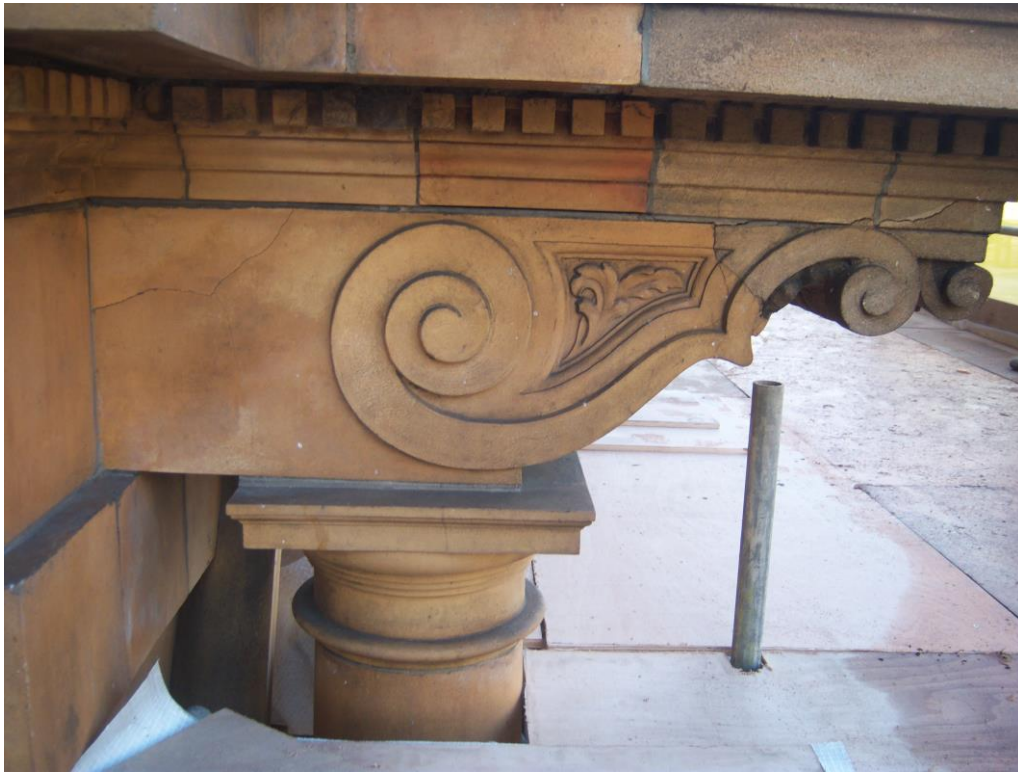
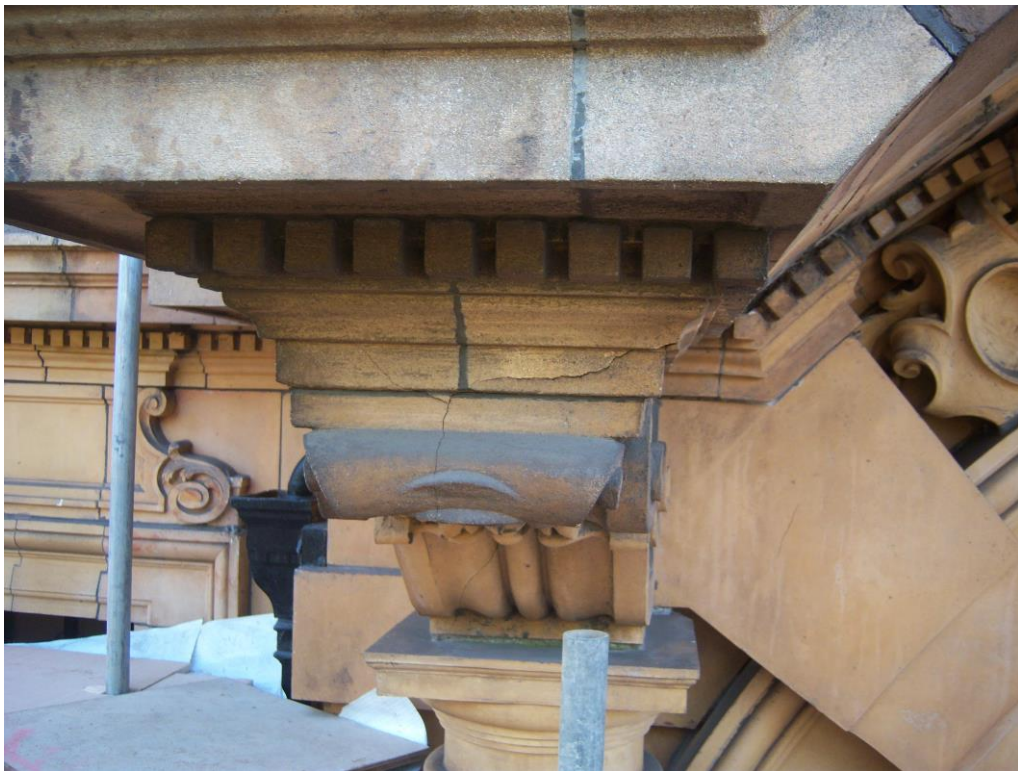
Fractures evident throughout both corbels in all directions

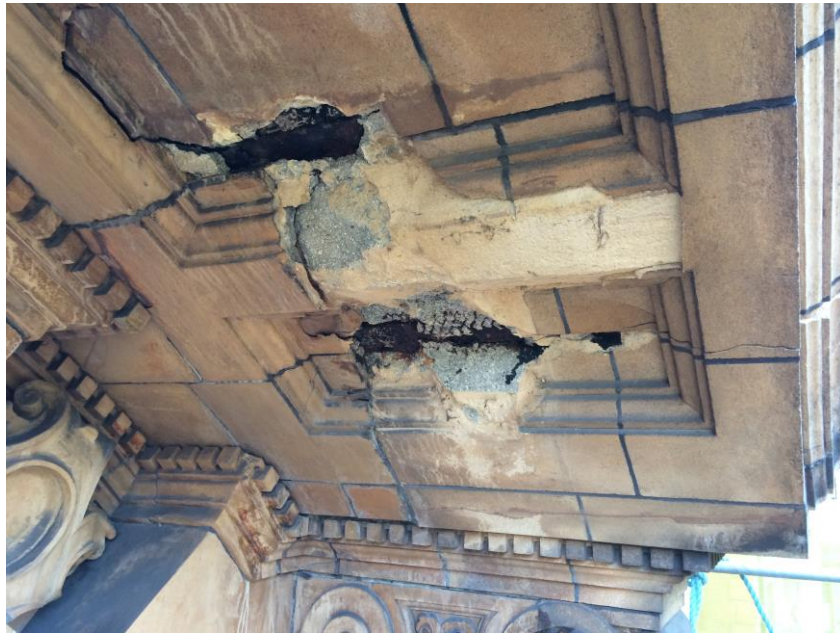
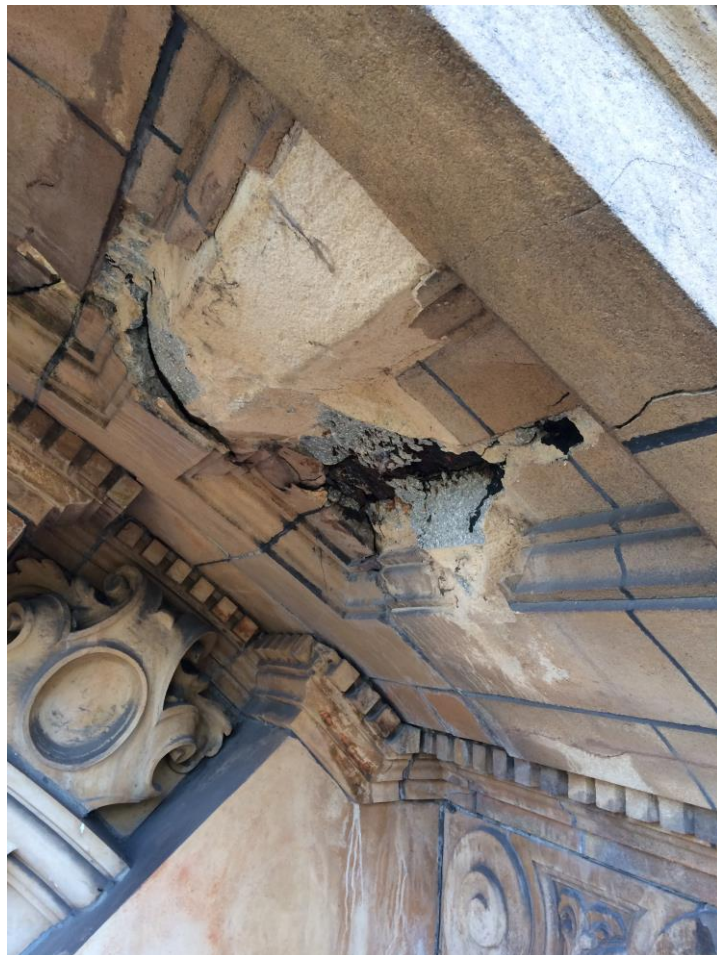
Without much encouragement the hollowest of fractured Terracotta on the canopy soffit was removed exposing corroded steel.

- Have the structure inspected by an appropriately qualified structural engineer for calculated details of load and possible recommendation for a replacement system, also to assess the likelihood of further issues with other embedded steels.
