Colwall C.E Primary School

Groundwater Flooding - Desk Study & Site Investigation Report

Colwall Green, Malvern, Herefordshire, WR13 6DU

Date:	December 2014	
Revision:	FINAL	
Project Number:	HYG124	
Document Reference:	HYG124 R 141014 AJ Colwall School Groundwater Flooding Investigation Report	
Document File Path:	P:\HYG124 Colwall School\Reports\Draft\HYG124 R 141014 AJ Colwall School Groundwater Flooding Investigation Report.docx

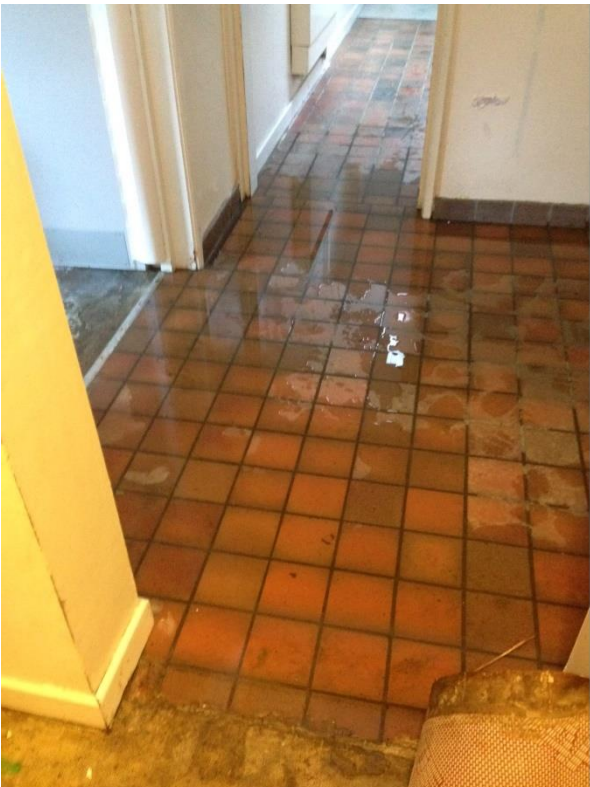
Ref.	Photograph	Description
1

<p>The photograph shows a tiled floor in a corridor that is partially flooded with water. The water is clear and reflects the overhead lights. The tiles are a reddish-brown color. The walls are white, and there are white door frames visible. The perspective is from a low angle, looking down the length of the corridor.</p>	<p>Photograph taken from the disabled lift access area viewing the corridor and along the circulation area towards the north of the site. The photograph shows the extent of groundwater flooding in this lower area of the 1993 building extension.</p>

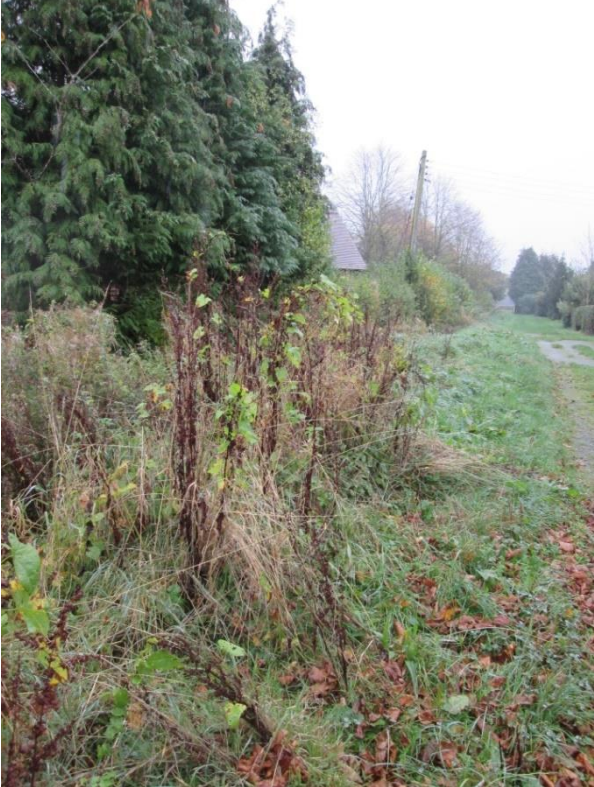
Ref.	Photograph	Description
6

<p>Photograph taken viewing the southern adjacent drain (water course) towards the east, along the southern school boundary. The drain was observed to be very overgrown with little water visible within the watercourse during the site walkover.</p>
7

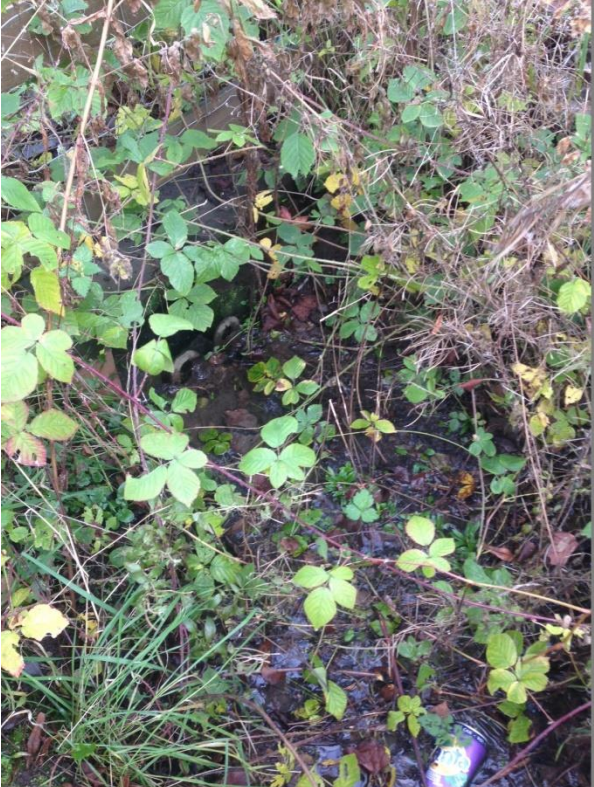
<p>View of the drain before it becomes culverted in the south western corner of the site. It was not clear as to where the culvert reappears, but it is thought the culvert flows to the north-west away from the school towards the playing fields.</p>

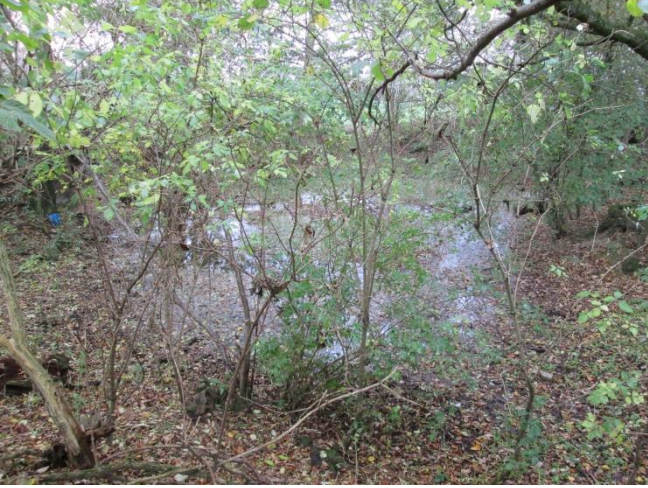
Ref.	Photograph	Description
8

<p>Photograph shows a wetland area situated to the west of the site. The wetland area is thought to be fed by a discharging spring although no spring discharge into the wetland could be observed at the time of the walkover.</p>
9

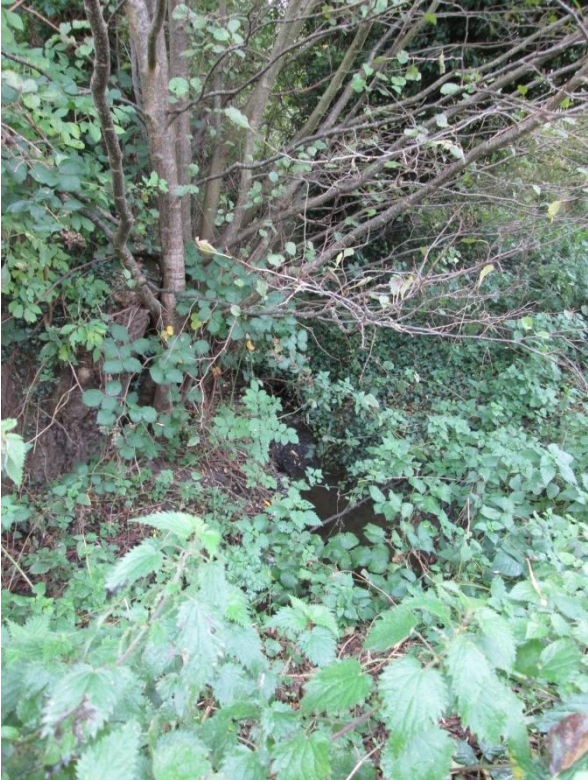
<p>Photograph shown in Ref 10 is the stream which was flowing at the time of the site walkover and feeds the moats in this area of Brockbury House.</p>

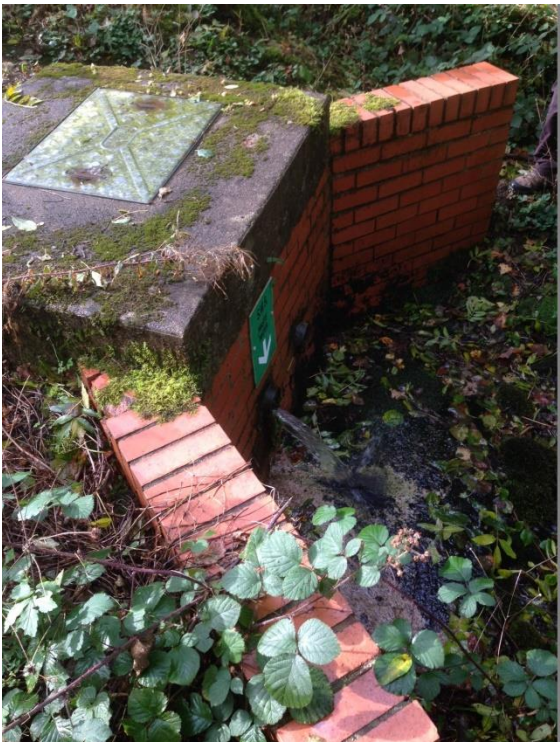
<p>Photograph viewing the spring outlet which shows the overflow pipe discharging water out of the brick chamber. The rate of flow was estimated to be approximately 1.5l/s.</p>

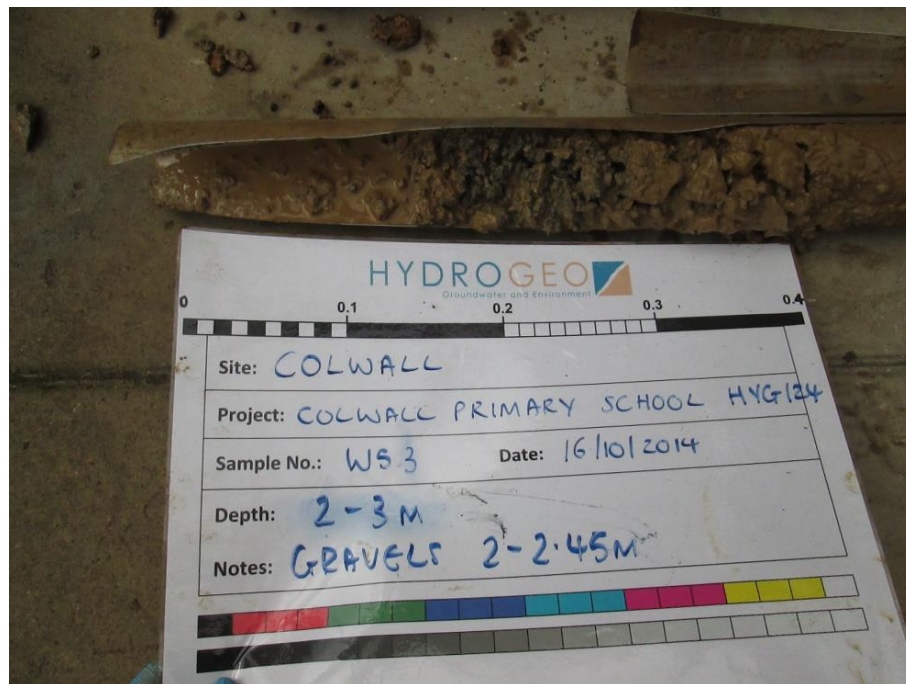
Figure 7 Gravel Band within the Colwall Gelifluctate

The gravel layers within the Gelifluctate Formation were observed between 2mbgl to 2.45mbgl and again at 3mbgl to 3.90mbgl within WS3, with a very thin layer of gravels observed in WS5 at 1.95mbgl to 2mbgl and a very gravelly clay layer in WS8 at 1mbgl to 1.35mbgl.

The gravel bands within WS3 were observed to be very wet upon retrieval during drilling. The gravels were found to comprise a mixture of varying fine to medium, sub-angular to sub-rounded sandstones and limestones as shown in Figure 6. No other borehole around the site encountered gravel bands like the bands observed in WS3.

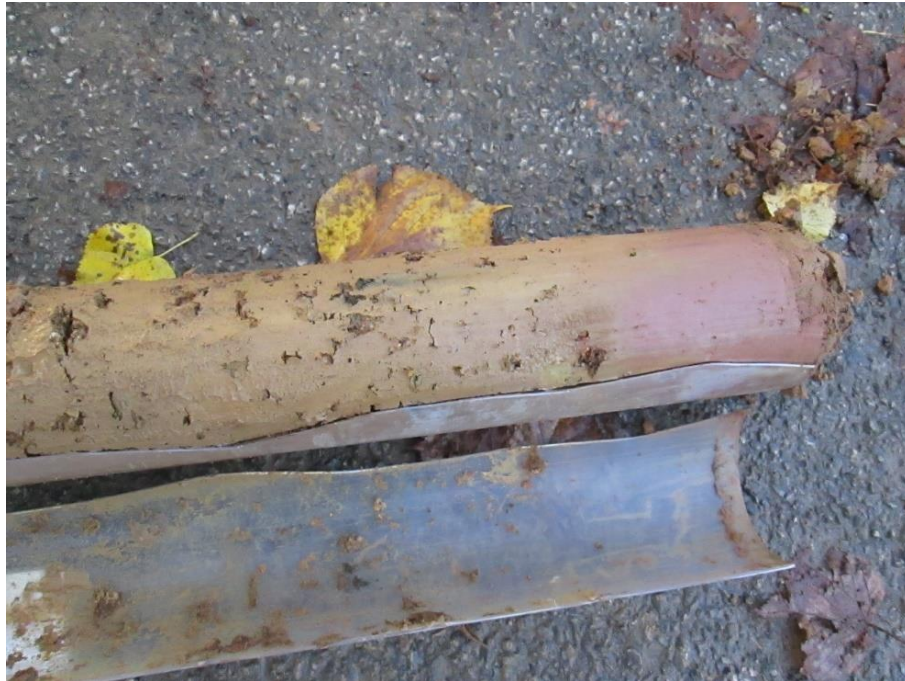
Figure 9 Transition from Colwall Gelifluctate Formation to the Raglan Mudstone

Figure 9 shows the transition from the light brown Colwall Gelifluctate Formation to the dark red Raglan Mudstone Formation encountered within WS1 at 2.95mbgl. The transition was encountered at its shallowest in WS8 within the staff room area at 2.50mbgl and at its deepest within WS2 at 3.20mbgl.

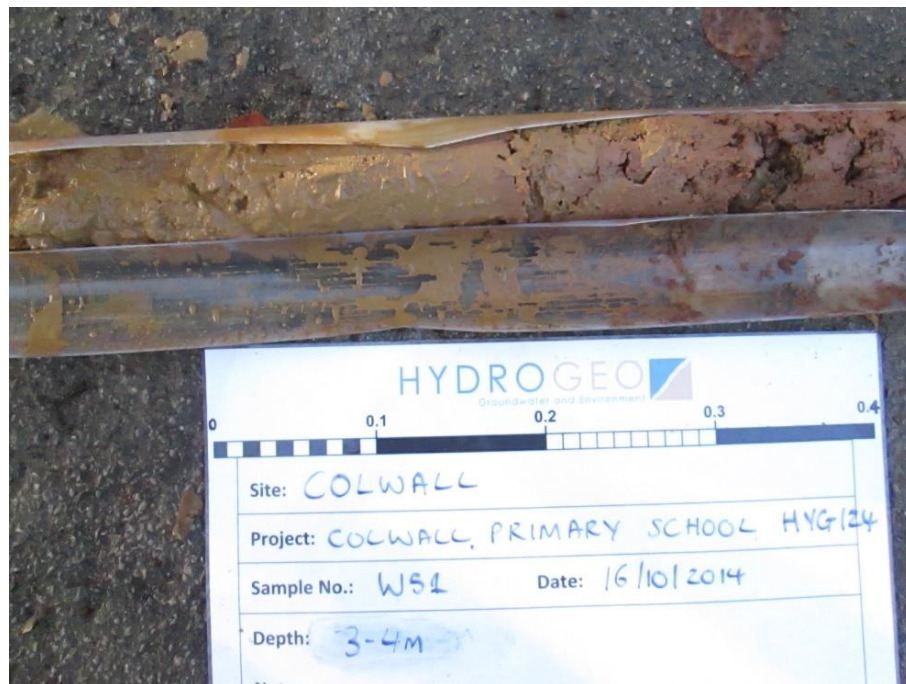
Figure 12 Raglan Mudstone Formation Gravels

A gravel layer was observed within the Raglan Mudstone Formation in WS1 which was comprised a loose, very clayey, grey to red sub-angular to sub-rounded fine to medium of dark grey to yellow sandstones. This is considered likely to be a highly weathered zone of the Raglan Mudstone Formation and was found to contain the most gravel within the mudstone formation at the site.

The gravels in the Raglan Mudstone Formation in WS1 were found to be very wet upon retrieval from the hole between 3mbgl to 3.30mbgl. Occasional dark grey pockets of sand and fine gravels were observed as shown in Figure 13.

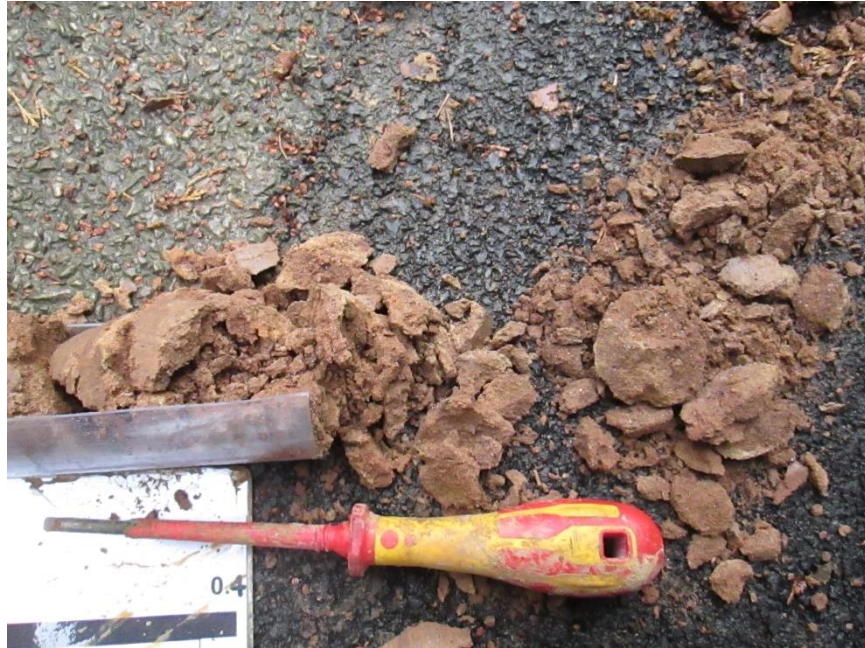
Figure 14 Sand Layer In The Raglan Mudstone Formation

A dark brown to red slightly clayey silty fine to medium sand of the Raglan Mudstone Formation was observed within WS4 at 3.30mbgl to the base of the hole. The sand was

distinctively different to the overlying firm clay and was not encountered within any of the other windowless sample holes across the site. The sand was observed to be dry upon recovery from the hole and was very crumbly easily broken apart as shown below in Figure 14.

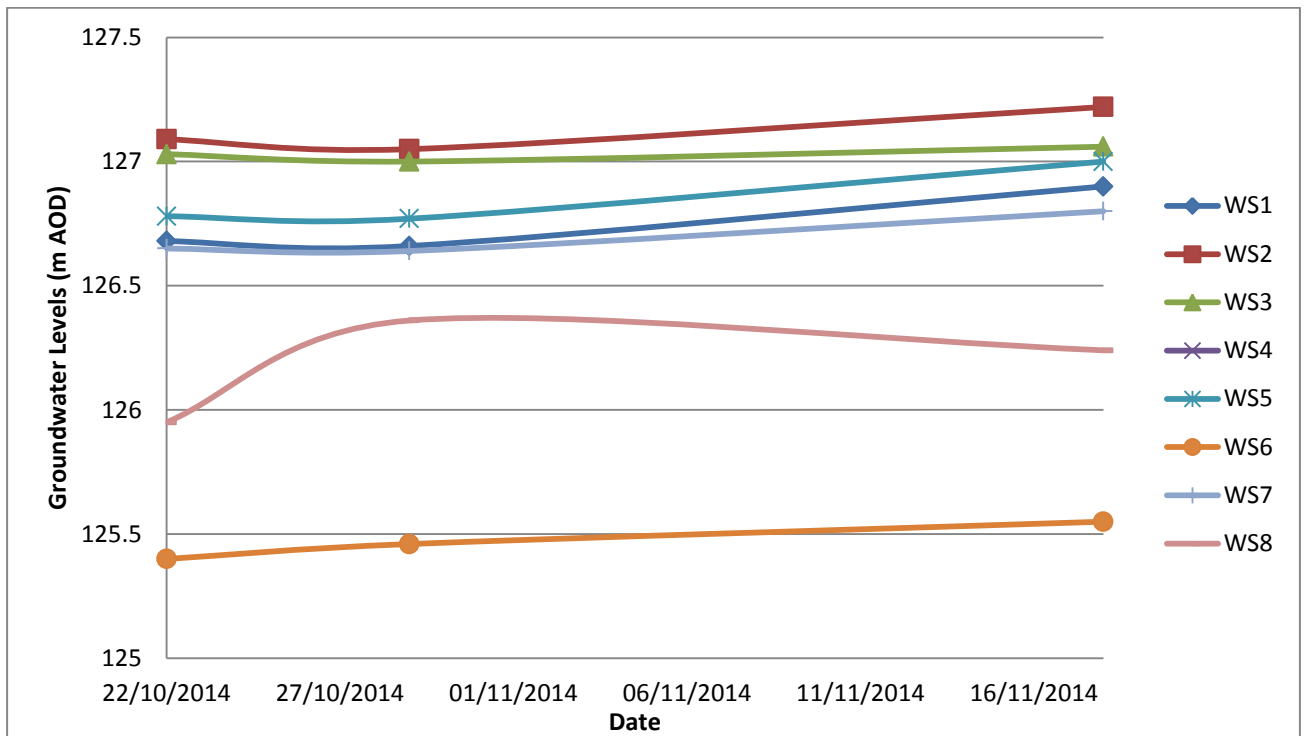
Figure 15 Groundwater Level Hydrograph (22/10/2014 – 18/11/2014)

Figure 15 and the groundwater contour plot in Drawing 1 shows that the groundwater level is highest in the south-eastern area of the site in WS2 (127.05 to 127.22m AOD). The lowest recorded groundwater level is in WS6, situated towards the centre of the school building (125.40 to 125.55m AOD).

Groundwater levels generally increase during the monitoring period in all of the boreholes with the exception of WS8, which recorded the largest fluctuation in groundwater during this period. The groundwater level in WS8 was a maximum of 126.36m AOD on the 29th October 2014 with the groundwater level subsequently falling to 126.24m AOD on the 18th November 2014. .

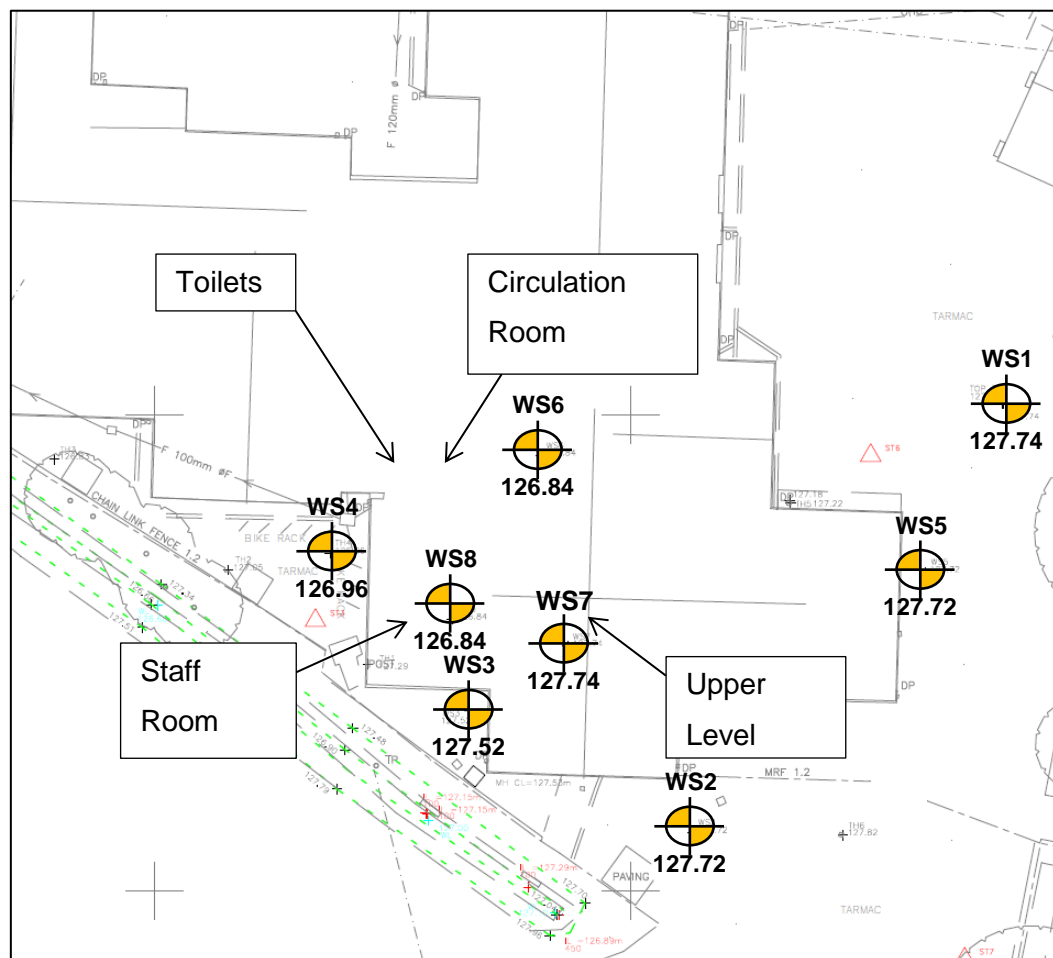
Figure 18 School Building Ground Levels (mAOD)

Figure 18 shows a 0.90m difference in floor level between WS7 and WS8 and a 0.68m difference between WS3 and WS8. Boreholes WS8 and WS6 represent the lowest areas

of the site under investigation. The staff room, circulation area and the lift section of the lower level 1993 extension is where groundwater flooding has occurred although the exact points of entry are not clear.

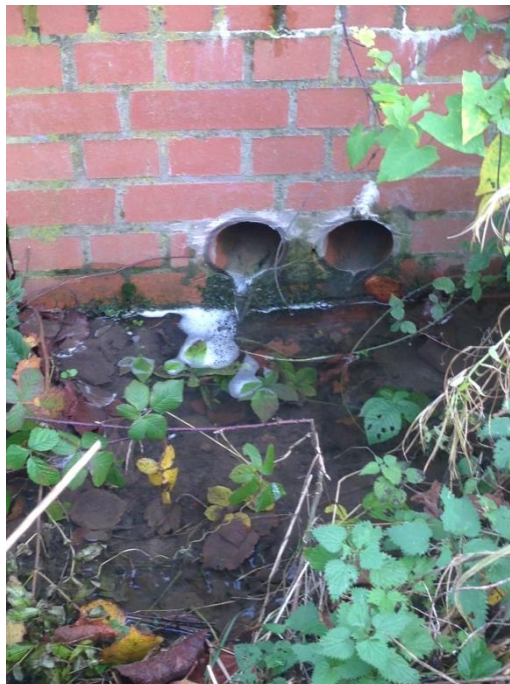
Figure 19 Discharge of Runoff Water into Adjacent Watercourse

Water leaking from the unlined open drain will recharge shallow groundwater to the south of the school building. This raises the shallow groundwater level locally, and induces groundwater flow towards the school building. Drawing 001 depicts an increase in the groundwater hydraulic gradient from WS3 to WS8.

The increased steepness in the hydraulic gradient between WS3 and WS8, is likely the result of groundwater being forced downwards beneath the foundations of the 1993 building extension. Groundwater will be forced to flow towards the school building and will flow under pressure behind and beneath the building foundations and floor slab membrane where the building has been excavated below the natural ground level.

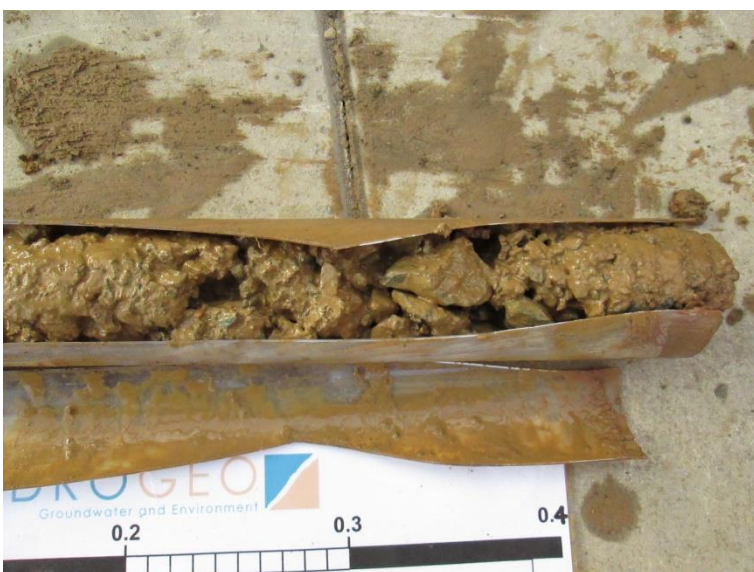
Photograph depicts a very wet, clayey, gravel band encountered within the Colwall Gelifluctate Formation within WS3 between 3mbgl to 3.90mbgl. WS3 had the shallowest water strike at 0.70mbgl of all the holes and the highest rise of the water level to 0.40mbgl following the completion of drilling.
