# ADL Traffic and Highways Engineering Ltd

# BRIEFING NOTE B4362 AND U92404 LUCTON

(ADL REF: 3409, MARCH 2018)

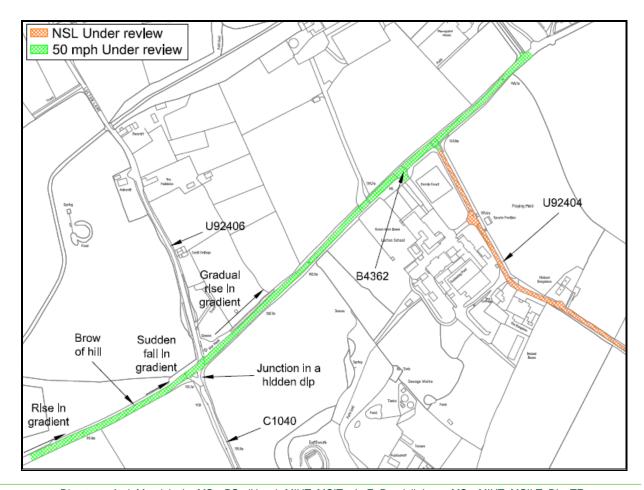
In September 2014 a request was received for a speed reduction on the B4362 (in the vicinity of Lucton School and the C1040/U92406 crossroads) and on the U92404. In February 2018, the Local Member requested that the section of the B4362 particularly in the vicinity of the junction with the C1040 and the U92406 to be reviewed as part of the speed limit appraisal/

The figure below shows the extent of both these roads under review.

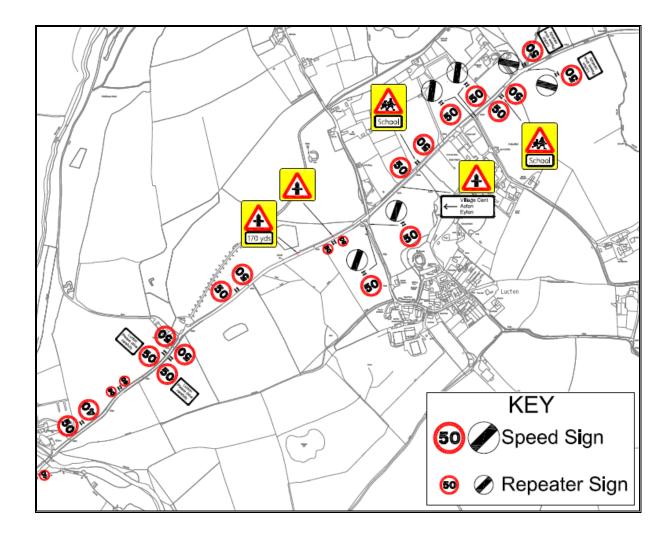
The main 50mph speed terminals on yellow backing boards are located approximately 600 metres northeast of Mortimers Close and 190 metres northeast of the junction with the U92404. These terminals are also provided with the village entry sign – "Lucton – Please drive carefully" and are distinctly visible.

There are a number of 50 mph repeater signs along this route. In the vicinity of Lucton School, there are school warning signs on the B4362, approximately 120 metres east and 200 metres west of the junction with the U92404. A sketch showing the existing signage along the B4362 is shown on the next page.

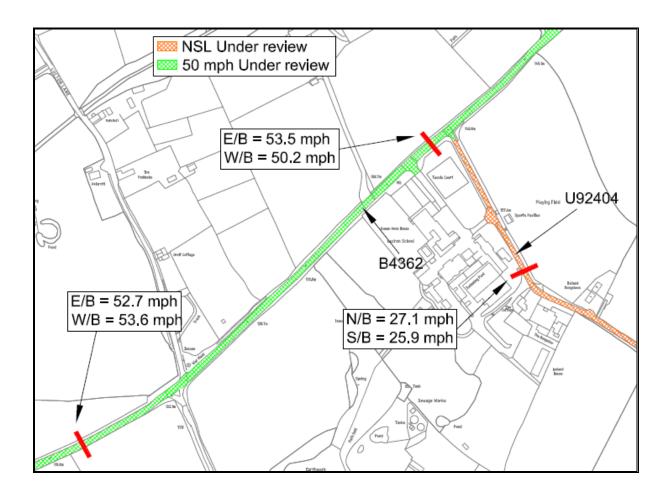
The speed surveys were undertaken on the B4362 (on either side of the B4362 / C1040 / U92406 crosswords) and on the U92404. The figure below shows the speed survey locations and the 85<sup>th</sup> percentile speed survey results.

Speed Survey Location	Northeastbound	Southwestbound
B4362 (East of crossroads)	53.5mph	50.2mph
B4362 (West of crossroads)	52.7mph	53.6mph
Speed Survey Location	Northbound	Southbound
U92404	27.1mph	25.9mph

The 85<sup>th</sup> percentile speeds on the B4362 indicate a good level of compliance with the existing 50mph speed limit and are below ACPO guidelines for the speed enforcement intervention level of 57mph i.e. speed limit (50mph) +10% +2mph.

The 85<sup>th</sup> percentile speeds on the U92404 indicate that the road side environment and road geometry dictate the vehicle speeds and not the posted national speed limit.

Therefore, without appropriate traffic engineering measures in place, it is not recommendable to reduce the speed limit of the B4362 from its current 50mph to 40mph.

It is recommended to reduce the speed limit of the U92404 from its current national speed limit to 30mph from a point approximately seven metres south of the junction with the B4362 for a distance of 230 metres in southerly direction.
