BRIEFING NOTE

B4224, C1292 AND C1297 MORDIFORD VILLAGE

(ADL REF: 3409/44/21A)

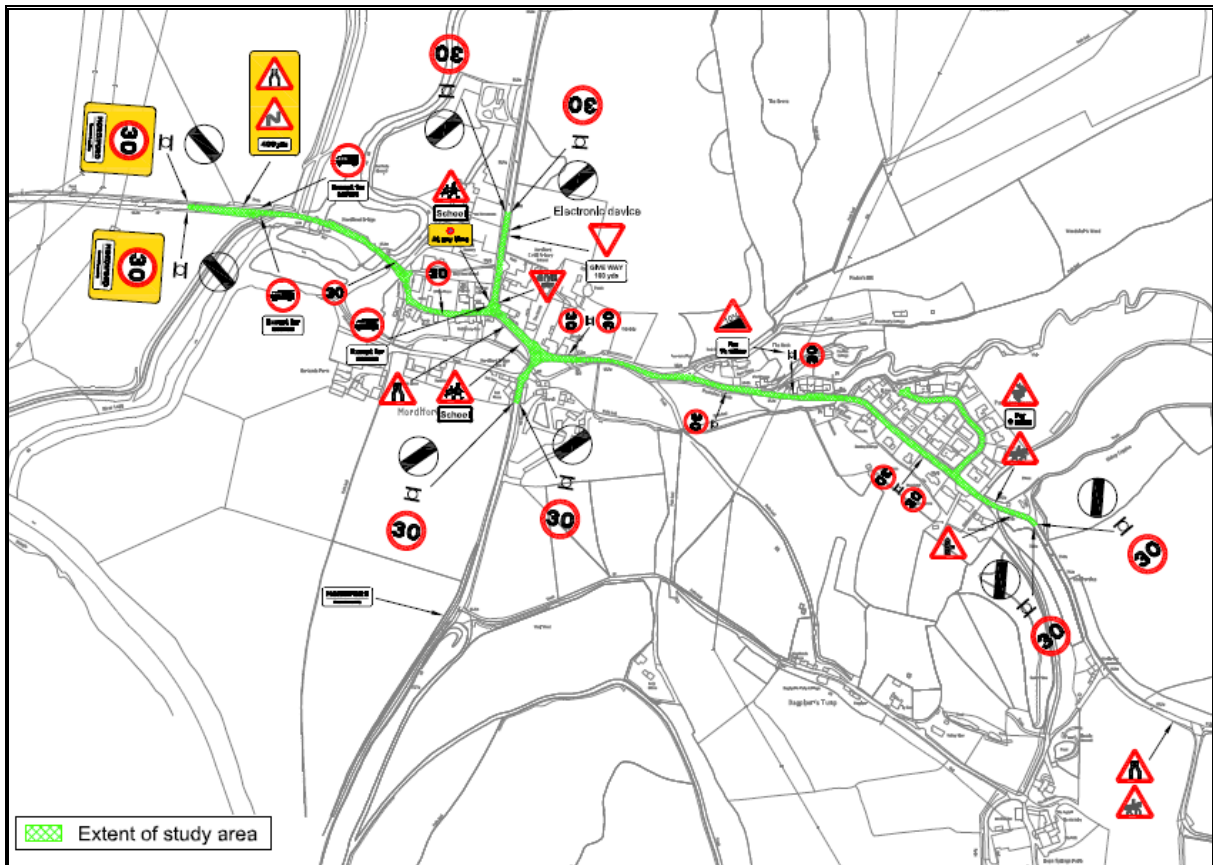
The 30 mph speed terminals on the B4224 to the west are displayed on yellow backing boards and are readily visible from a distance of in excess 150 metres. To the south, the 30 mph speed terminals are located under tree canopy and are not displayed on yellow backing boards. The tree canopy causes obscuration to these speed terminals.

There are a number of 30 repeater signs on the B4224. The current signage is shown on the plan below.

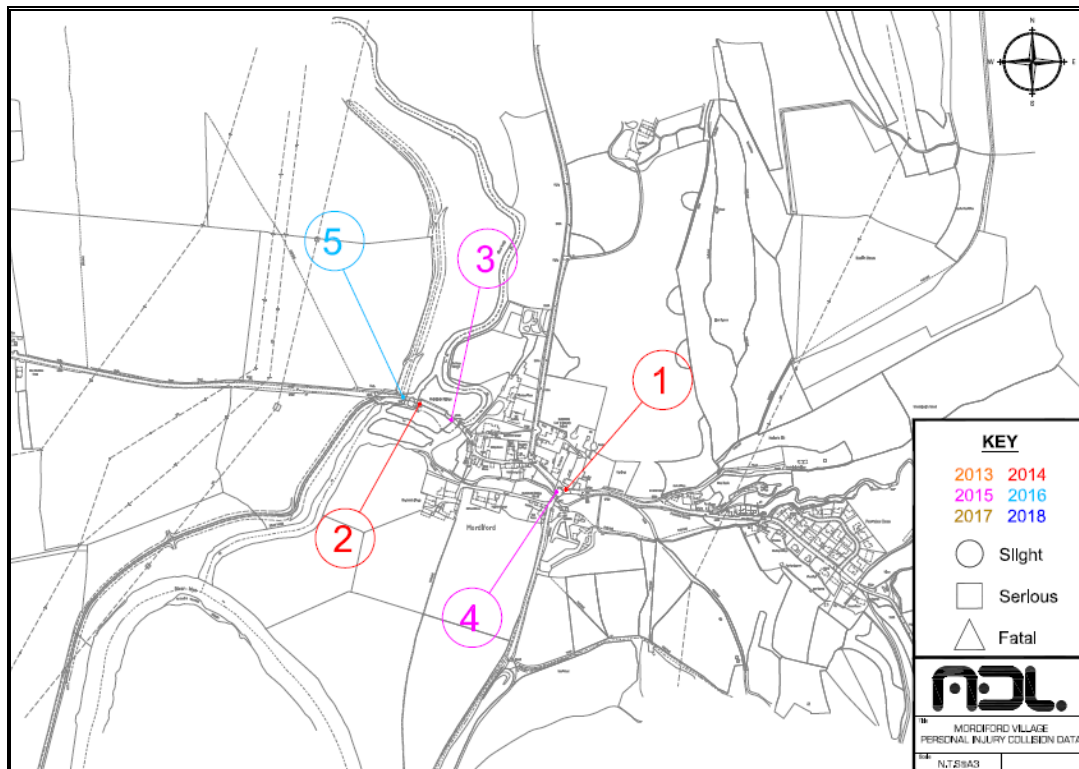
Plan Location	Date	Brief Description
1	13/07/2014	Driver of a vehicle failed to look properly and was likely using mobile phone while driving, collided with a cyclist while turning right onto the C1297. The collision was classed a slight.
2	18/07/2014	A driver of a vehicle failed to stop on time and hit the rear of the car which had stopped on the bridge to allow oncoming vehicles to pass. The collision was classed a slight.
3	10/02/2015	A driver of a vehicle failed to stop on time and hit the rear of the car which had stopped on the bridge to allow oncoming vehicles to pass. The collision was classed a slight.
4	19/06/2015	Driver of a vehicle lost control whilst negotiating the bend on B4224 adjacent to the C1297 and veered onto the path of an oncoming vehicle. The collision was classed a slight.
5	16/08/2016	A driver of a vehicle failed to stop on time and hit the rear of the car which had stopped on the bridge to allow oncoming vehicles to pass. The collision was classed a slight.

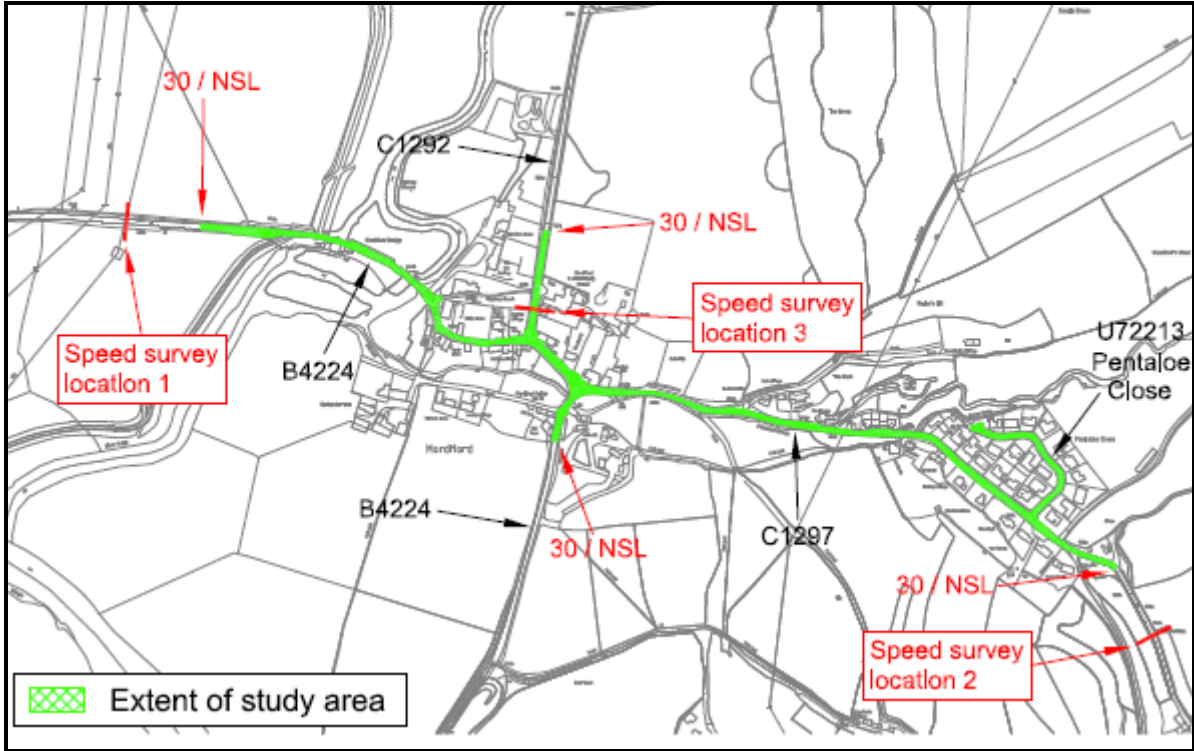
The speed surveys were undertaken at three locations in Mordiford; one on the B4224 in the west end of the village, second on the C1297 on the east end of the village and third on the C1292 opposite the school. The table below depicts the average 85th percentile speeds recorded over a seven-day period commencing on 20th June 2018 at these locations.

Eastbound	Westbound
Location 1 (B4224)	44.8mph	48.5mph

Northbound	Southbound
Location 2 (C1297)	31.2mph	26.0mph
Location 3 (C1292) adjacent to school	33.3mph	32.7mph

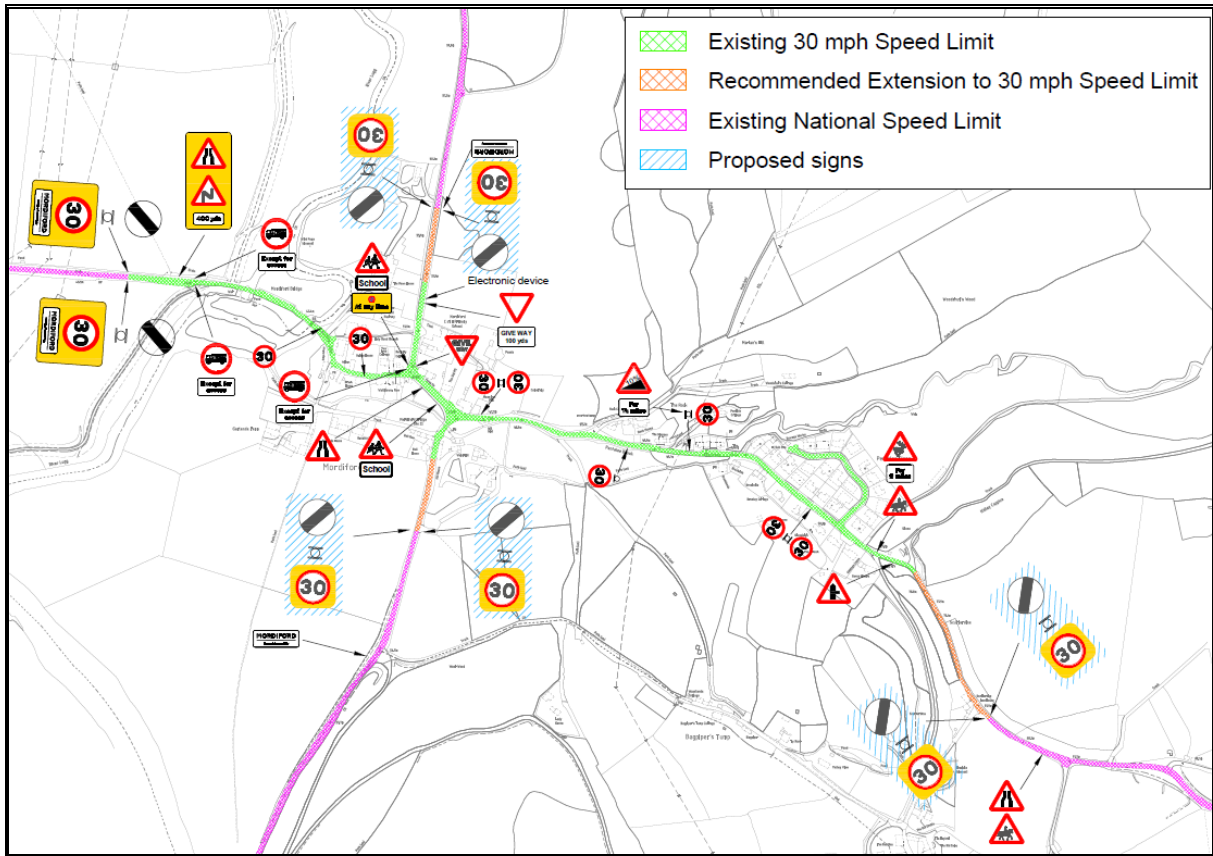
The recommendations are shown on the plan on the next page:

It is not recommended to extend the current 30 mph speed limit on the B4224 to the west of Mordiford Village westwards.

It is recommended to extend the current 30 mph speed limit on the B4224 to the south of the village by further approximately 75 metres. A village name sign could be placed on the east side of the carriageway due to the availability of adequate verge width.

It is recommended to extend the current 30 mph speed limit on the C1297 to the east of the village to a location adjacent to Scutterdine Cottage.

It is recommended to extend the existing 30 mph speed limit further northwards by approximately 100 metres to coincide with the current village name sign and could be co-located with 30 roundels with red surfacing.

1. Display the 30 speed terminal signs on the C1292 on the yellow backing boards.
2. Display the 30 speed terminal signs on the B4224 (south) on the yellow backing boards and investigate the possibility of implementing a village name sign on the east side of the carriageway.
