**Peterchurch Primary School**

Stage 1 - Feasibility Study

5<sup>th</sup> July 2019

Hayhurst & Co Architects

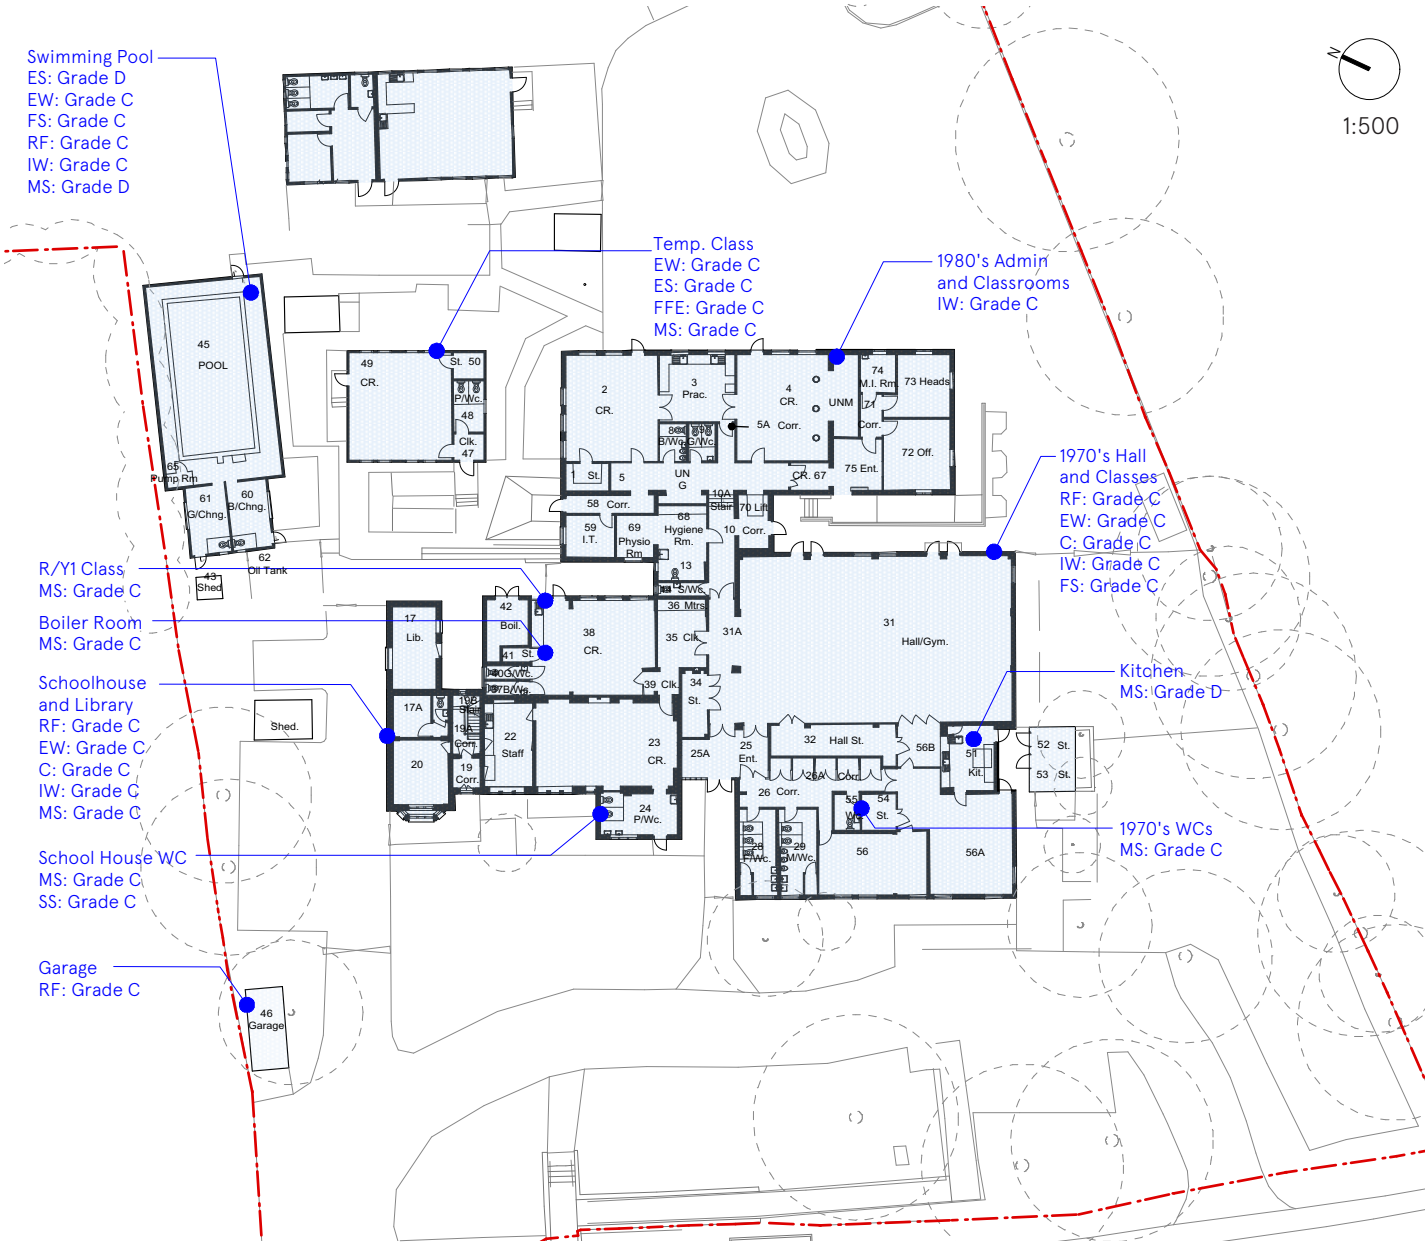
The majority of the building fabric has been identified as Grade B (Satisfactory) except for where shown on the adjacent diagram as Grade C (Poor) and Grade D (Bad). Please see Condition and Compliance Survey for full information and priority gradings.

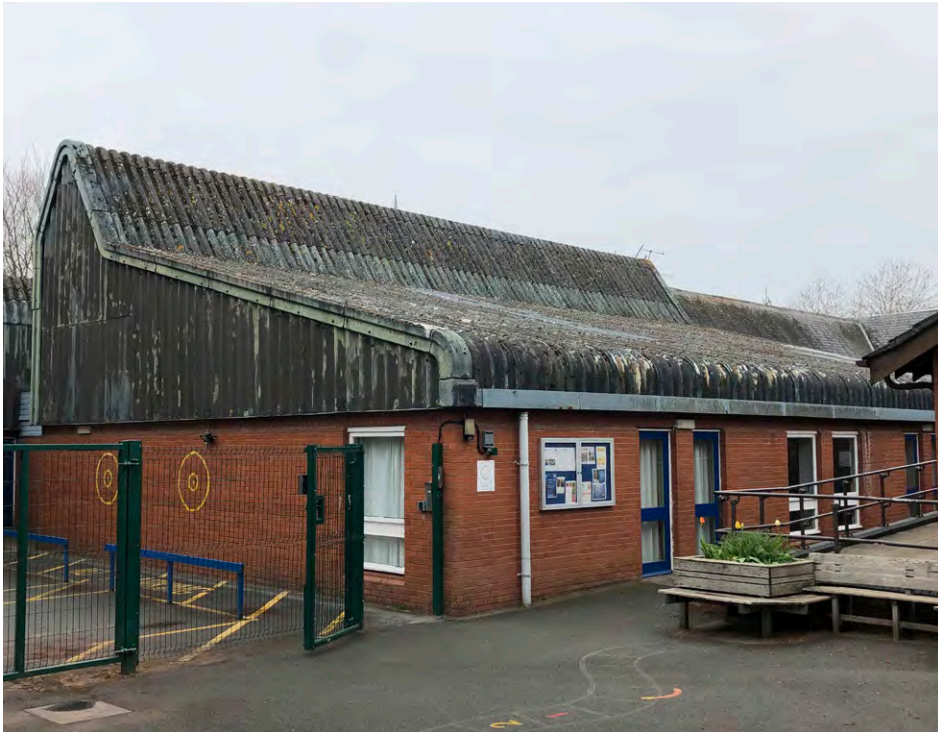
In the main school building, there are many signs of cracking to the wall finishes. Other ceiling finishes in disrepair include cracked, damp, stained and dated suspended ceiling tiles. The asbestos roof has been failing and water ingress has led to failure of the plasterboard ceilings. There are numerous leaks to the roof throughout the building. Externally the main building is in fair condition. The condition report recommends remedial works to the mortar and other effected elements.

Asbestos cement sheet roof to hall and classrooms to the front of the site

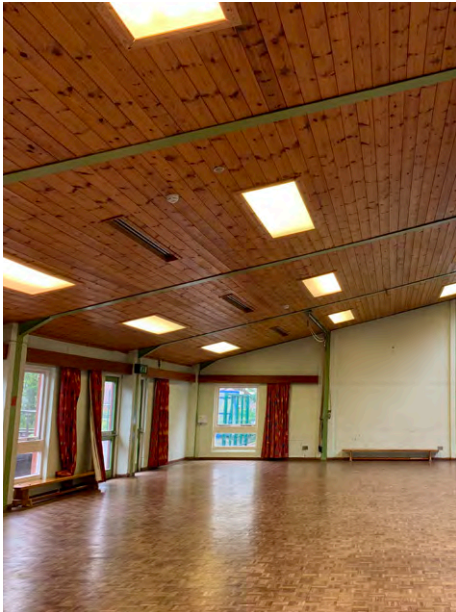
Existing hall ceiling which is subject to leaks and requires remedial works

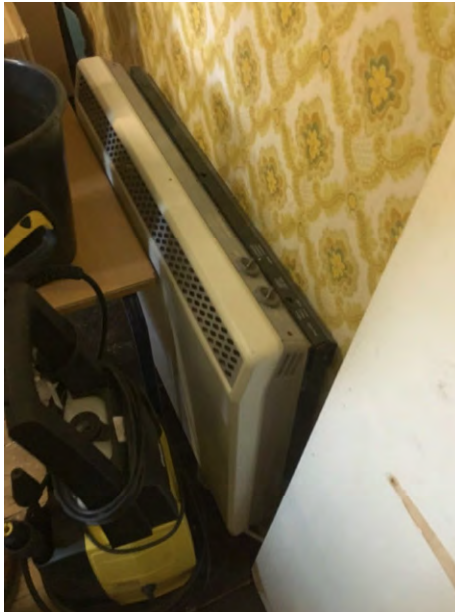
The condition survey identifies urgent works relating to the replacement of the existing heating plant and equipment, extract fans, electric hot water heaters,

electric space heaters Sub electrical distribution boards all of which are considered to have reached the end of their serviceable life and operate at an increased risk of failure or offer a poor performance. The report also recommends the removal of a redundant kitchen ventilation system and unused and uncertified lifting hoists. It is also recommended that mechanical extract ventilation is provided to toilet areas throughout the building which currently rely upon passive ventilation.

Example of the existing electric heaters - existing system identified as requiring replacement

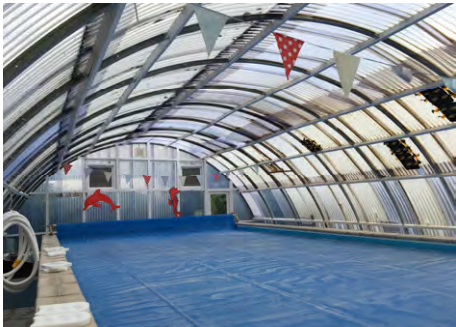
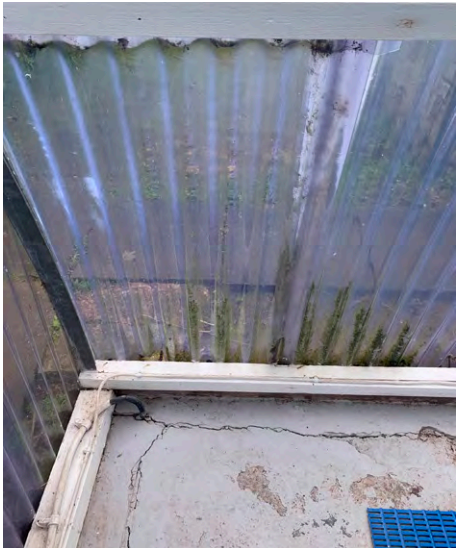
The swimming pool building is in poor condition with many signs of inadequate repair to the polycarbonate roof. The vents and the concrete slab floor are also in poor condition. The timber cladding to the pool plant room is also in poor condition.

Poor condition swimming pool poly tunnel roof and concrete slab

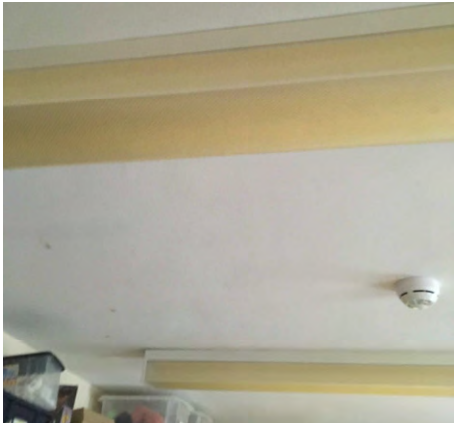
Example of the existing lighting installation- highlighted for replacement

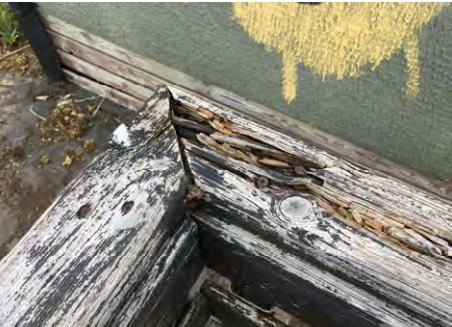
The mobile classroom on site is in fair condition, however the access ramp is in poor condition affected by timber decay to the timber joints.

Poor condition of ramp to temporary classroom

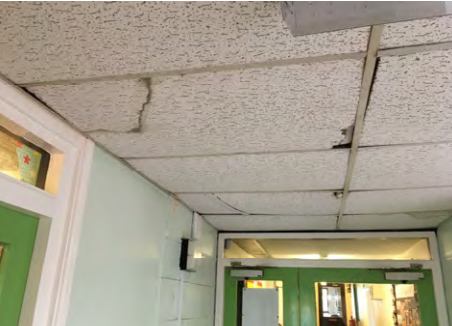
Ceiling tiles- require replacement

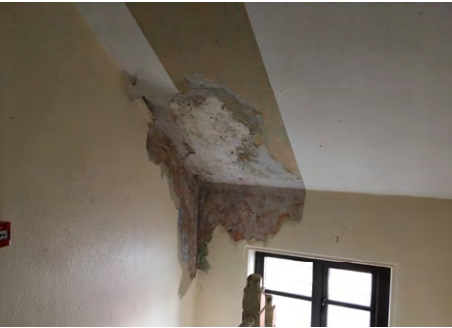
Severe water damage above staircase

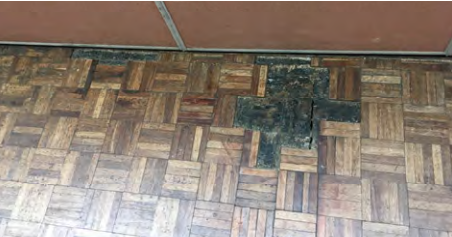
Lifting parquet hall flooring

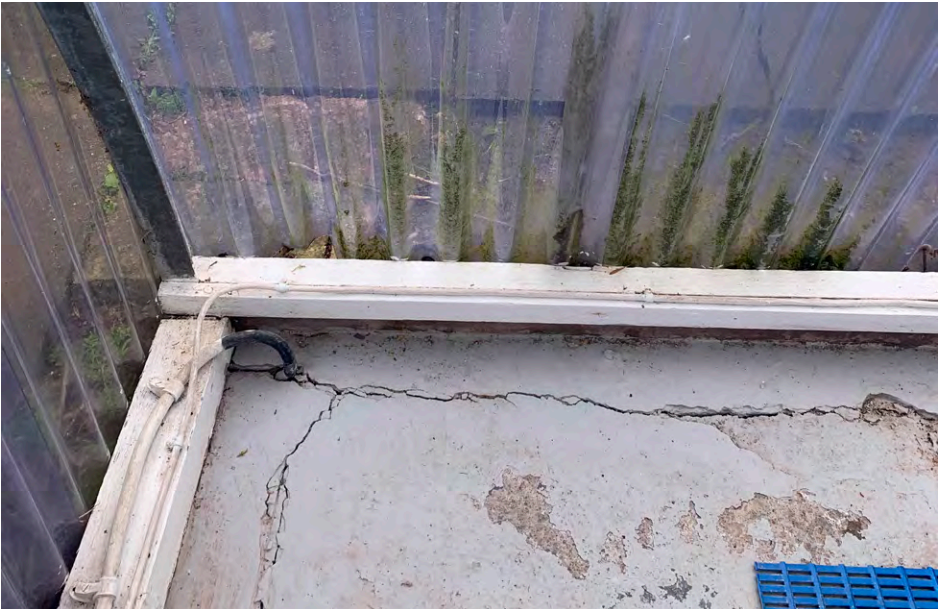
The condition survey has highlighted the concrete floor as requiring attention. See condition survey for detailed analysis of existing condition.

Cracked concrete floor to the swimming pool, with algae growth on the polytunnel roof.

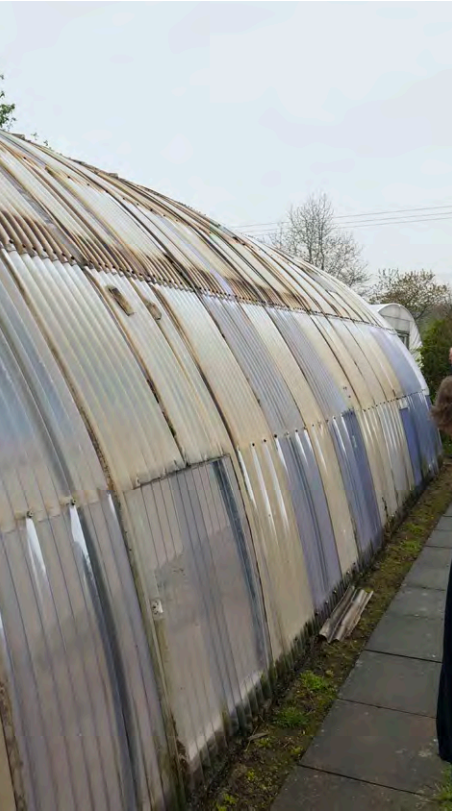
The swimming pool is raised above the ground, enclosed under a poly-tunnel with a shed-type structure at one end that provides changing facilities. The swimming pool is a great asset to the school and is used frequently, however the covering is in poor condition, no longer water tight, and the changing facilities are small with minimal WC provision.

Exterior of Swimming Pool Polytunnel roof
