# Partnership Meeting

## Wye Catchment Nutrient Management Board

# River Lugg SSSI Condition Assessment (2026)

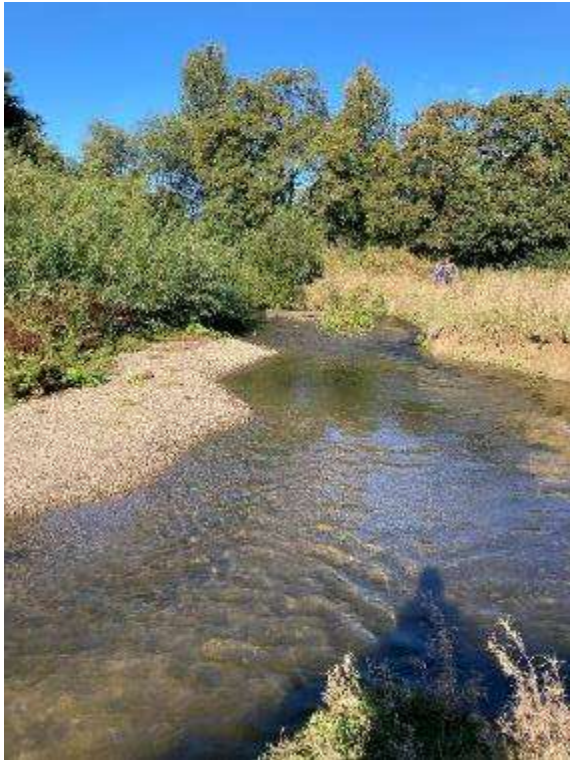
**Figure 29. RHS Site 1, HMC = 2. Naturally functioning section of River, intermediate weir reduces overall HMC. Maize field in adjacent floodplain with limited riparian buffer.**

Limited physical restoration is required along this unit to achieve favourable condition. Restoration efforts should focus on removal of redundant in-channel structures including weirs and groynes.

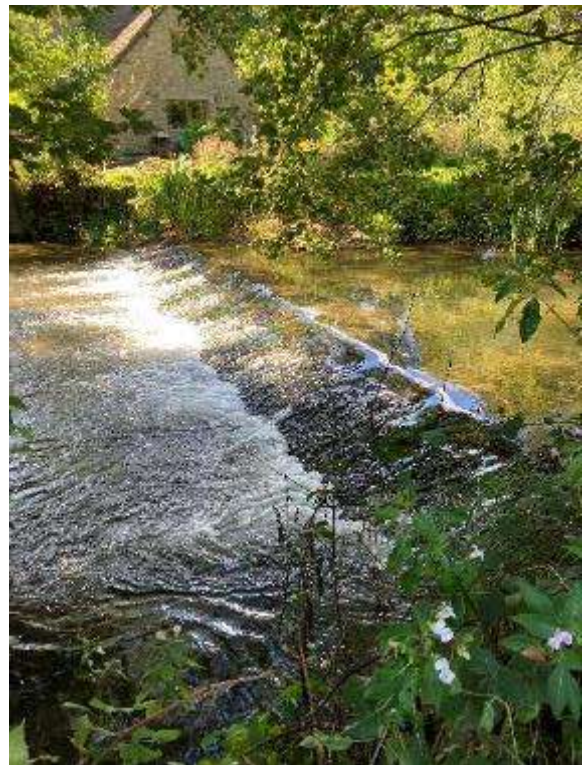
**Figure 30. RHS Site 3, HMC = 2. Score impacted by minor ford and poaching. Adjacent habitat low intensity cattle grazing.**

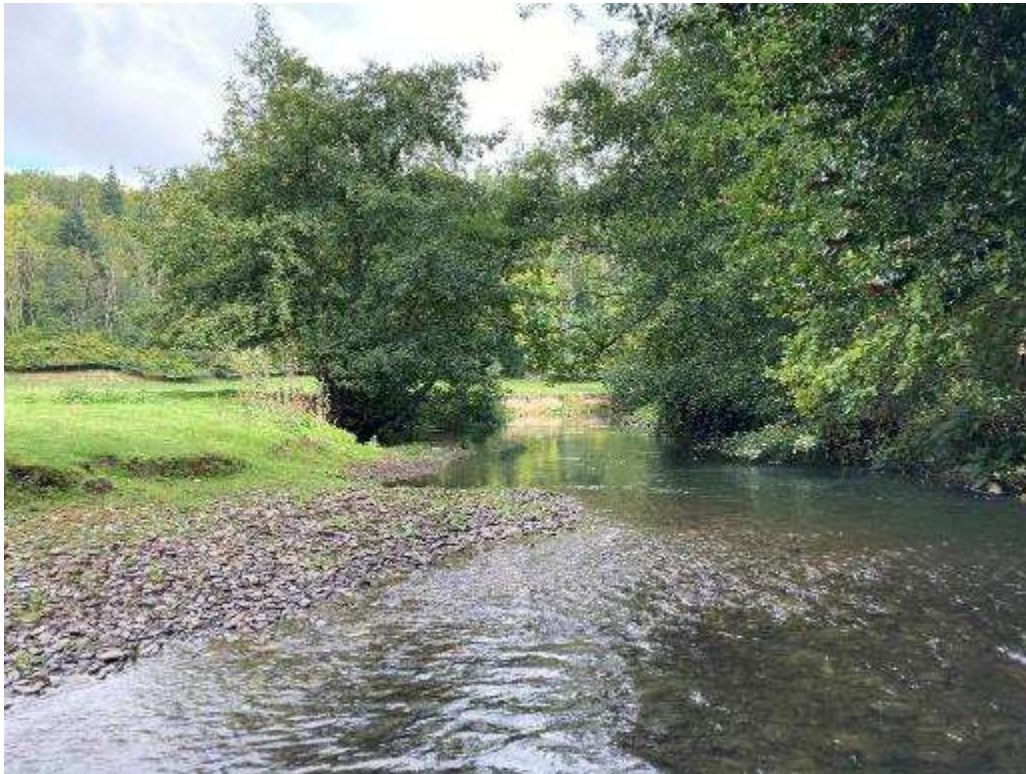
**Figure 32. RHS Site 3, HMC = 1. Pristine reach, floodplain land use low intensity cattle grazing and broadleaf woodland. Otter signs present.**

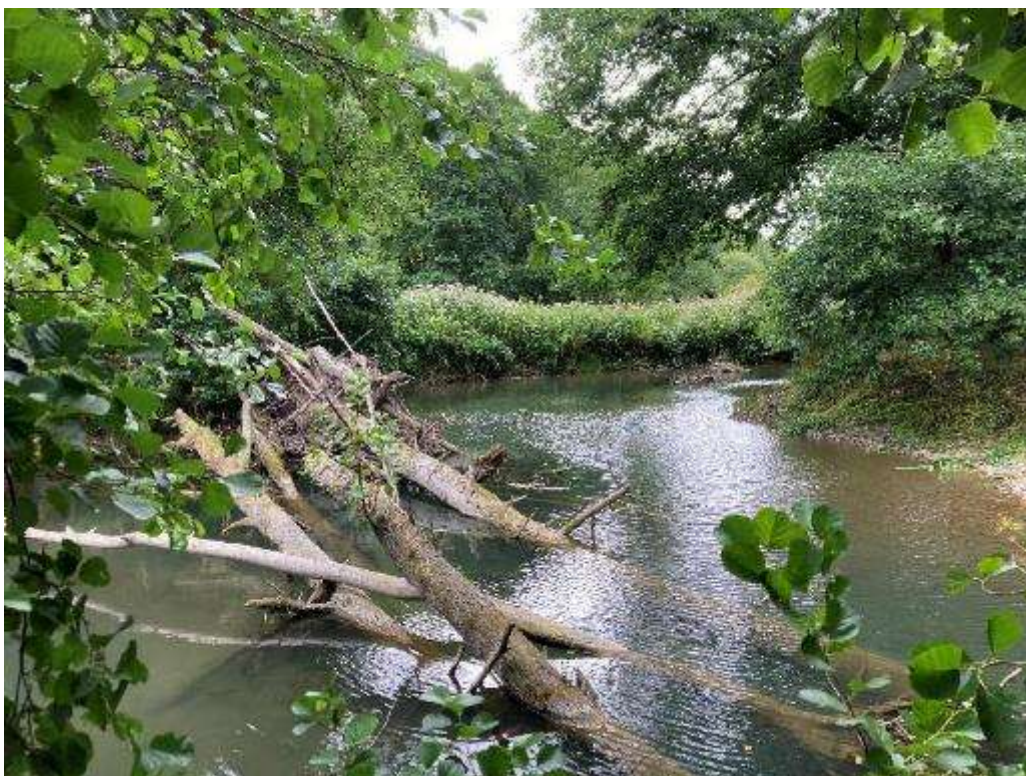
**Figure 31. RHS Site 4, HMC = 1. Natural reach of river with fallen trees. Extensive Himalayan balsam on right bank.**

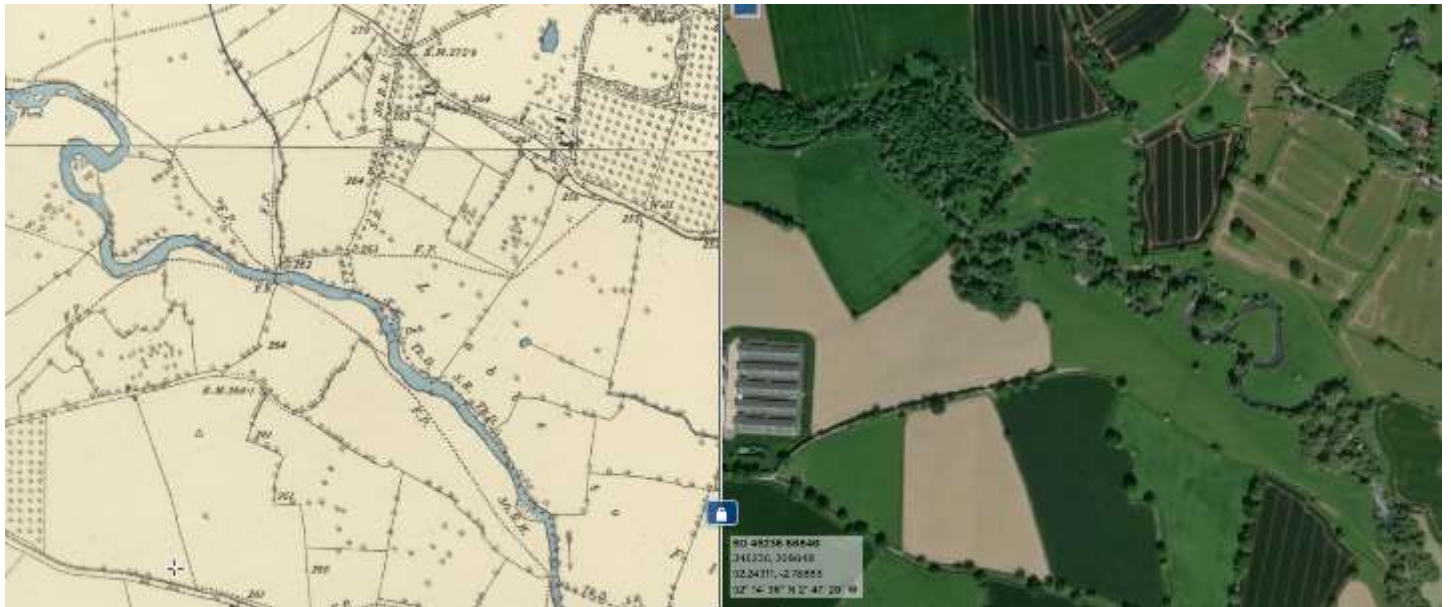
**Figure 33. Comparison Historic Map (OS 1830 – 1880 country layer) to ESRI World Imagery 2026. Note development of meanders in right hand image (2026).**

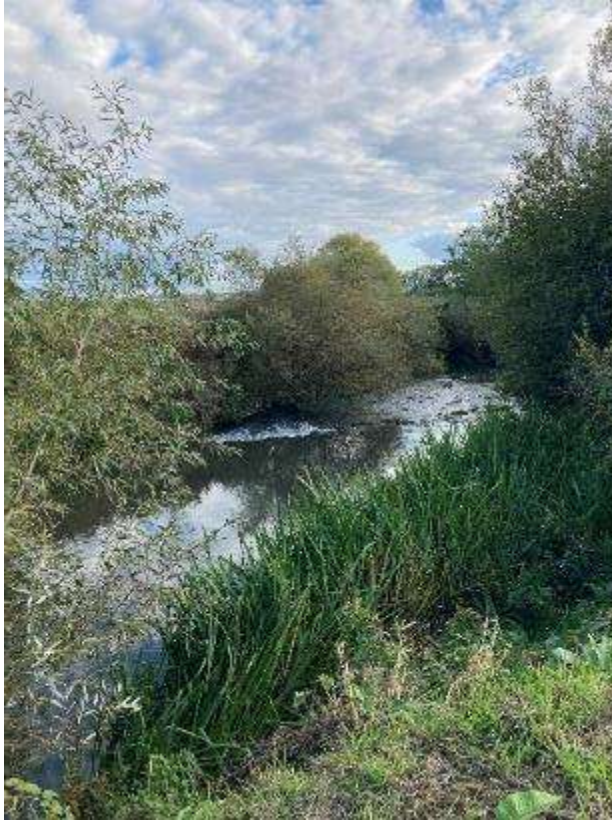
**Figure 37. RHS Site 5, HMC = 2. Left bank land use broadleaf woodland, right bank improved grassland and arable.**

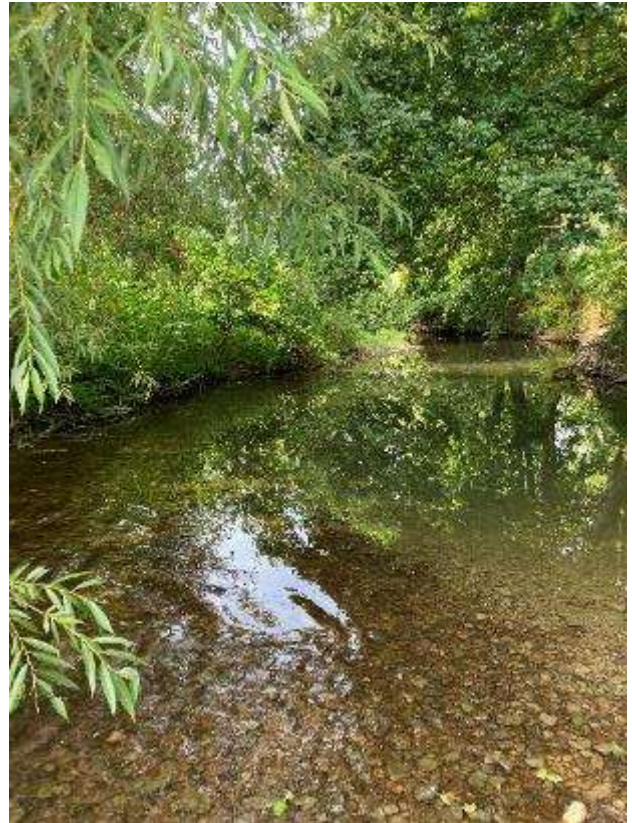
**Figure 36. RHS Site 6. Natural functioning reach of river. Land use semi-improved grassland with patches of broadleaf**

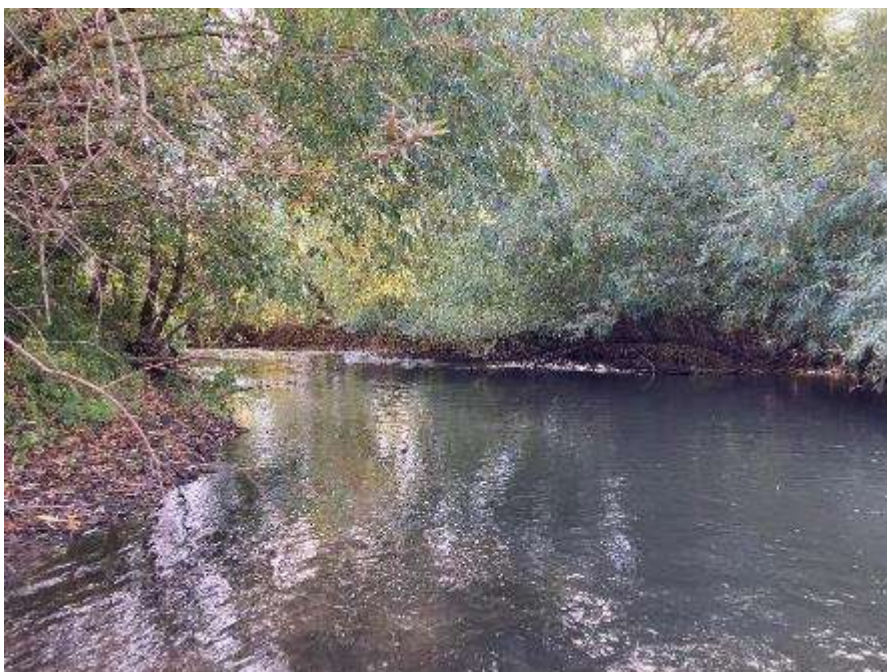
**Figure 35. RHS Site 5. Broadleaf woodland provides dappled shading along this stretch.**

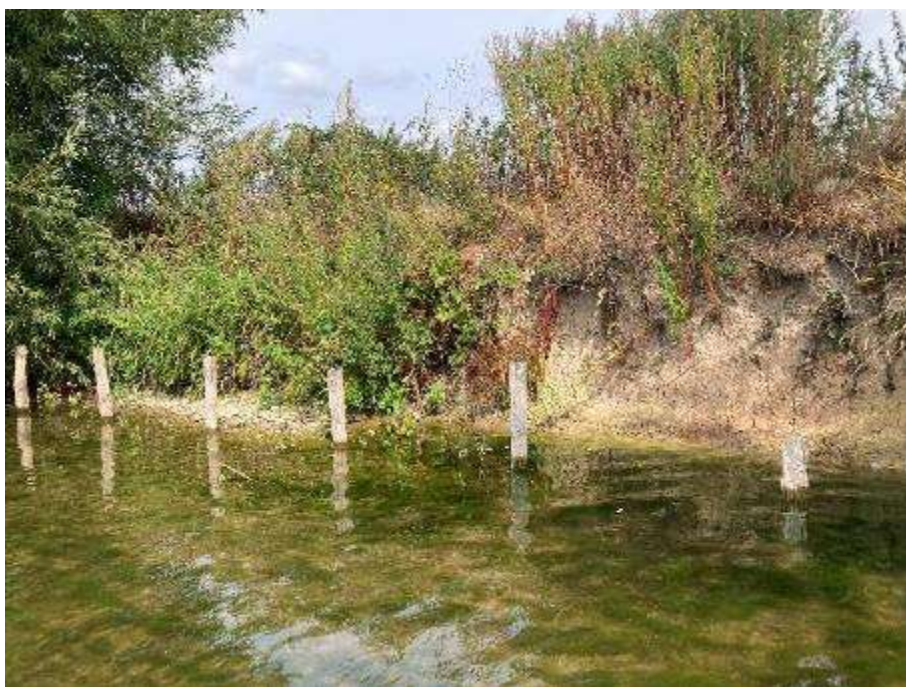
**Figure 38. RHS Site 6. Fence posts reduce habitat modification class. Filamentous algae extensive along this reach.**

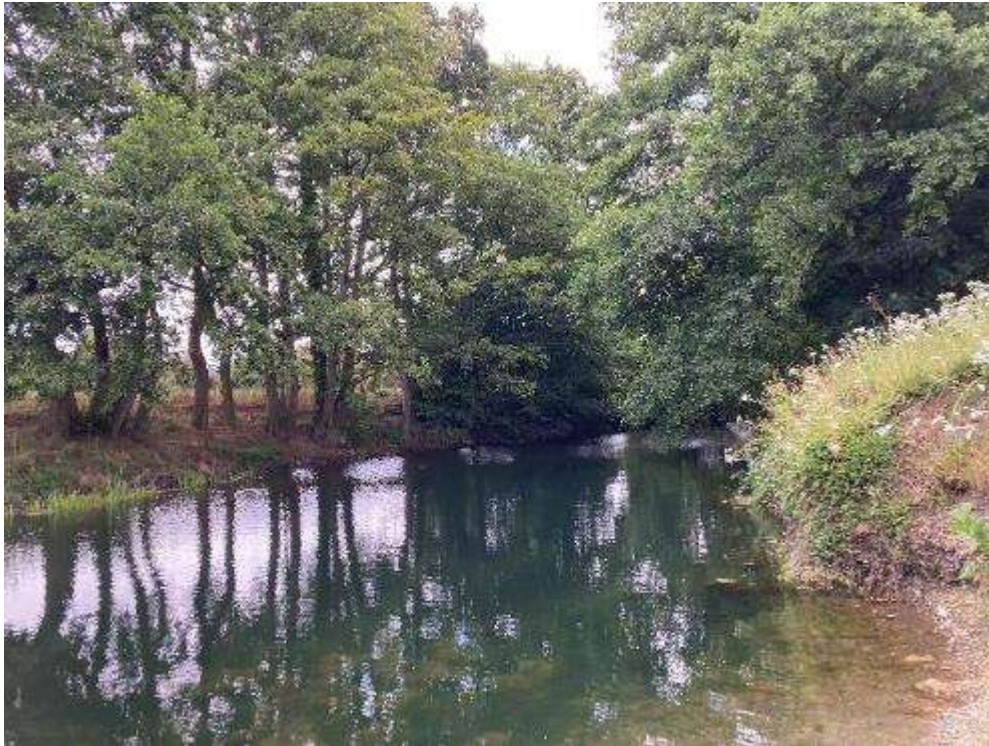
**Figure 41. RHS Site 7. Site historically dredged and embanked, extensive FGA.**

Recommendation: physical channel restoration to re-establish floodplain connectivity and restore over deepened and embanked channels should be investigated on a reach-by-reach basis.

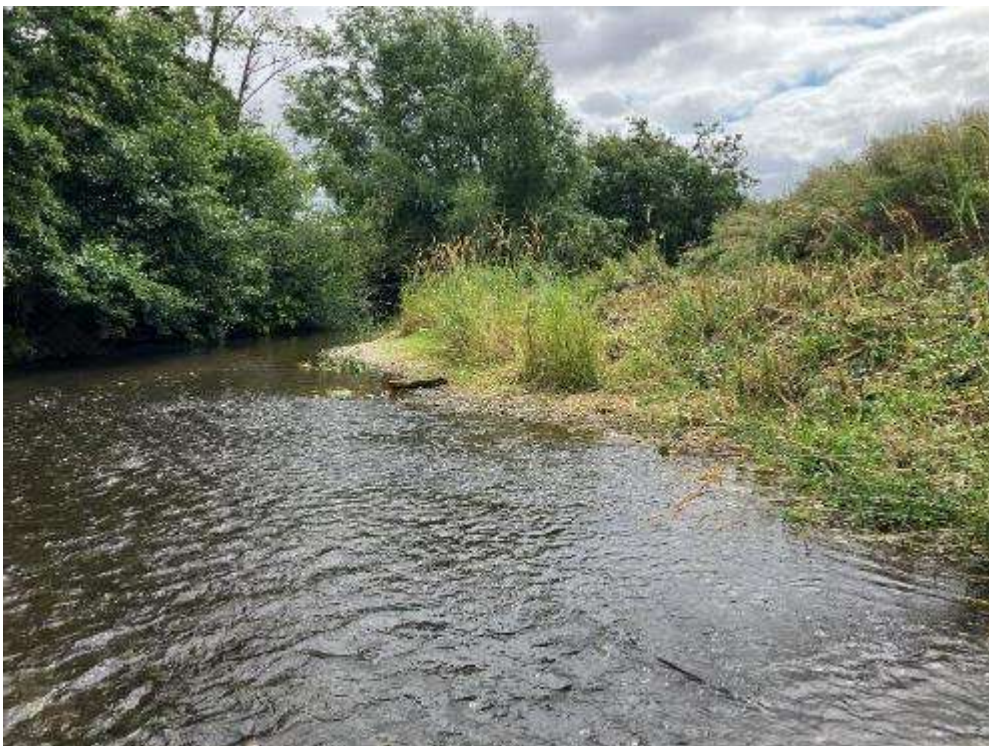
**Figure 40. RHS Site 8. Bank profile and depth more natural in contrast to site 7 upstream (Figure 10).**

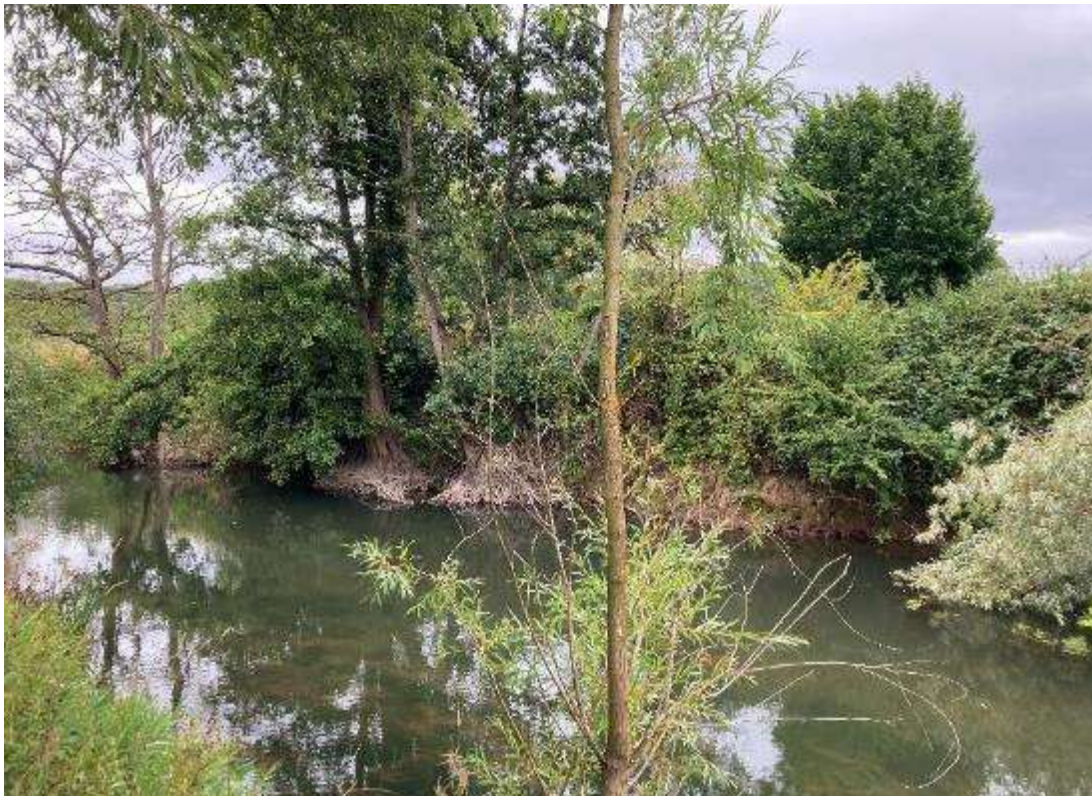
**Figure 43. RHS Site 9. Reach appears over deepened, extensive filamentous algae but some habitat provided by tree features. Banks 3m+.**

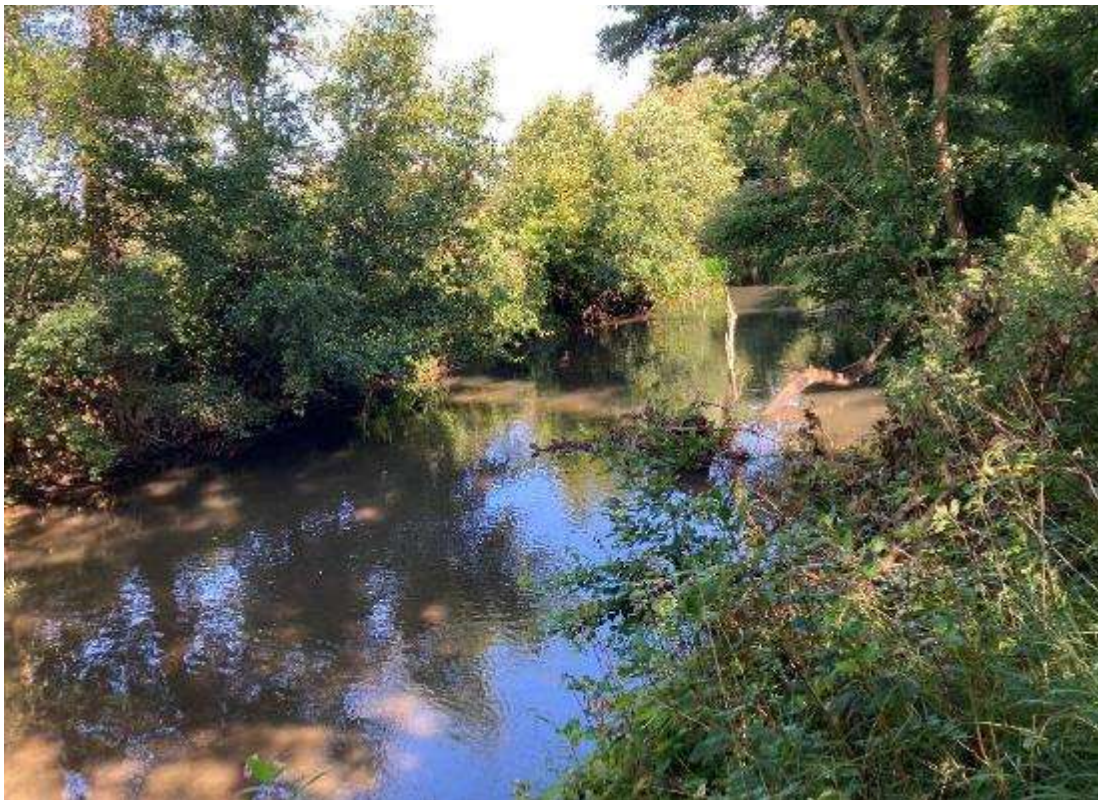
**Figure 42. RHS Site 12. River running along broadleaf woodland, over deepened & heavy siltation pressure.**

Recommendation: understanding the sources of sediment through a sediment fingerprinting study is required to systematically address sedimentation impacts. No regret actions including drain blocking and floodplain conversion from arable to grassland should be initiated.

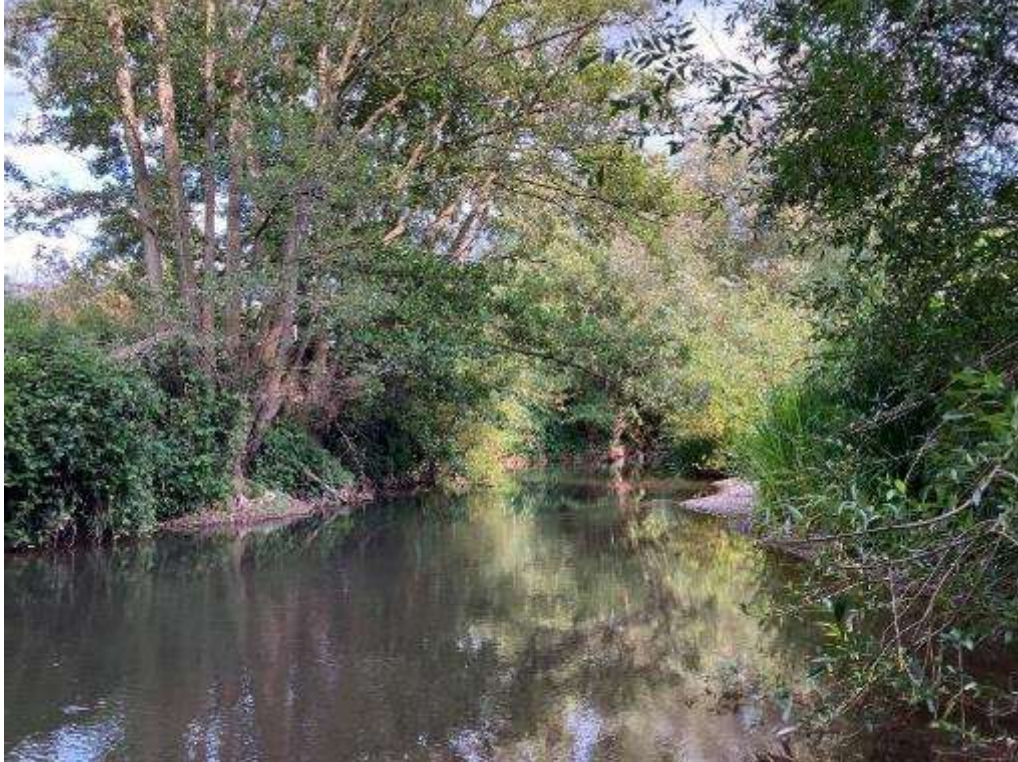
**Figure 45. RHS Site 13. HMC = 1. Site relatively unmodified though the left bank is somewhat high and the river width appears to be wide**

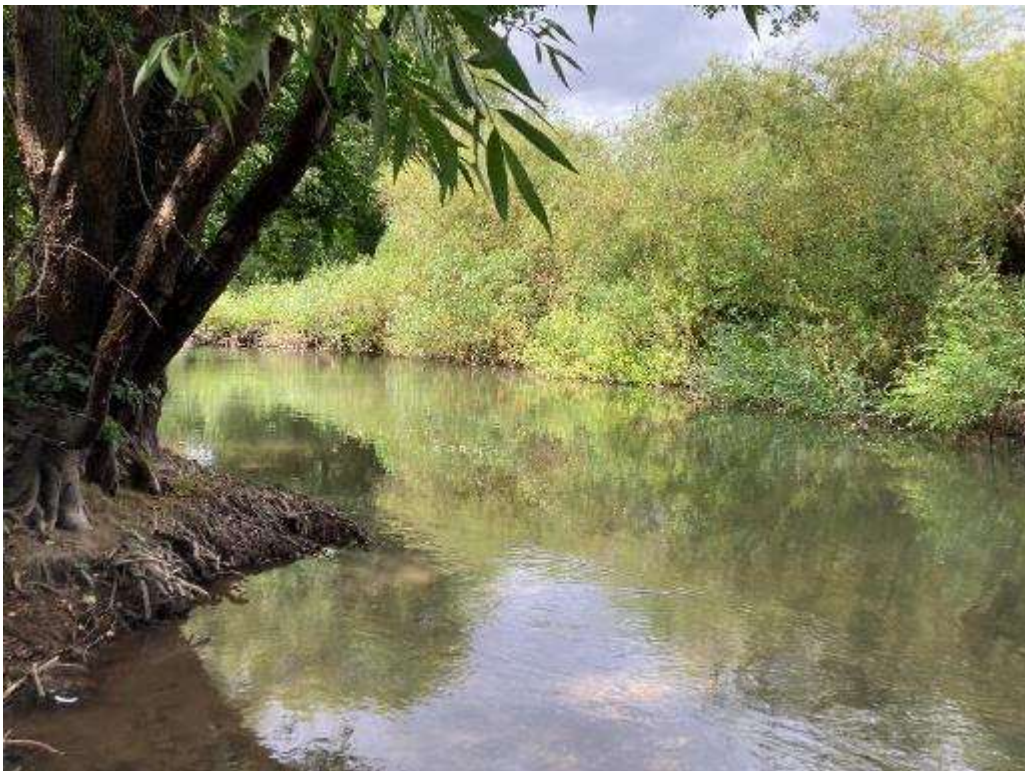
**Figure 44. RHS Site 14. HMC = 5. Significantly over deepened & disconnected from floodplain.**

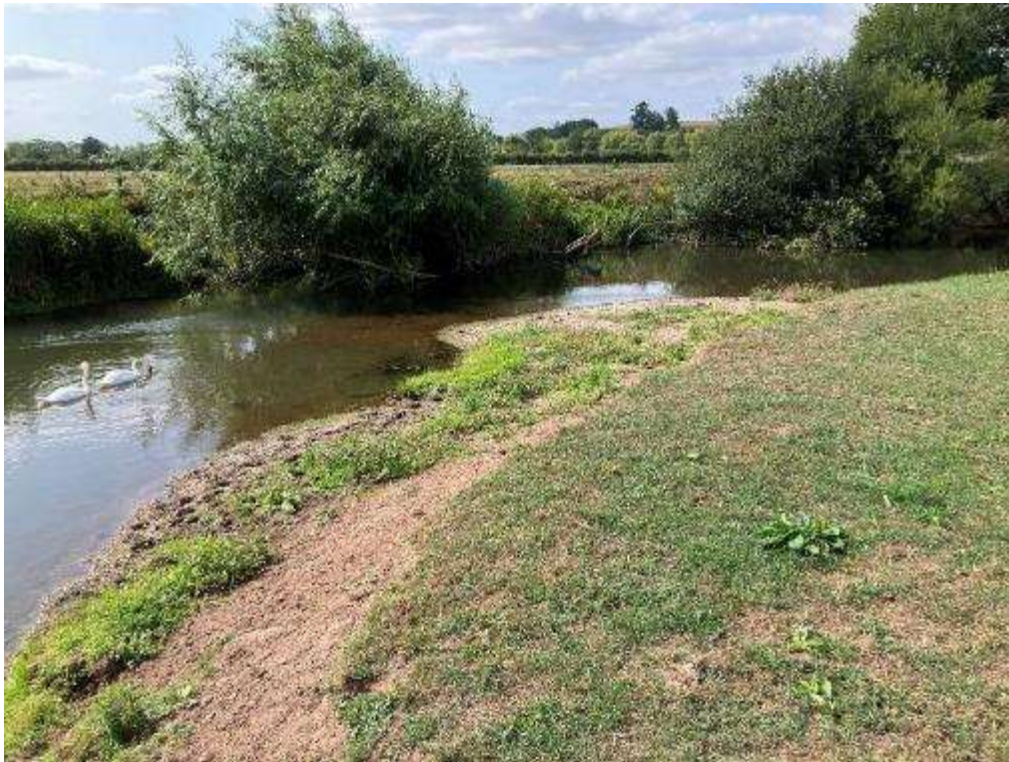
**Figure 47. RHS site 17. HMC = 2. Note poaching from livestock.**

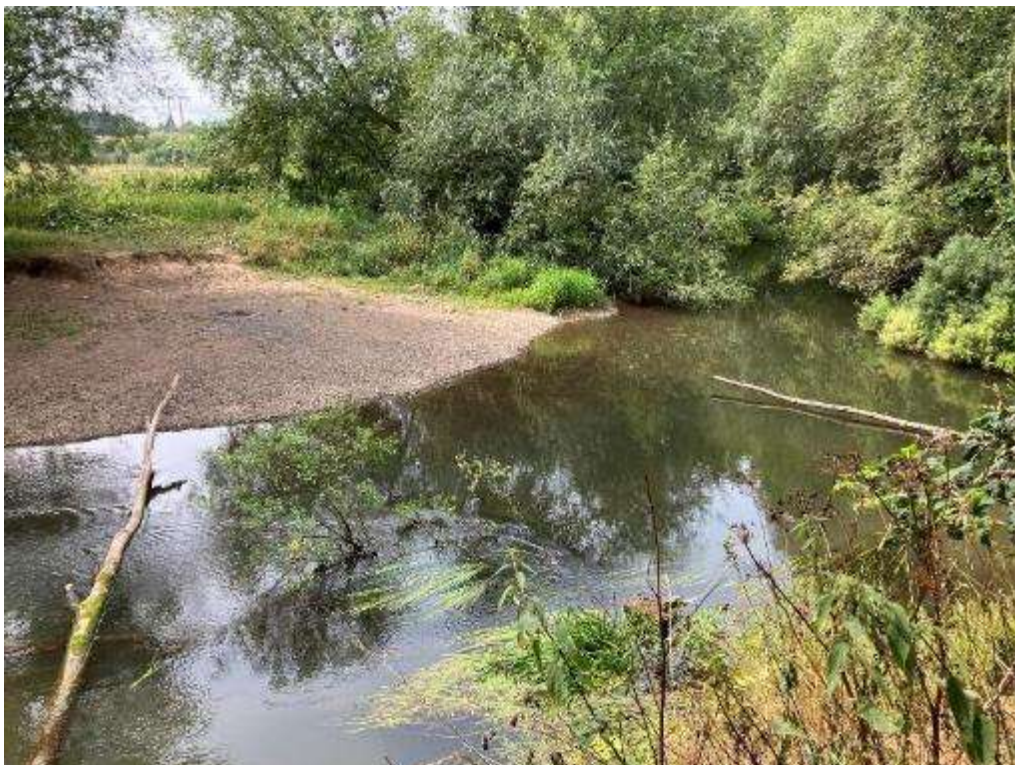
**Figure 46. RHS Site 18. HMC =1 Relatively unmodified stretch of river**

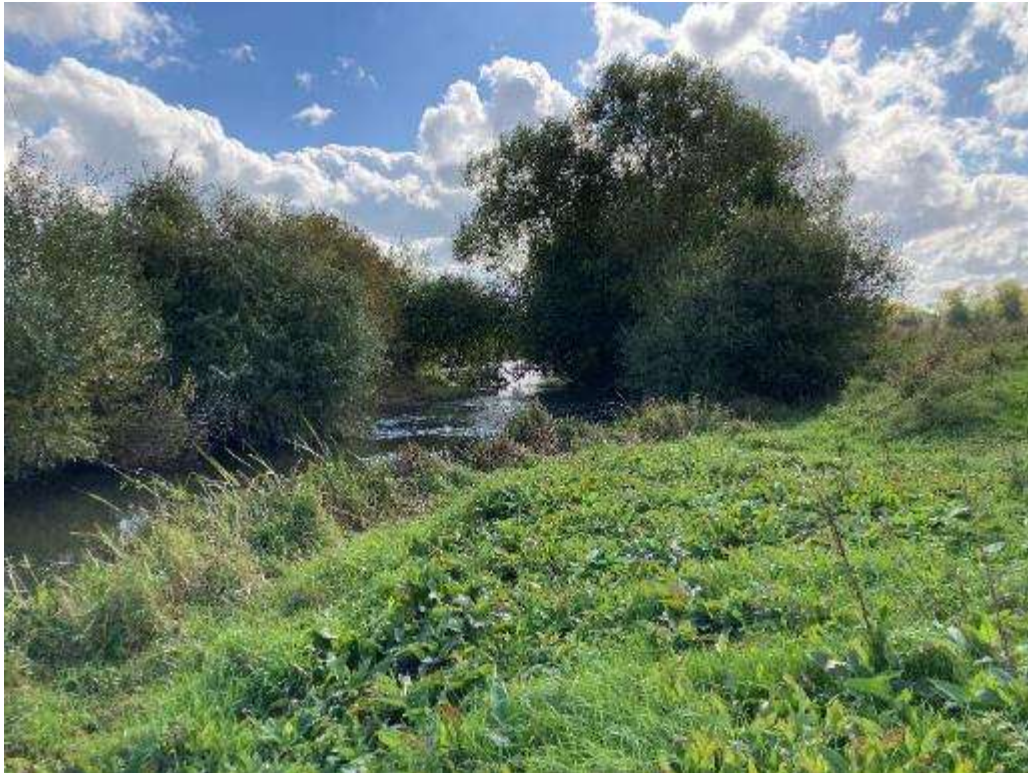
**Figure 49. RHS Site 20. HMC = 3. Site score impacted by major bridge.**

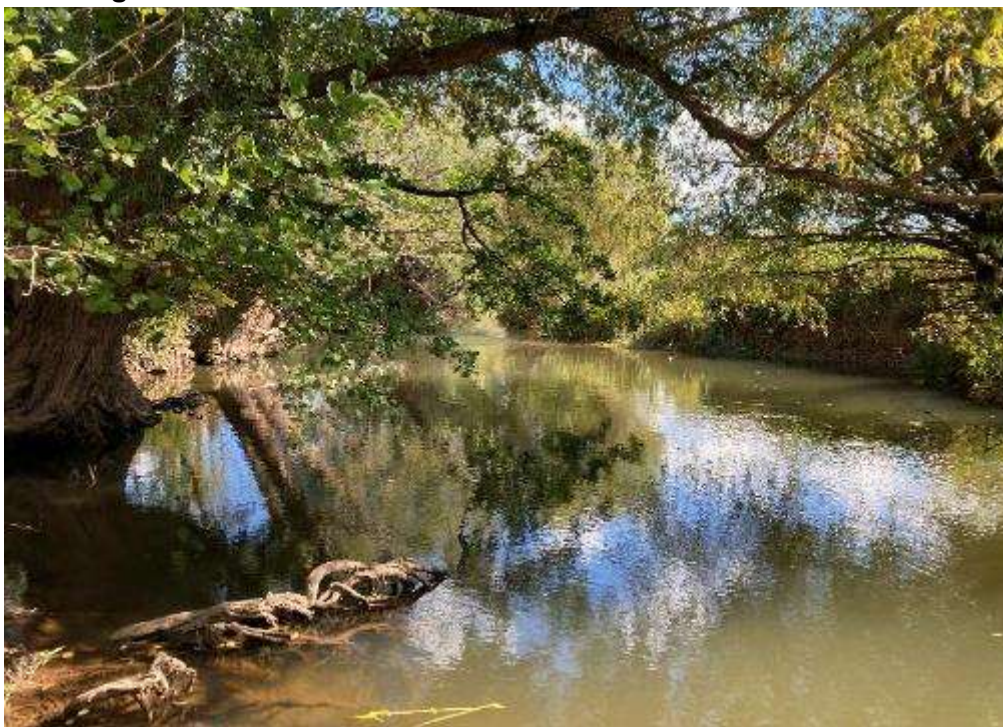
**Figure 48. RHS Site 21. HMC = 4. Site over deepened, embanked and heavily silted. Some positive habitat features formed by trees, including submerged tree roots**

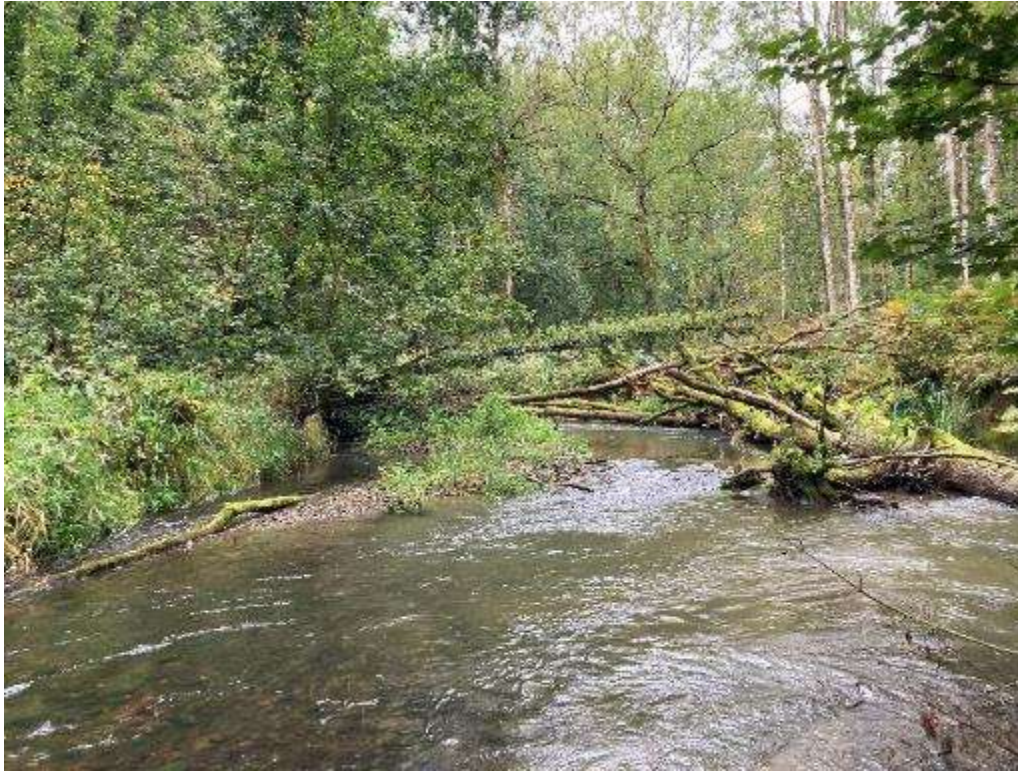
**Figure 59. RHS Site 3. Woody debris log dam which has created a mid-channel bar. The mid channel bar had extensive evidence of otter feeding.**

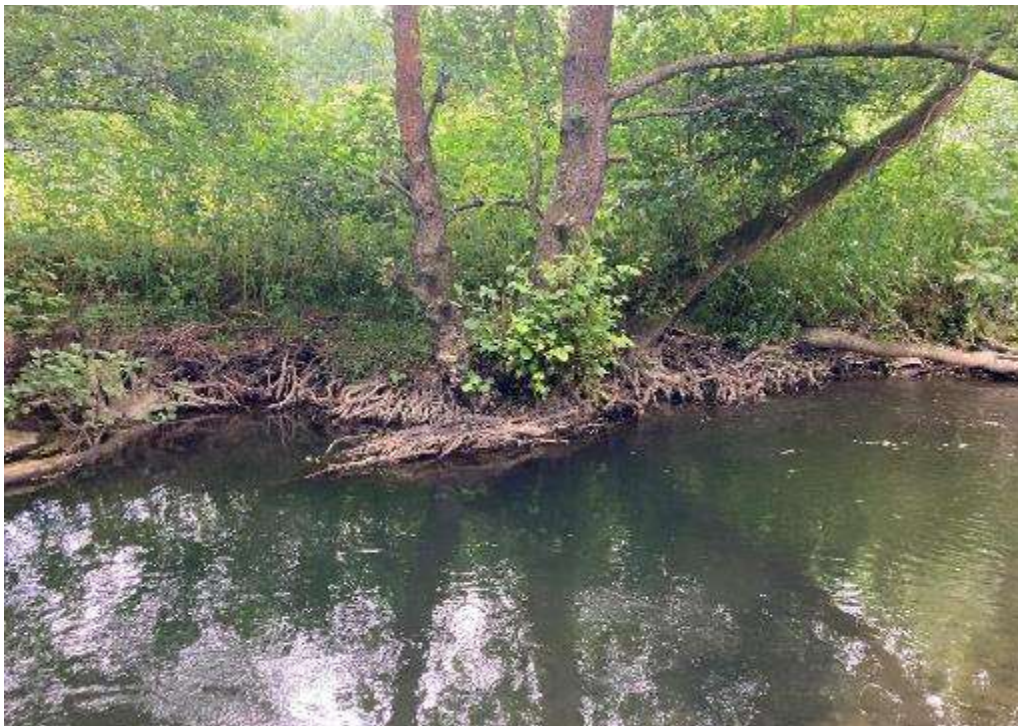
**Figure 58. RHS Site 4. Tree roots bind the bank and also create refugia sites for fish to hide from predators, stay cool in summer and rest during the daytime during upstream migration.**

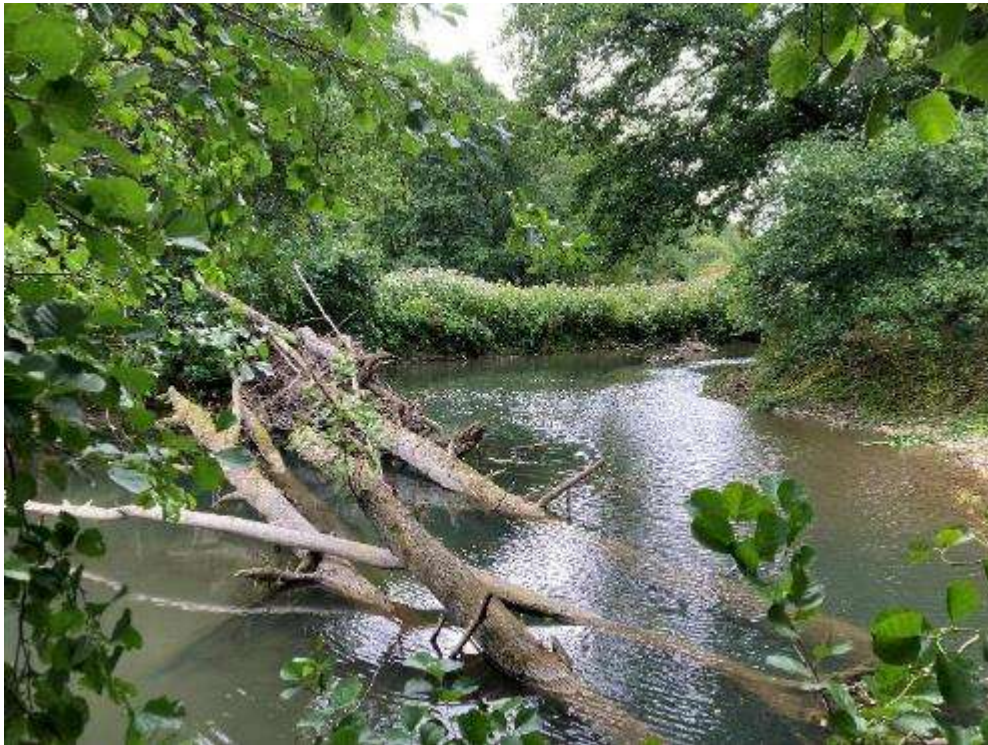
**Figure 61. RHS Site 4. Large stand of Himalayan Balsam along bank top.**

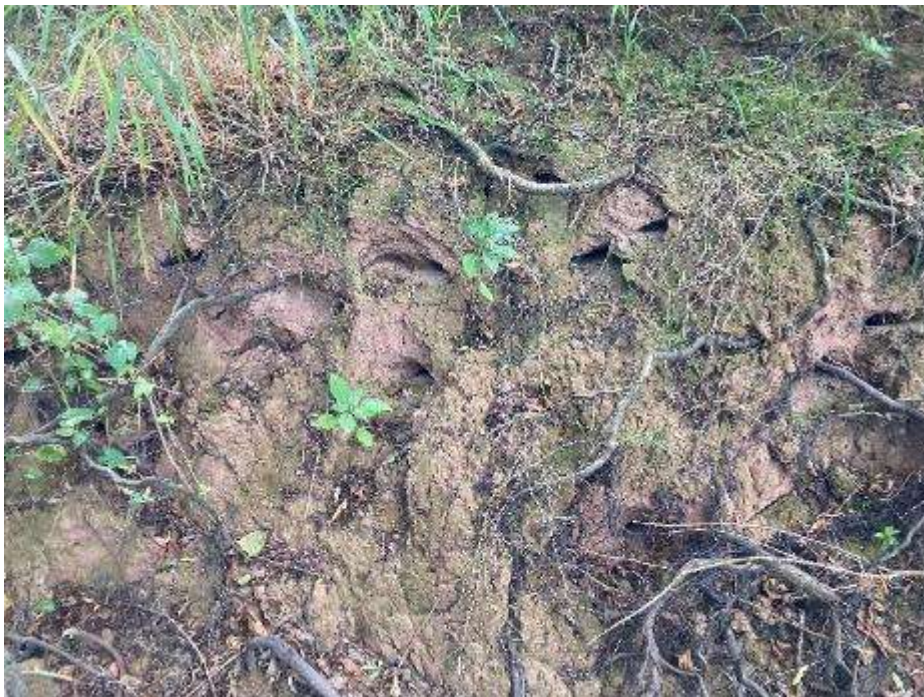
**Figure 62. RHS Site 14. Crayfish burrows recorded extensively along the River Lugg.**

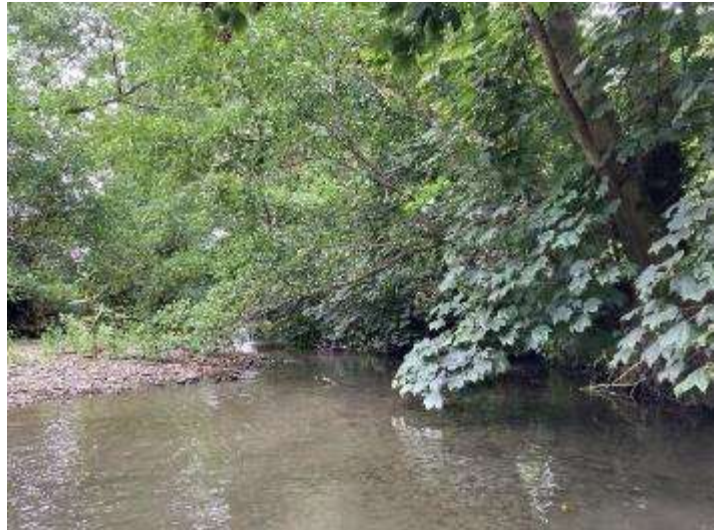
Figure 64. River Lugg Macrophyte Site 1.

*Cladophora/Rhizoclonium* (C2), Zygnematales (C4), *Fontinalis antipyretica* (C3), *Oenanthe crocata* (C3) & *Ranunculus* (Batrachian) (C3). The RMNI status is higher than expected (6.99 – 6.02) and the number of expected taxa and functional groups is slightly below expected (taxa - 7.03 – 8.830. NFG – 4 – 5.63). Diatom cover 50-75%, identified as *Melosira varians* by J. Doe. Filamentous algae cover 20%, which is likely driving the Good classification status. Site likely impacted by nutrient enrichment.

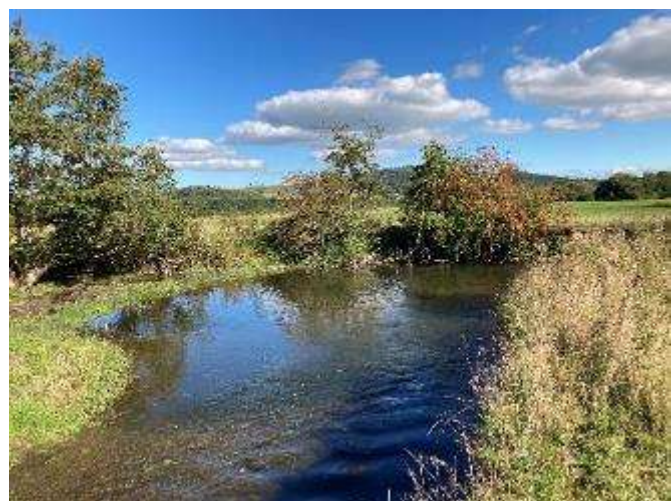
Figure 65. Macrophyte site 2

The river is geomorphologically intact along this reach with good species diversity. Fully wadable; clear/cloudy mix; gravel pebble mostly run habitat. The RMNI status is higher than expected (6.6 – 6.1) and the number of expected taxa and functional groups is slightly higher than expected (taxa – 14 – 8.89. NFG – 6 – 5.67). Diatom cover <0.1 %. Gravel bar with diverse and typical vegetation. Filamentous algae cover 30%, which is likely driving the Good classification status. Site likely impacted by nutrient enrichment.

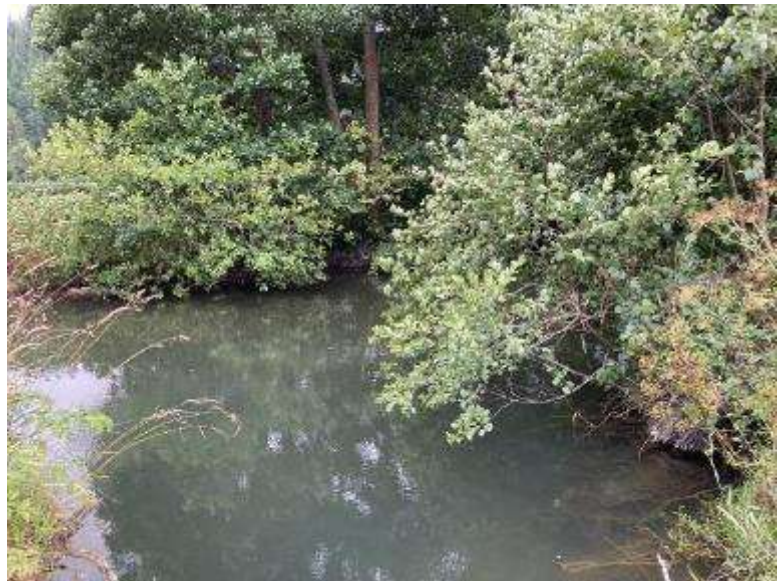
Figure 66. Macrophyte Site 3.

The river is geomorphologically intact along this reach. Only 50% wadable, fast, deep runs, unstable bed; little slack habitat & 100% cloudy. The RMNI status is higher than expected (7.5 – 5.9) and the number of expected taxa and functional groups is lower than expected (taxa 5 – 7.9. NFG – 3 – 4.67). Diatom cover not recorded, probably >50%. Algae cover along this reach was significantly higher than the upstream sites. *Cladophora glomerata* was recorded covering 25 – 50% of the channel with total algae cover estimated at 45%. High algae cover & lower than expected species diversity is driving the poor classification score.

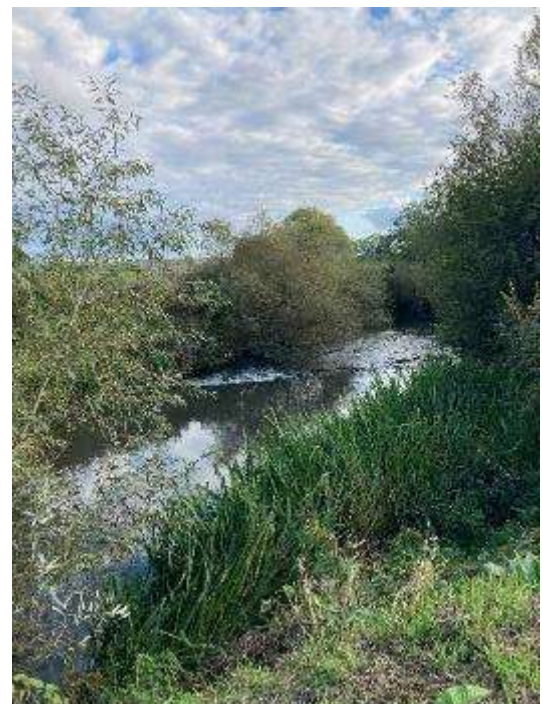
Figure 67. Macrophyte Site 4.

Geomorphologically highly natural reach with fairly high species diversity. Fully wadable. clear; very coarse bed (50% cobbles); unstable (98%). Very few vascular plants. Number of taxa and functional groups both higher than expected. RMNI also slightly higher than expected (6.45 – 6.09). Filamentous algae cover ~3%. High status is driven by low algae, high species diversity and geomorphology-appropriate community. Site passing for plant community attribute.

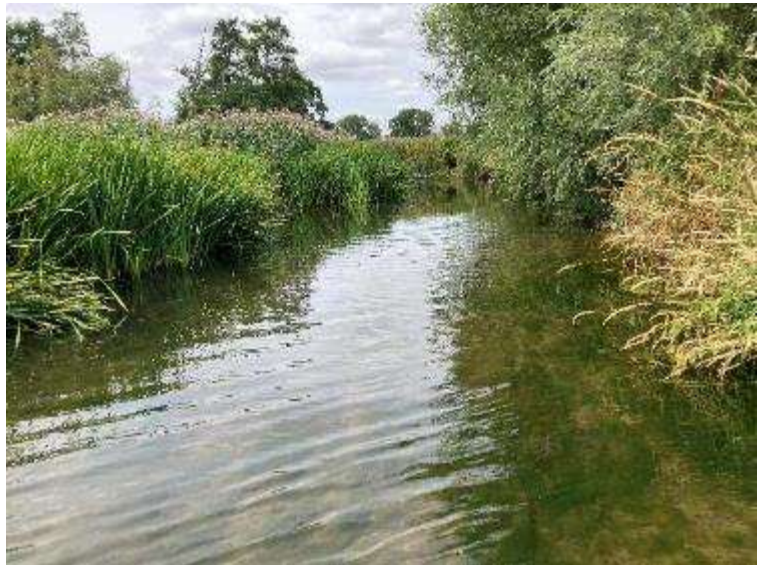
Figure 68. Macrophyte Site 5.

Geomorphologically intact reach. 70% wadable, heavy silt load; mostly glide habitat. Species diversity lower than upstream sites. RMNI higher than expected (7.73 – 6.35) and number of taxa and functional groups also lower than expected (taxa – 5 – 8.4. NFG – 3 – 5.38). Filamentous algae cover estimated ~30%. Silt-influenced, algal-dominated reach with low species diversity driving Poor status.

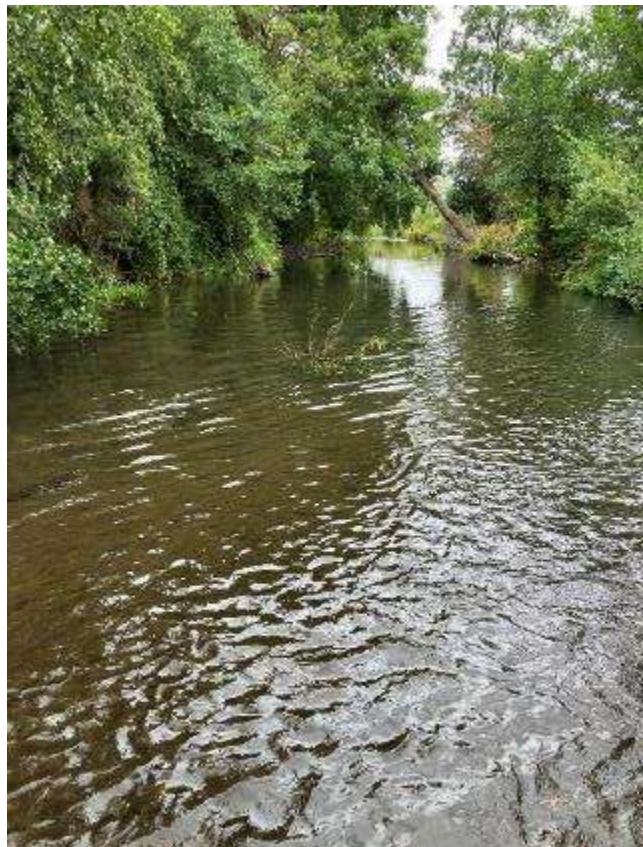
Figure 69. Macrophyte site 6.

Geomorphologically intact reach. Only 45% wadable, open and fast; unstable bed. Filamentous algae cover recorded at ~55%, predominantly *Cladophora glomerata*, indicative of high nutrient enrichment. RMNI higher than expected (7.6 – 6.5). Fairly diverse section with number of taxa higher than expected and NFG as expected. Results indicate Poor classification is driven by high algae cover & nutrient enrichment.

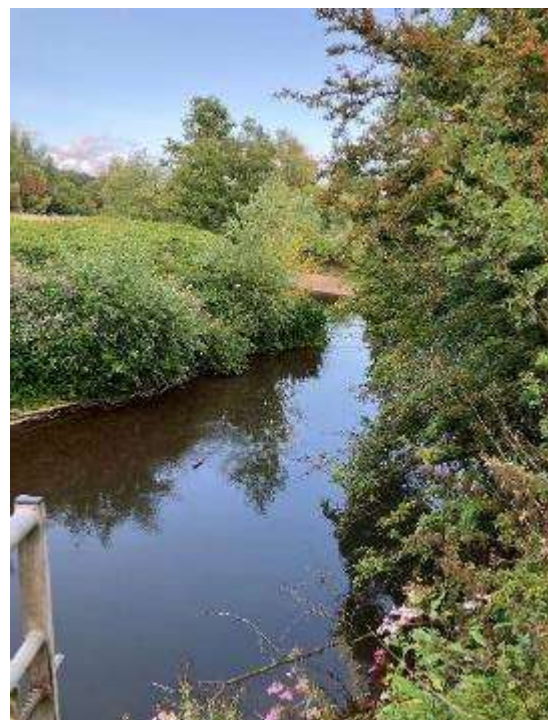
Figure 71. Macrophyte site 8.

Site recorded as deeply incised with steep banks. 60% wadable, run; gravel bed; 95% unstable. RMNI higher than expected (7.7 – 6.7).and species diversity as expected. Filamentous algae cover recorded at ~15%, predominantly *Cladophora glomerata*. Moderate status driven by nutrient tolerant species and high algae cover, indicative of nutrient enrichment.

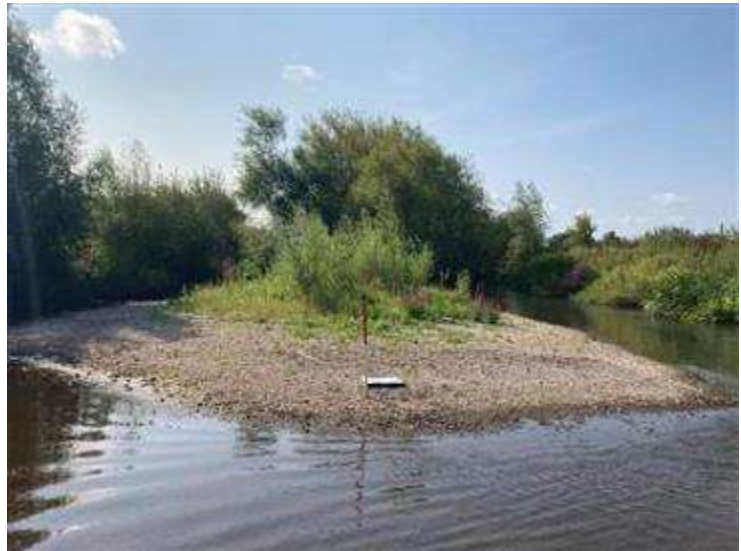
Site historically re-aligned and over deepened with bank and bed re-sectioning present. However, re-naturalising. 70% wadable, gravel pebble bed, mixed run/slack habitat. Site borderline Moderate/Good, EQR = 0.59). RMNI higher than expected (7.7 – 6.7). Species diversity higher than expected. Diverse gravel bar vegetation, including: *Bidens tripartita*, *Epilobium hirsutum*, *Lycopus europaeus*, *Lythrum salicaria*, *Mentha aquatica*, *M. × smithiana*, *Persicaria lapathifolia*, *P. maculosa*, *Phalaris arundinacea*, *Ranunculus sceleratus*, *Rorippa palustris*, *Salix alba*, *Scrophularia auriculata* and *Tripleurospermum inodorum*. No notable taxa. Filamentous algae cover ~8%. Moderate classification appears to be driven primarily by the RMNI score rather than species composition or algae cover.

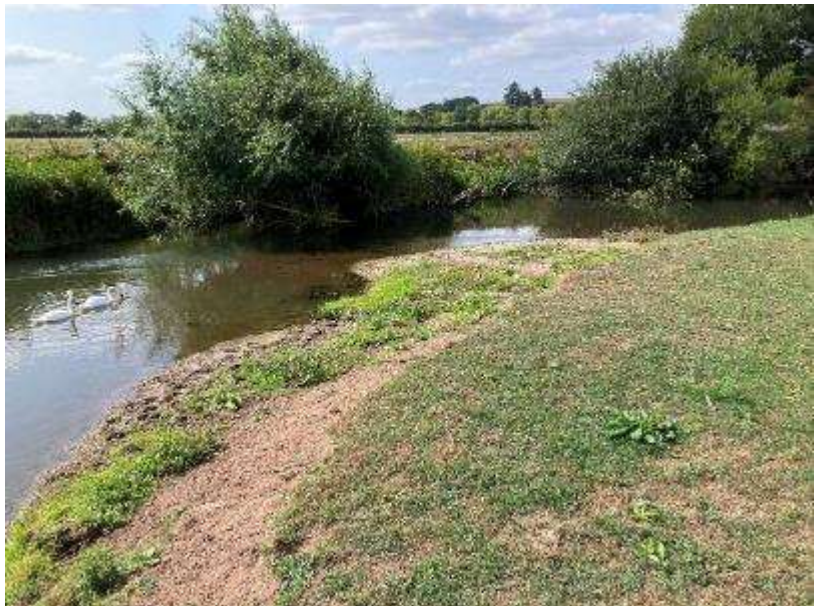
Geomorphologically intact but heavily sedimented reach, with extensive cattle poaching. 60% wadable, mostly run, mixed gravel/silt. Diversity of characteristic species but impact from grazing clear. Sufficient species consistent with the diversity of habitats and flow types etc. No *Potamogeton* and plenty of *Cladophora*, the latter being expected for a site with a lot of poached banks and silt inputs. RMNI higher than expected (7.9 – 6.6). Species diversity for taxa and functional groups slightly lower than expected (taxa – 7 – 8.58. NFG 5 – 5.49). Filamentous algae cover at 5%, significantly lower than upstream reaches.

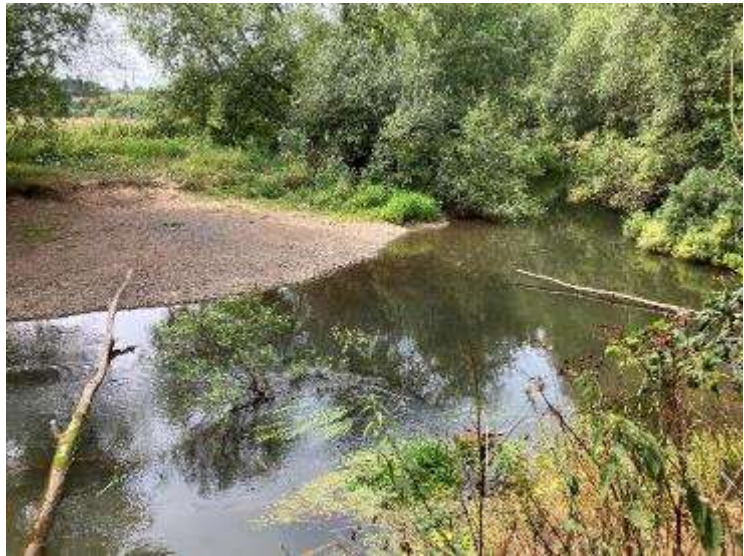
Figure 72. Macrophyte site 11.

Geomorphologically intact reach running along Lugg Meadows SSSI. Turbid (80%), 95% unstable gravel, mix of run/slack. Relatively species rich. Dog access to the gravel bar means ~20 spp absent which should be there. Some *Potamogeton* species present including fennel pondweed and perfoliate pondweed. Freshwater sponge abundant under trees. Low filamentous algae cover ~1%. RMNI higher than expected (7.7 – 6.6). Species diversity significantly higher than expected (taxa – 13 – 8.5. NFG 9 – 5.5). Not clear why site is scoring Moderate status other than higher-than-expected RMNI.
