# Partnership Meeting

## Wye Catchment Nutrient Management Board

# River Lugg SSSI Condition Assessment (2026)

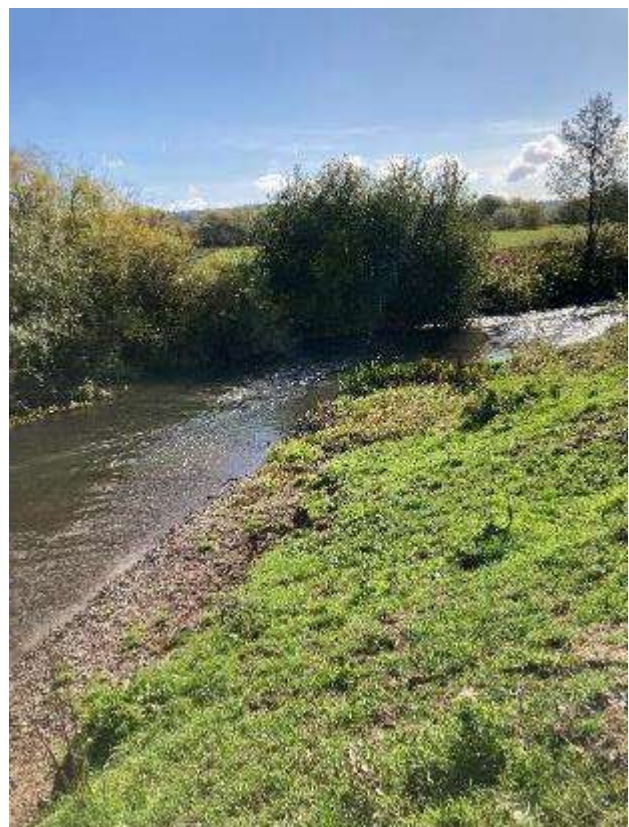
Figure 73. Macrophyte site 12.

*Cladophora glomerata*. High algae cover likely driving Poor classification score, indicating nutrient enrichment.

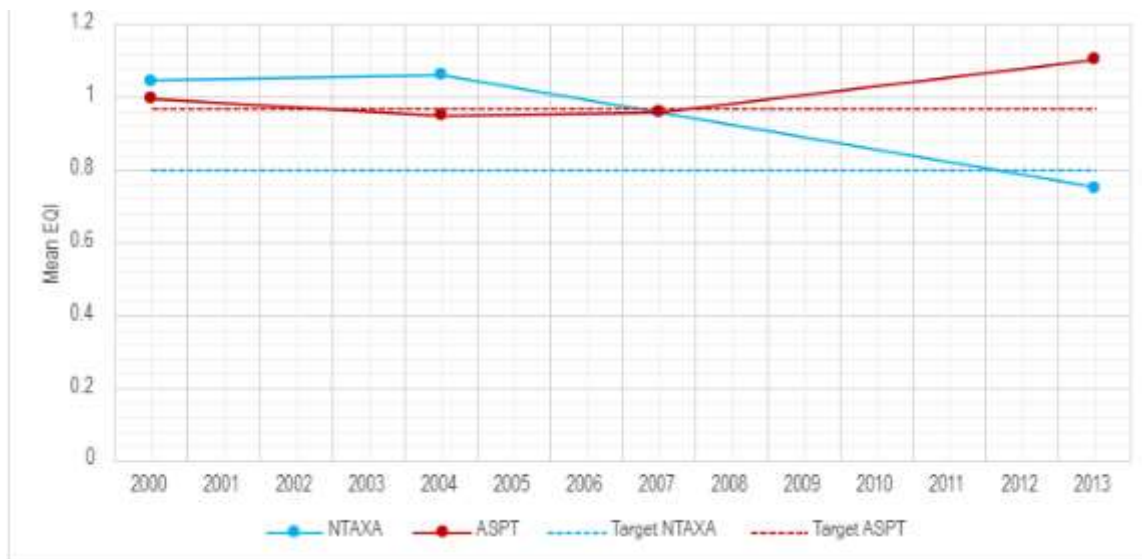
Historical NTAXA & ASPT scores for the years available – 2000-2013 – are shown in **figure 77**. Although there are considerable gaps in the time series, this unit has undergone fluctuations in both NTAXA and ASPT. Between 2004 and 2007, the score for NTAXA remained well above its target, indicating that the diversity of macroinvertebrates

was high. The ASPT score, on the other hand, remained close to its target, passing in the year 2000 but failing by a small margin in 2004 and 2007.

**Figure 77. Yearly Mean NTAXA and ASPT Scores Unit 3 (2000 – 2013)**

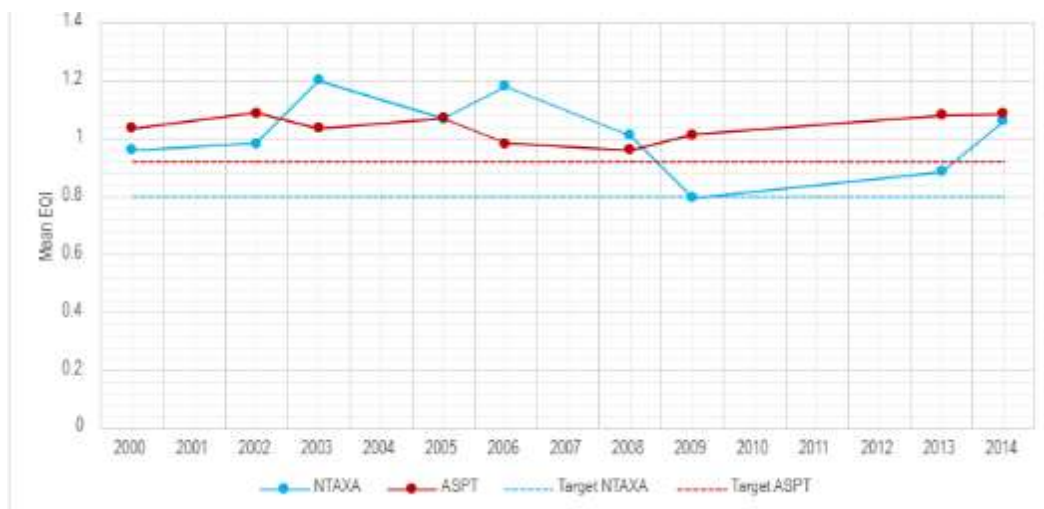
Figure 78 shows historical ASPT and NTAXA scores for Unit 2 between the years 2000 and 2014. During this time, monitoring was comparatively consistent, with the only gap greater than two years between 2009 and 2013.

The graph shows a relatively consistent ASPT, passing the target in all monitored years. In comparison, the NTAXA fluctuates, failing in 2009 and 2013. This indicates that while this stretch of river experienced consistently low levels of organic pollutants in this period, in these two years non-organic pollution events, may have negatively impacted the overall diversity. It is impossible to determine whether the 2009 and 2013 failing scores are indicative of one continuous or two discontinuous events, as no monitoring was undertaken in the years between.

**Figure 78. yearly Mean NTAXA and ASPT Scores Unit 2 (2000 – 2014)**

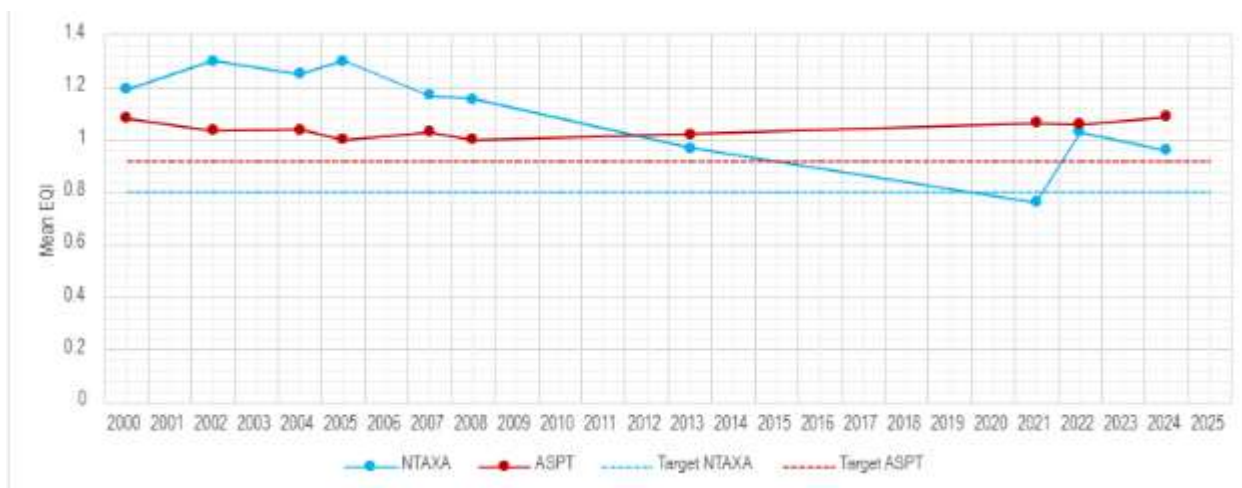
Similarly to the upstream units, Unit 1 shows a relatively constant ASPT score, passing the target for 'High' classification in all years monitored, while the NTAXA shows more fluctuation (**figure 79**). However, while it passes range from considerable margins to extremely close to the minimum target threshold, it only failed in one monitored year (2021). This indicates that, while this stretch of river suffers negative impacts from pressures other than inorganic pollutants, it generally remains in good health. However, it is worth noting that average NTAXA scores have decreased since the early 2000s, suggesting that the overall state of the unit is declining.

**Figure 79. River Lugg Yearly Mean NTAXA and ASPT Scores Unit 1 (2000 – 2025)**

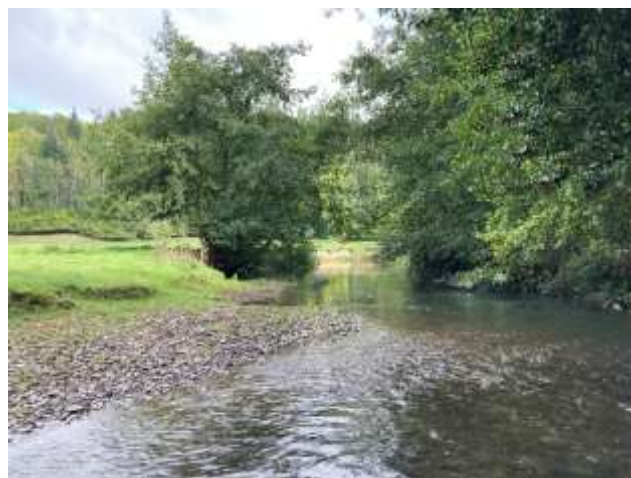
*Pristine reach near Aymestrey. The river here is connected to its floodplain & displays classic run-riffle-pool habitat.*

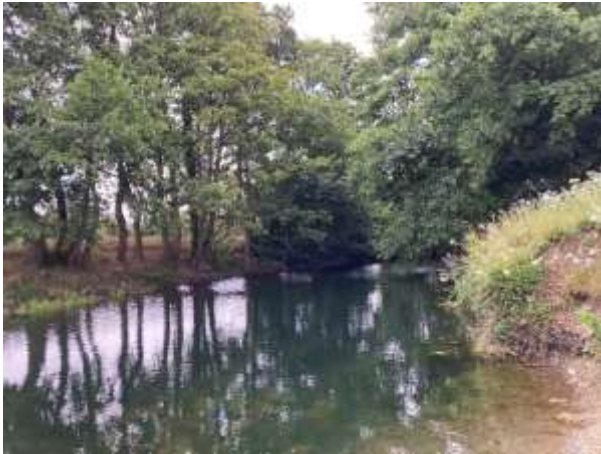
*The River Lugg near Leominster has been historically dredged, resulting in slower flows, siltation and high filamentous algae cover.*
