# River Lugg SSSI Condition Assessment (2026)

An assessment of the 'Rivers & Streams' & 'Otter' features

Date: 06<sup>th</sup> February 2026

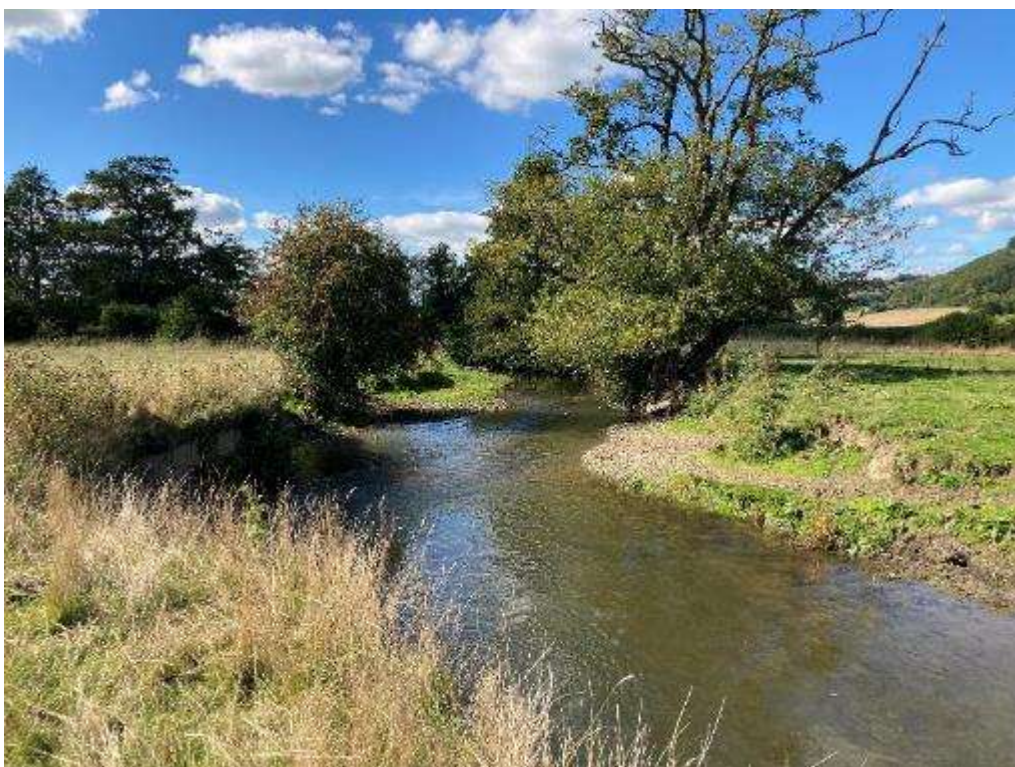
**Figure 30. RHS Site 3, HMC = 2. Score impacted by minor ford and poaching. Adjacent habitat low intensity cattle grazing.**

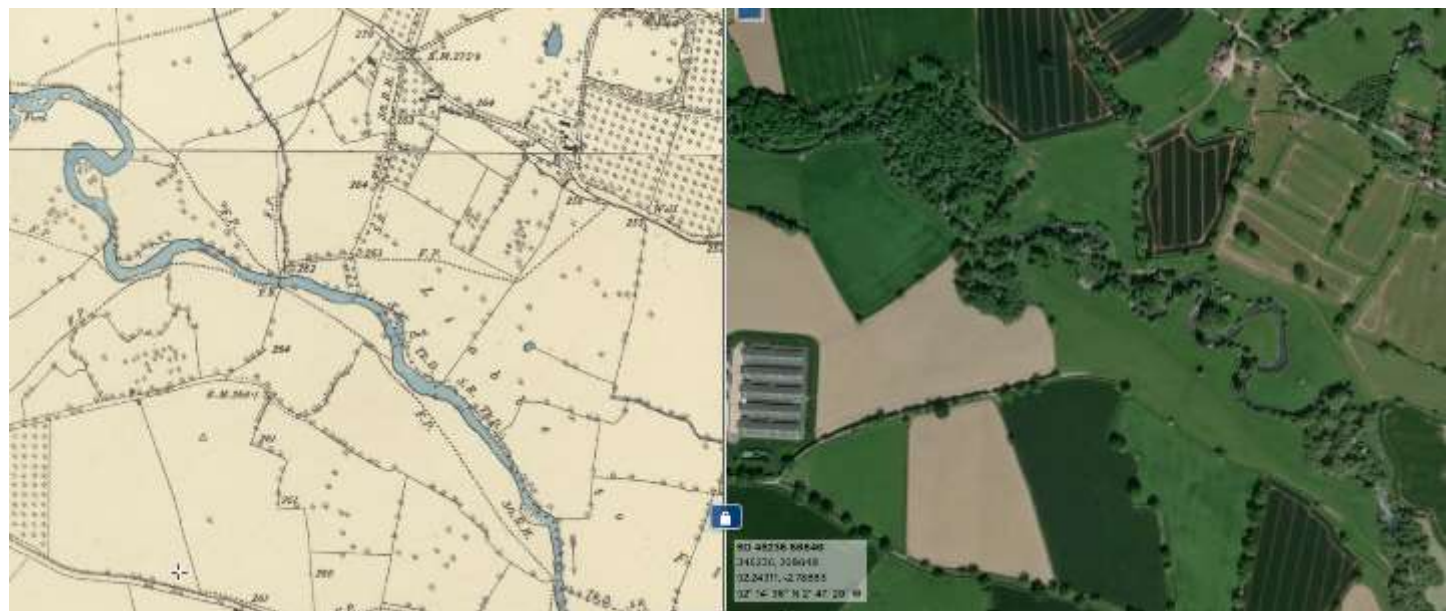
**Figure 33. Comparison Historic Map (OS 1830 – 1880 country layer) to ESRI World Imagery 2026. Note development of meanders in right hand image (2026).**

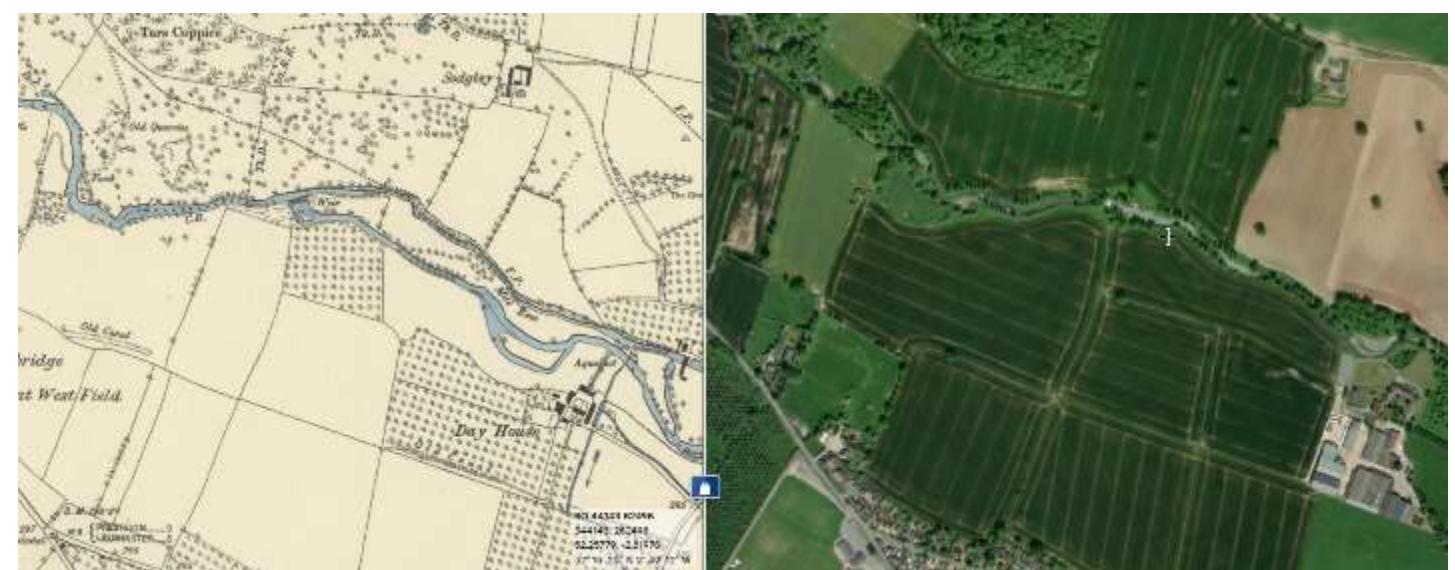
**Figure 34. Comparison Historic Map (OS 1830 – 1880 country layer) to ESRI World Imagery 2026. Note loss of mill leat.**

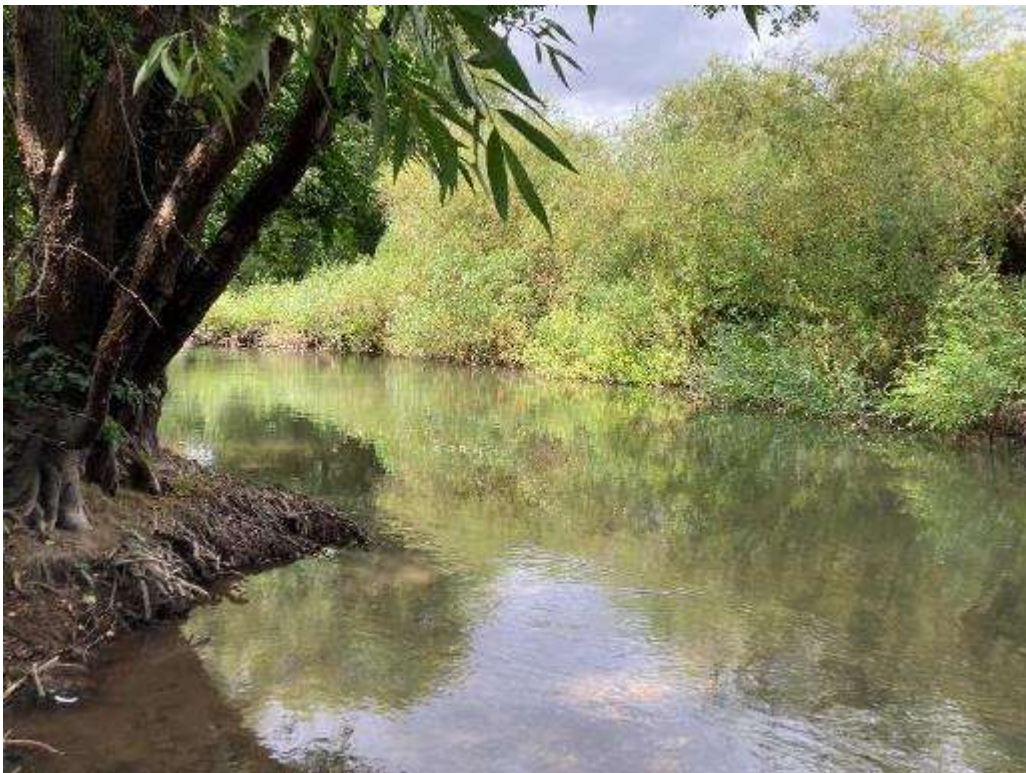
**Figure 44. RHS Site 14. HMC = 5. Significantly over deepened & disconnected from floodplain.**

Recommendation: physical channel restoration to re-establish floodplain connectivity and restore over deepened and embanked channels should be investigated on a reach-by-reach basis.

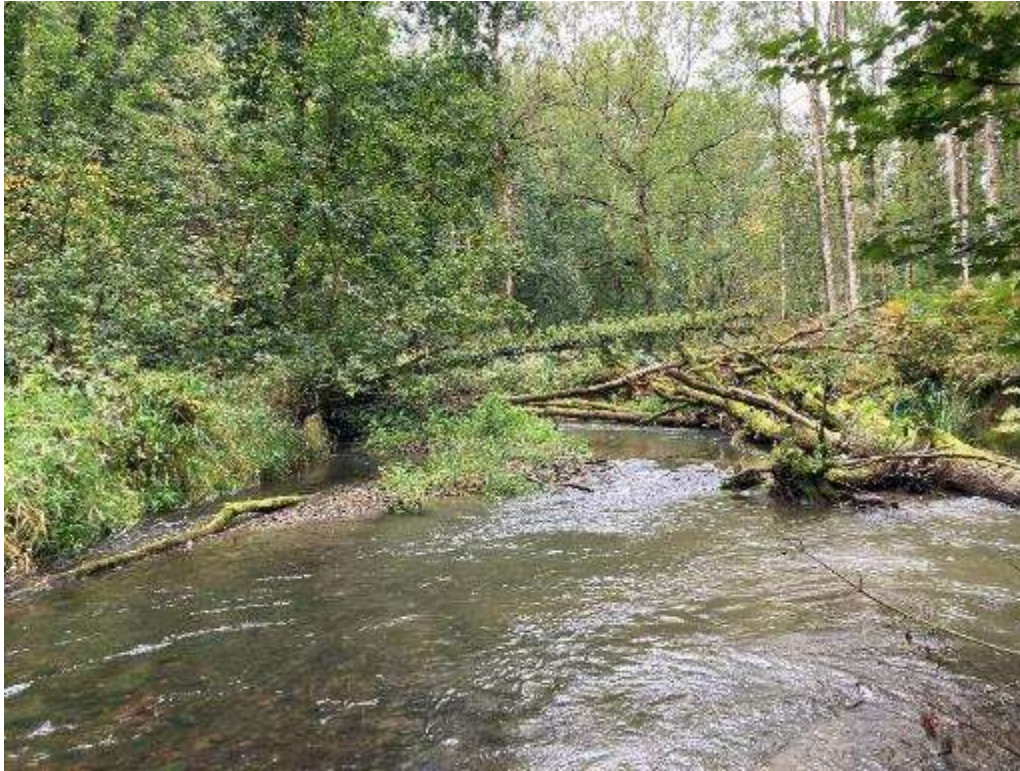
**Figure 59. RHS Site 3. Woody debris log dam which has created a mid-channel bar. The mid channel bar had extensive evidence of otter feeding.**

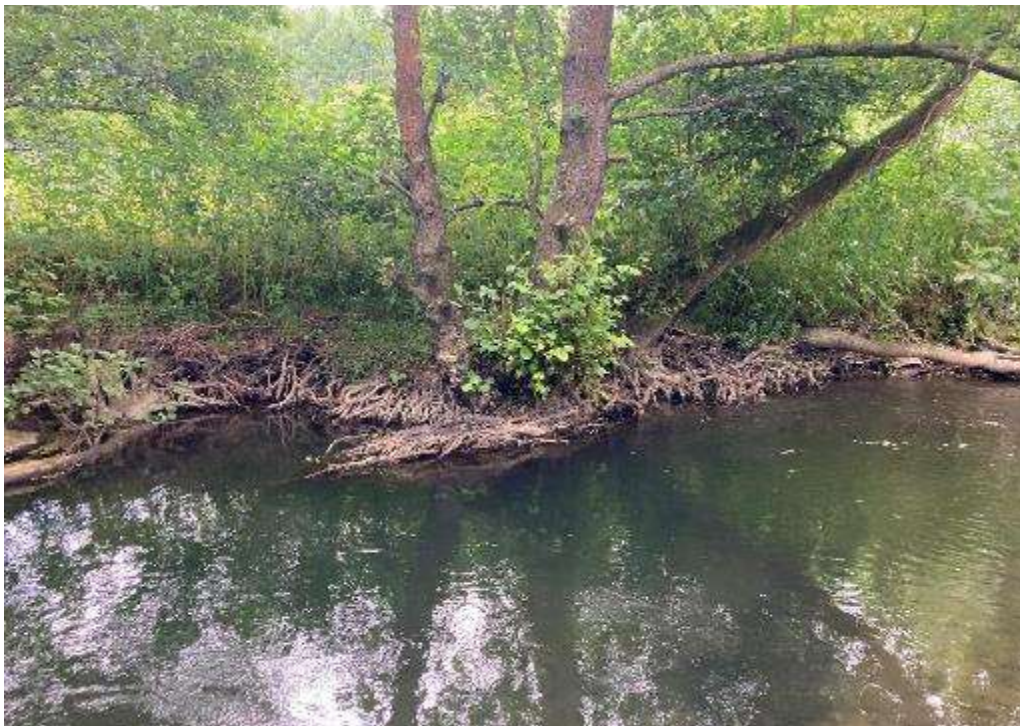
**Figure 58. RHS Site 4. Tree roots bind the bank and also create refugia sites for fish to hide from predators, stay cool in summer and rest during the daytime during upstream migration.**
