SEAT BELT ANCHORAGE TEST REPORT

REPORT REF No: 1146U

FOR A IN-VEHICLE
TEST TO DIRECTIVE 76/115/EEC
AS AMENDED BY 96/38/EC.

Vehicle: Mercedes Vito

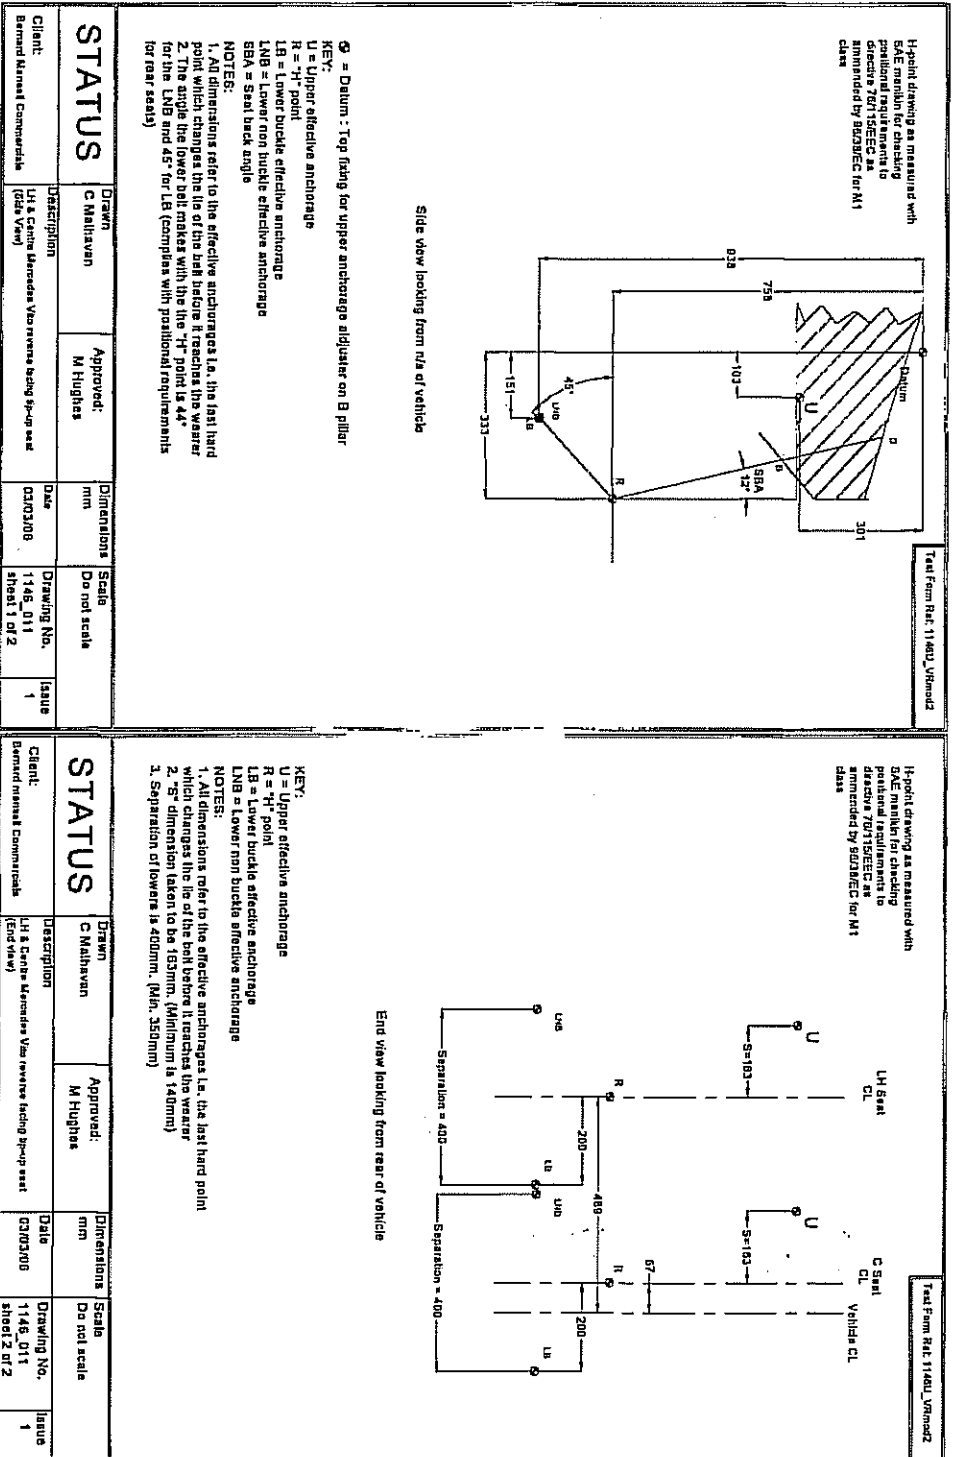
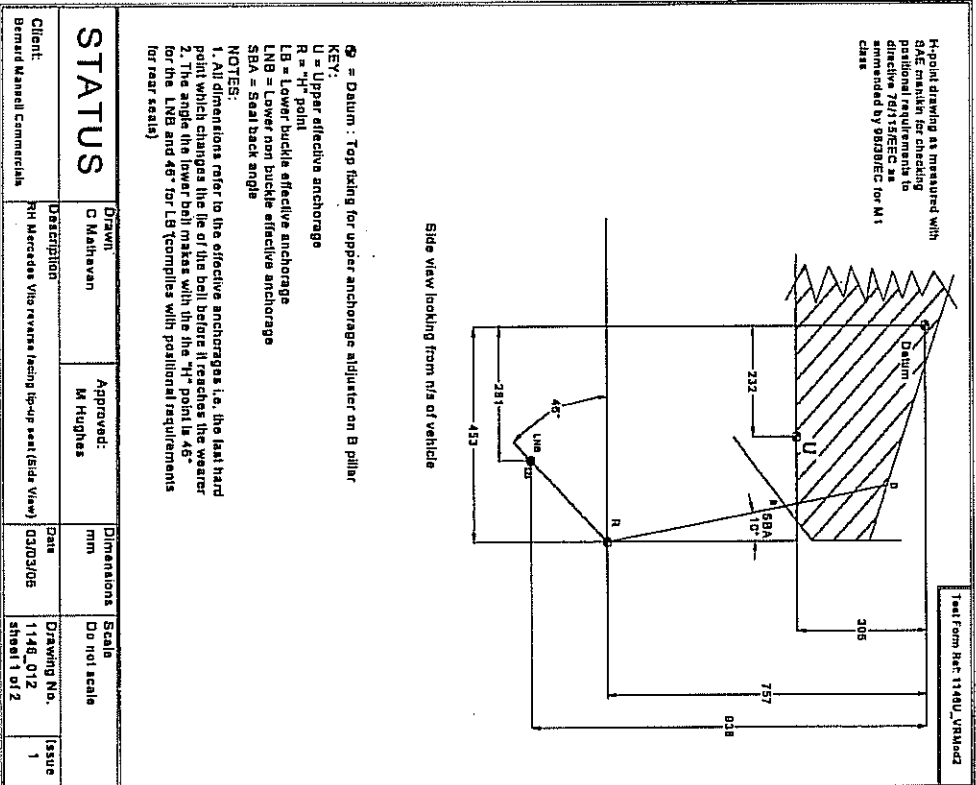
Appendix 3 - 'H' point drawing.**Drawings Supplied:**

A drawing showing the position of the 'H' point in relation to the effective belt anchorages, with regard to the requirements, is shown in appendix 3.

The vehicle seat belt anchorages tested complied with the positional requirements of Directive 76/115/EEC (as amended up to and including 96/38/EC) as demonstrated by the drawing in Appendix 3.

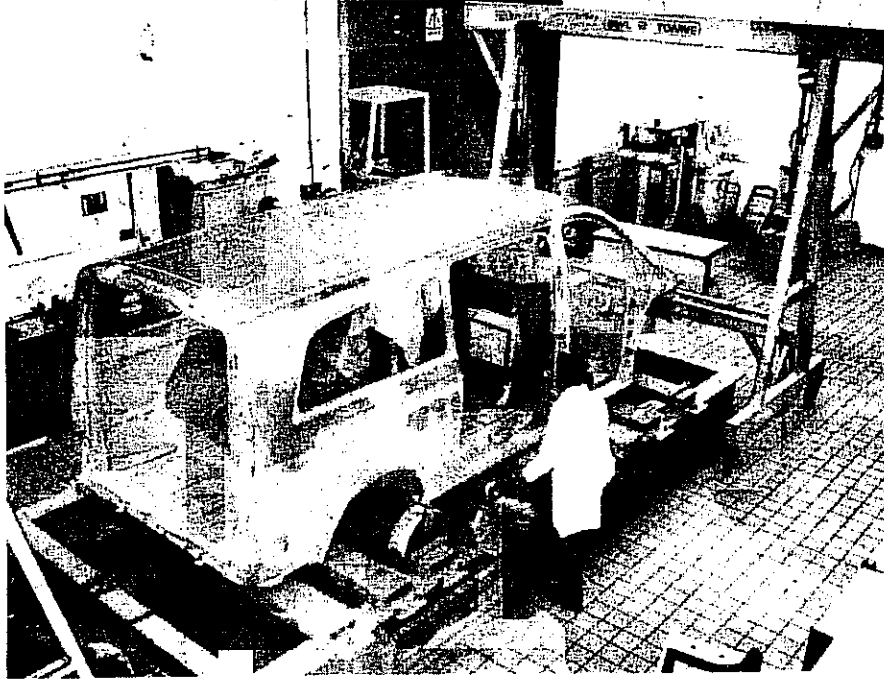
Figure 5.1 – Vehicle on test rig.

The rig used was a free standing structure with horizontal beams that could be moved into appropriate positions in order to clamp down the vehicle. A total of ten hydraulic rams were fitted to a carrier of which only six were required for the test. The rams were provided with a means vertical and horizontal position adjustment as well as having angular freedom in a vertical plane parallel to the longitudinal plane of the rig.

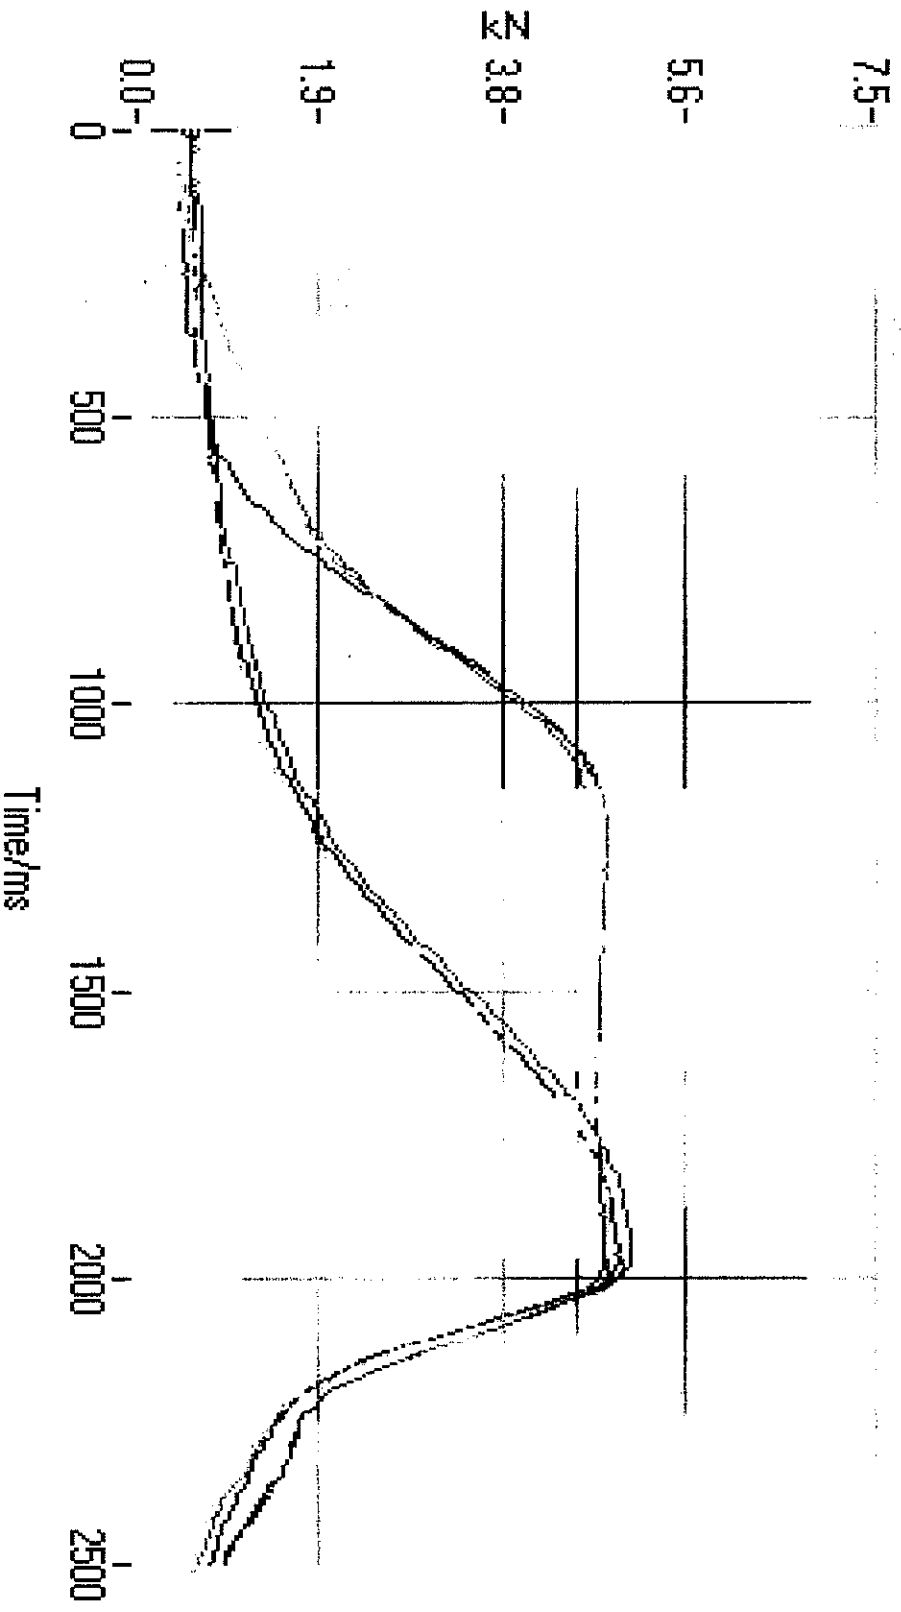
Test Reference: 1146_2292

The vehicle seat belt anchorages tested complied with the strength requirements of Directive 76/115/EEC (as amended up to and including 96/38/EC) as shown in the graphs in Appendix 7.

Test Details: Test of first row of seats to M1 (M3 load for reverse facing seats)

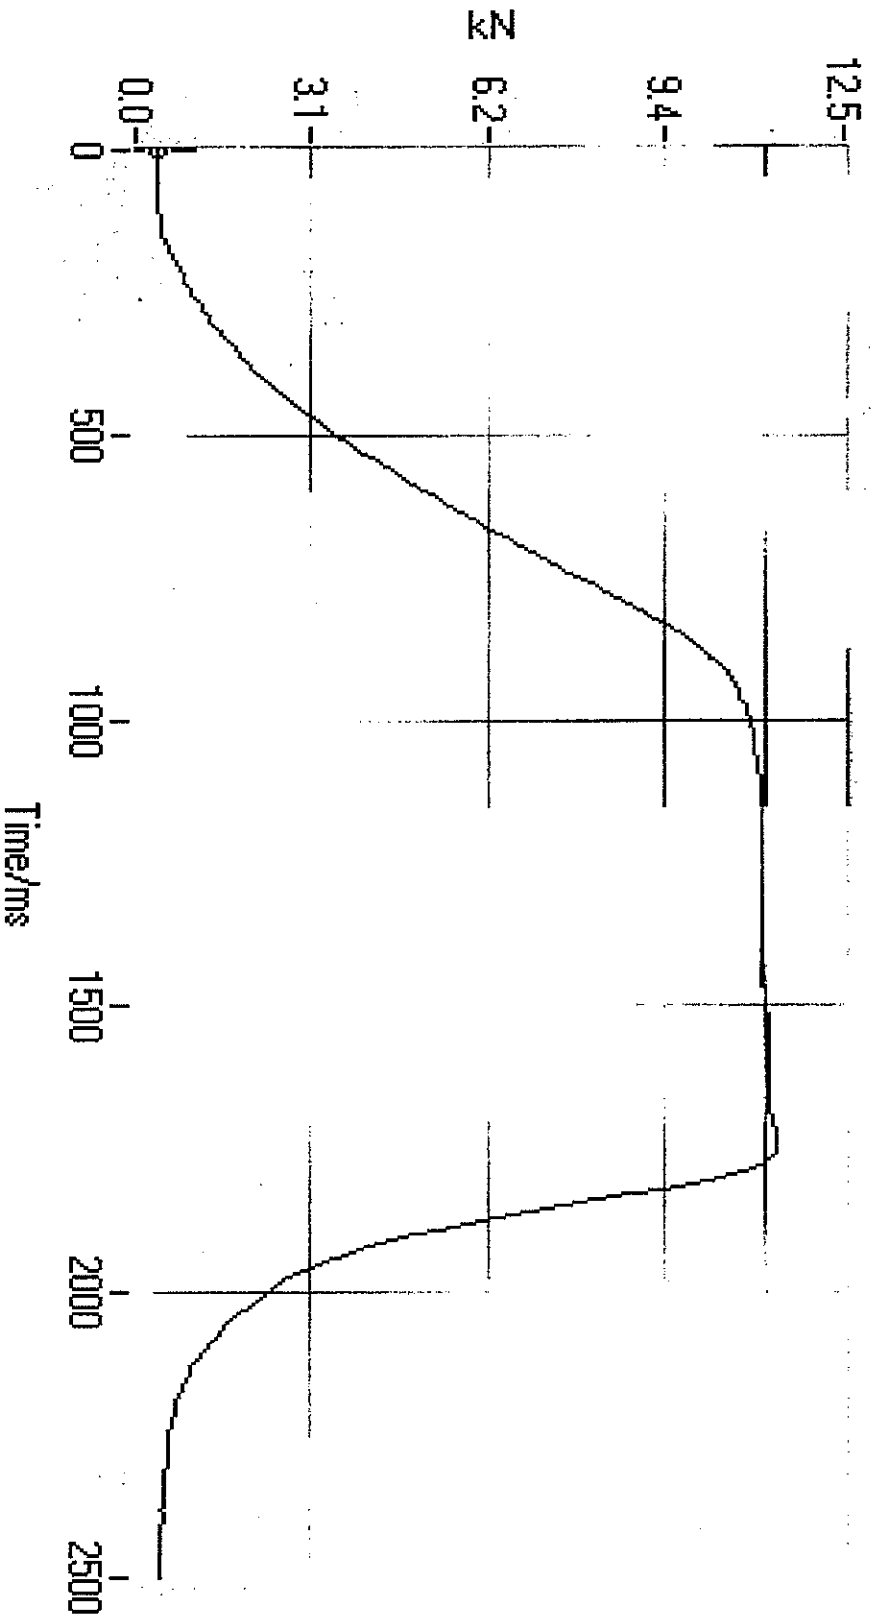
Test Reference: 1146_2293

The wheelchair chair restraints complied with the Motability requirements for forward facing wheelchairs applied to the rear restraints of a reverse facing wheelchair in the reverse direction.

Test Details: Test of wheelchair front tie-downs to Mobility standards(reverse direction)
