Masonry Inspection Report

Hereford Town Hall

Entrance Canopy

19th January 2016

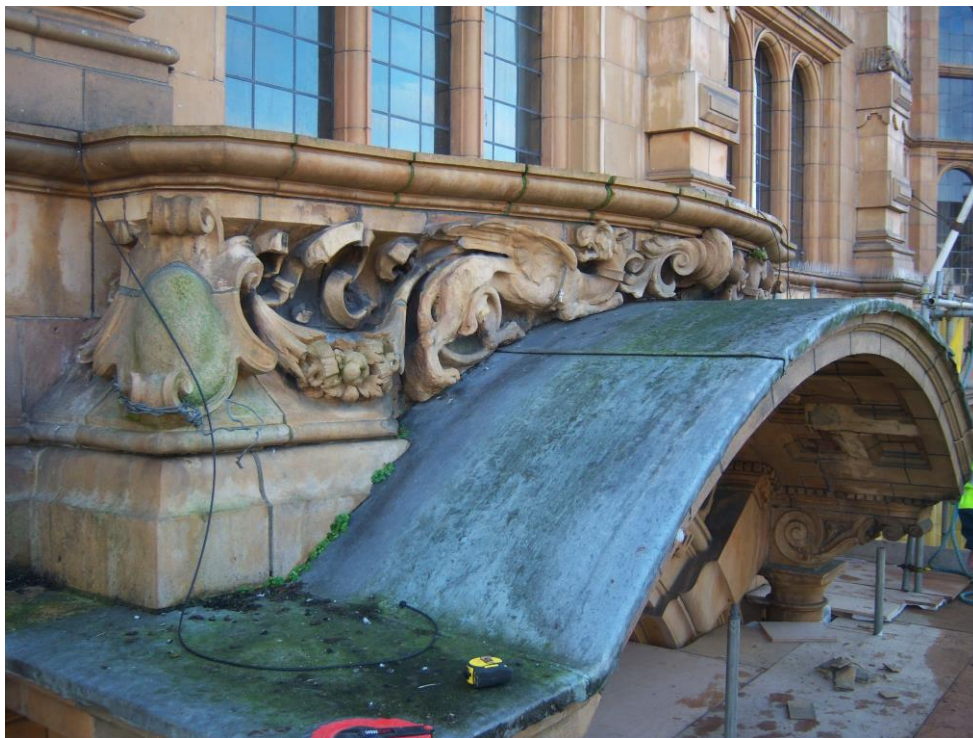
- The façade of the building - St Owen's Street elevation - is constructed in Terracotta that is heavily ornamented with banding, pilasters, finials, scrollwork & figures.
- The central doorway has rusticated pillars and round-headed arch, under a prominent round-headed canopy that is lead covered.
- The soffit of the canopy has recessed panels with ogee detail.
- The extended corbels have a dentilled detail above them and scroll & fine detail to their sides and front, the extended corbels are set on rusticated columns.
