Colwall C.E Primary School

Groundwater Flooding - Desk Study & Site Investigation Report

Colwall Green, Malvern, Herefordshire, WR13 6DU

Date:	December 2014	
Revision:	FINAL	
Project Number:	HYG124	
Document Reference:	HYG124 R 141014 AJ Colwall School Groundwater Flooding Investigation Report	
Document File Path:	P:\HYG124 Colwall School\Reports\Draft\HYG124 R 141014 AJ Colwall School Groundwater Flooding Investigation Report.docx

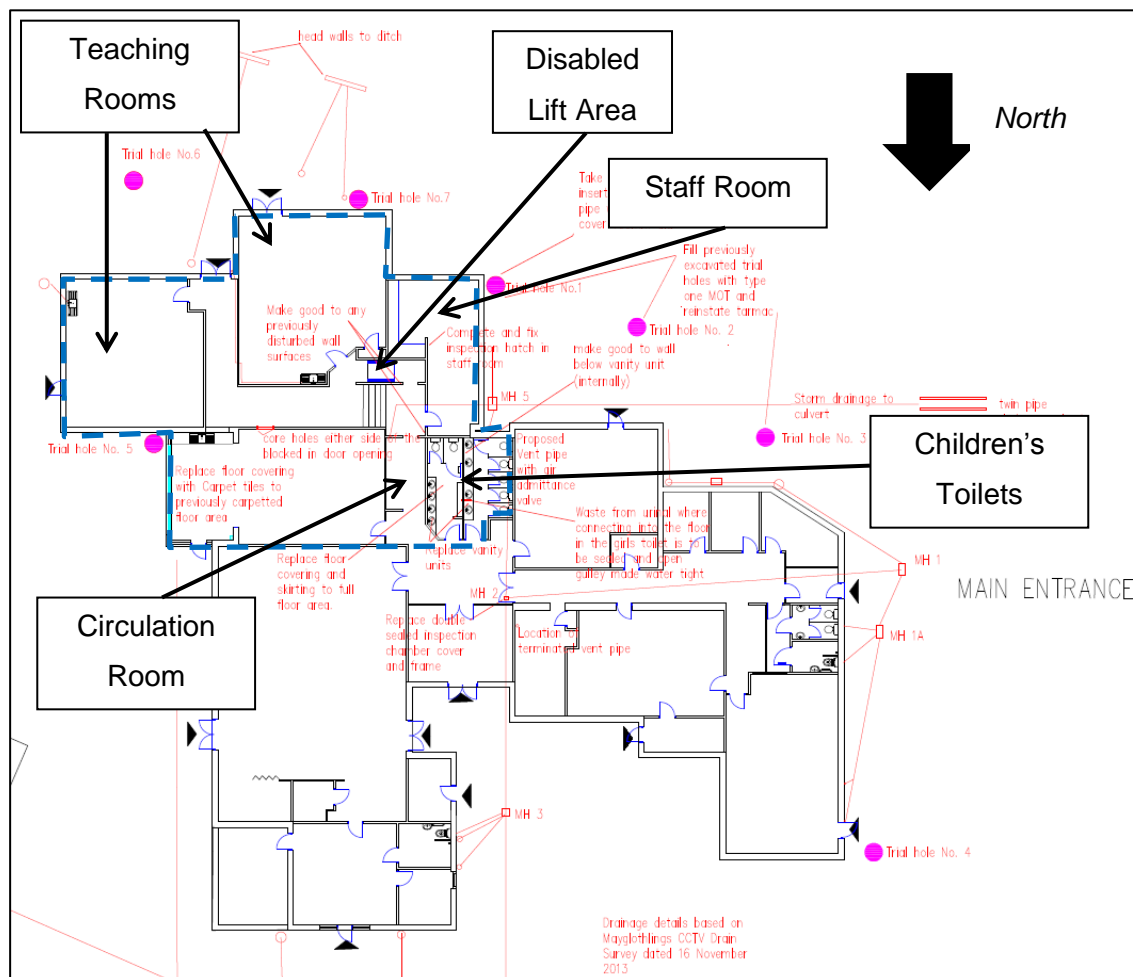
Figure 2 Existing School Building Layout

The original primary school building was built in the Victorian Period in 1865 with extensions to the building occurring in 1981 and 1993 respectively. The existing building layout is depicted below in Figure 2 which has been provided by HCC. The indicative outline of the 1993 building extension, where the most noticeable issues have been observed is shown below by the dashed blue line.

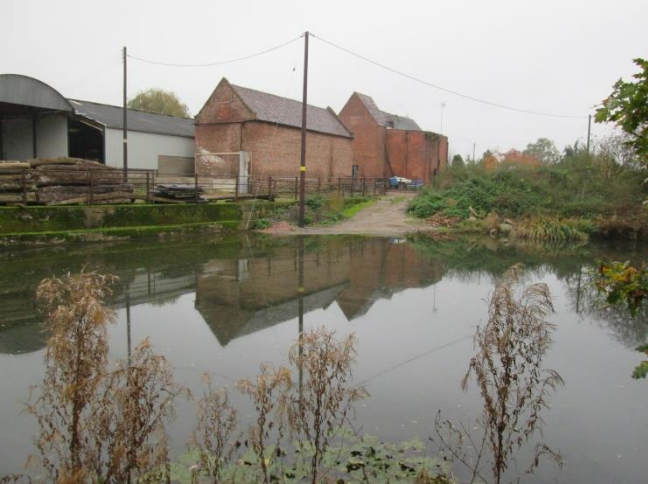
<p>Photograph shows a wetland area situated to the west of the site. The wetland area is thought to be fed by a discharging spring although no spring discharge into the wetland could be observed at the time of the walkover.</p>
9

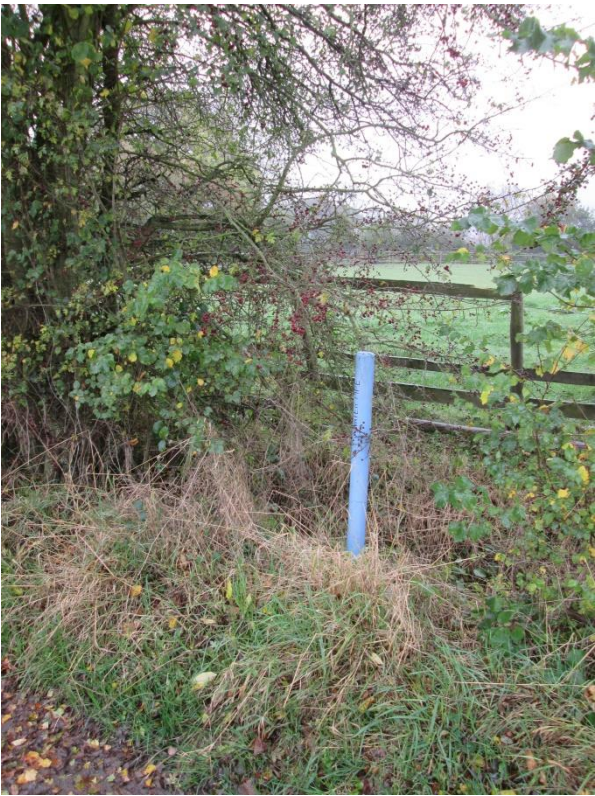
Ref.	Photograph	Description
11

A photograph showing a blue vertical pole marker standing in a field. The pole is surrounded by tall grass and some bushes. In the background, there is a wooden fence and several trees with green and some autumn-colored leaves. The sky is overcast.	<p>Photograph showing a blue pole marker which marks the position of the underground spring water pipe network approximately 225 metres to the east of the old school building.</p>
12

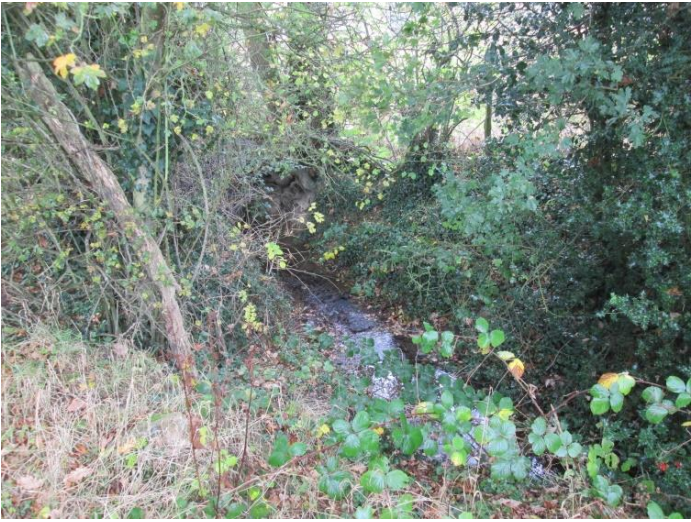
A photograph of a narrow stream flowing through a wooded area. The water is clear and reflects the surrounding greenery. The stream is bordered by dense trees and bushes, with some fallen branches visible in the foreground.	<p>Photograph of a stream which is situated approximately 340 metres to the east of the site. The stream was observed to be flowing at the time of the site visit.</p>

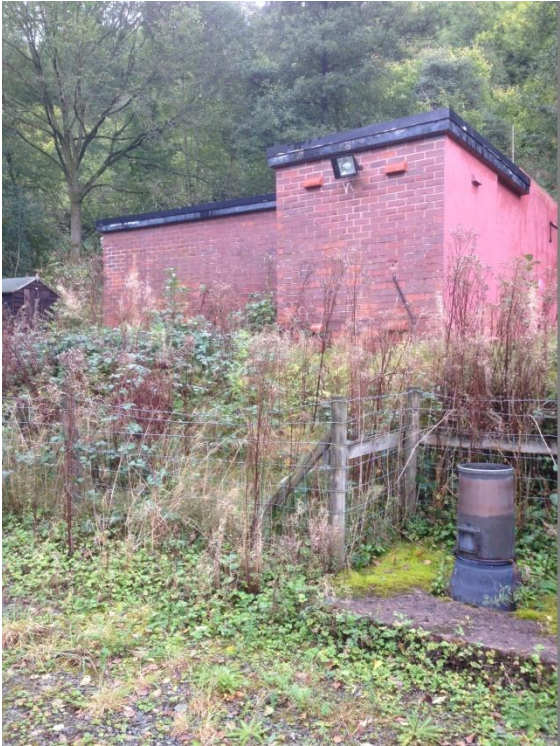
Ref.	Photograph	Description
13

<p>Photograph viewing the Primeswell Spring abstraction site and associated buildings approximately 1.5km to the south, south-west of the site (SO7599540365).</p>
14

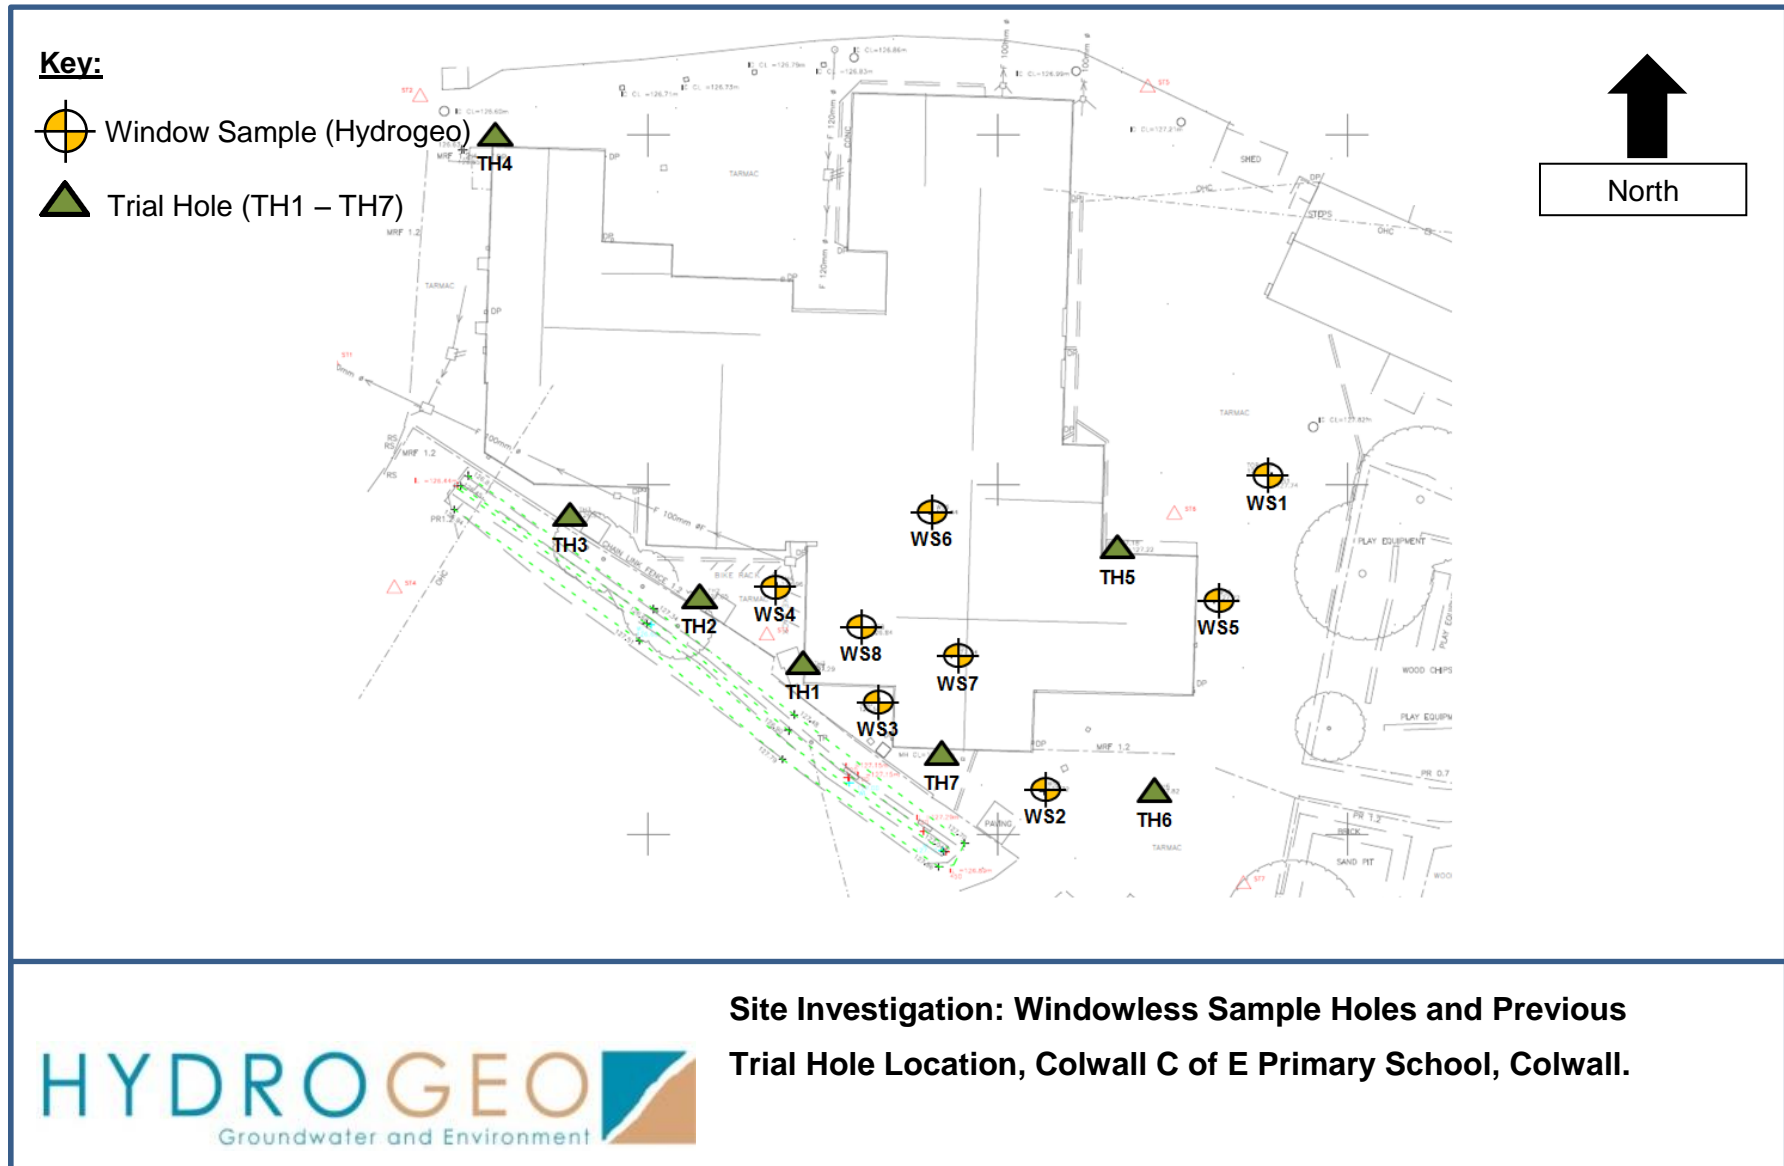
Figure 5 Windowless Sample Hole Location Plan Colwall Primary School

The exploratory holes at the site allowed for the made ground, Colwall Gelifluctate Formation and the Raglan Mudstone Formation to be visually inspected, logged and sampled to a maximum depth of 4 metres. The locations of the exploratory borehole locations are presented within Figure 5 and within the logs presented within Appendix B.

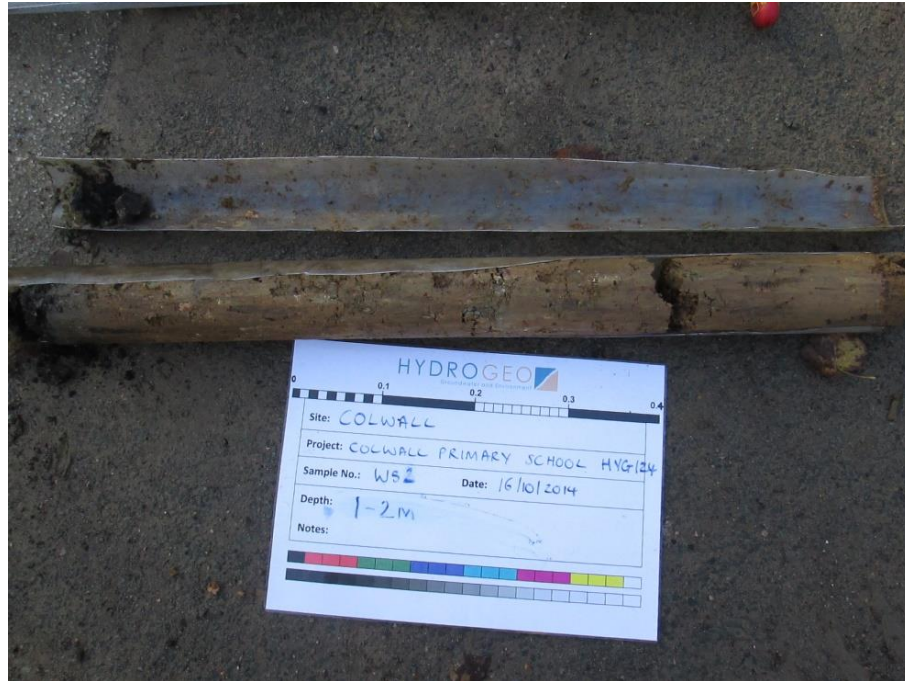
Figure 6 Sample of Colwall Gelifluctate Formation

The Colwall Gelifluctate Formation was encountered underlying the made ground within all 8 no. windowless sample holes. The Colwall Gelifluctate Formation beneath the site was found to comprise a light brown, orange, mottled grey sandy very gravelly soft to firm clay. Sand was observed to be fine to medium grained with the gravels varying from angular to sub-rounded fine to occasional coarse size melange of sandstones and

limestone's. Gravel content varied within the Gelifluctate Formation with depth and locality across the site area. A typical sample of the Colwall Gelifluctate Formation can be viewed below within Figure 6.

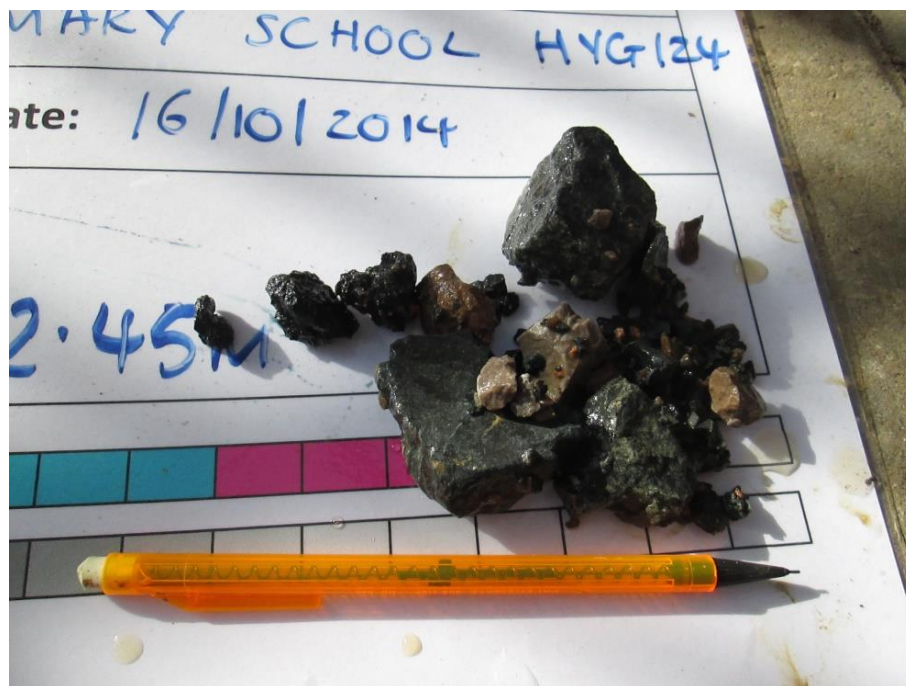
Figure 8 Colwall Gelifluctate Formation Gravels

The gravel layers within the Gelifluctate Formation were observed between 2mbgl to 2.45mbgl and again at 3mbgl to 3.90mbgl within WS3, with a very thin layer of gravels observed in WS5 at 1.95mbgl to 2mbgl and a very gravelly clay layer in WS8 at 1mbgl to 1.35mbgl.

The gravel bands within WS3 were observed to be very wet upon retrieval during drilling. The gravels were found to comprise a mixture of varying fine to medium, sub-angular to sub-rounded sandstones and limestones as shown in Figure 6. No other borehole around the site encountered gravel bands like the bands observed in WS3.

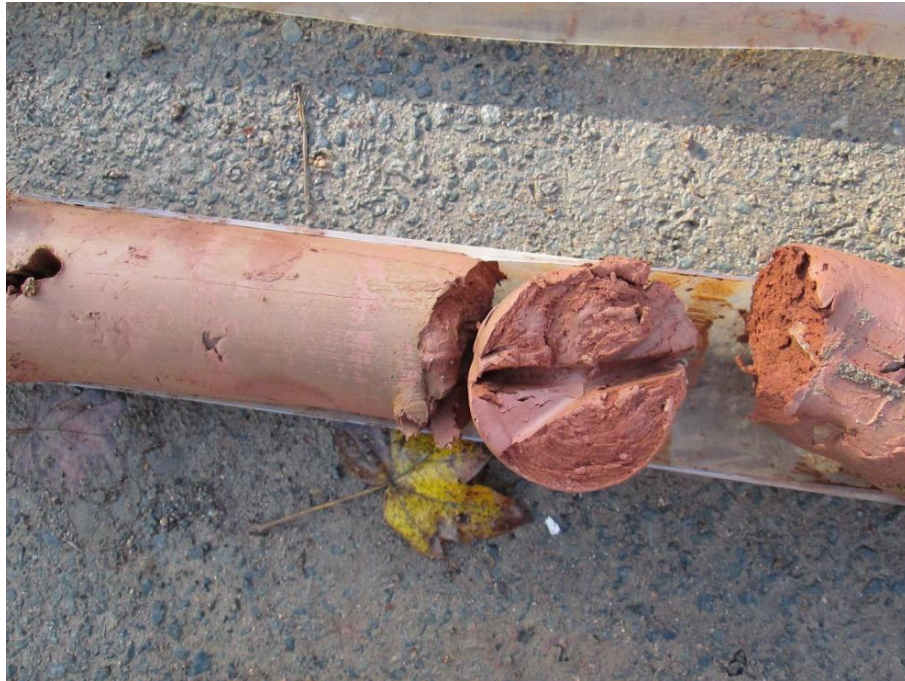
Figure 10 Raglan Mudstone Formation

The Raglan Mudstone Formation was generally found to comprise a dark red to dark brown mottled grey with silt and varying amounts of sand and gravel, soft to firm clay. All windowless sample holes, except WS3, encountered the Raglan Mudstone Formation underlying the Colwall Gelifluctate Formation. Gravel and sand content varied within locality and depth within the holes and generally comprised a fine to medium sand with angular to sub-rounded sandstone gravels. A typical sample recovery and cross section of the Raglan Mudstone Formation encountered at the site can be seen in Figure 10 and Figure 11, respectively.

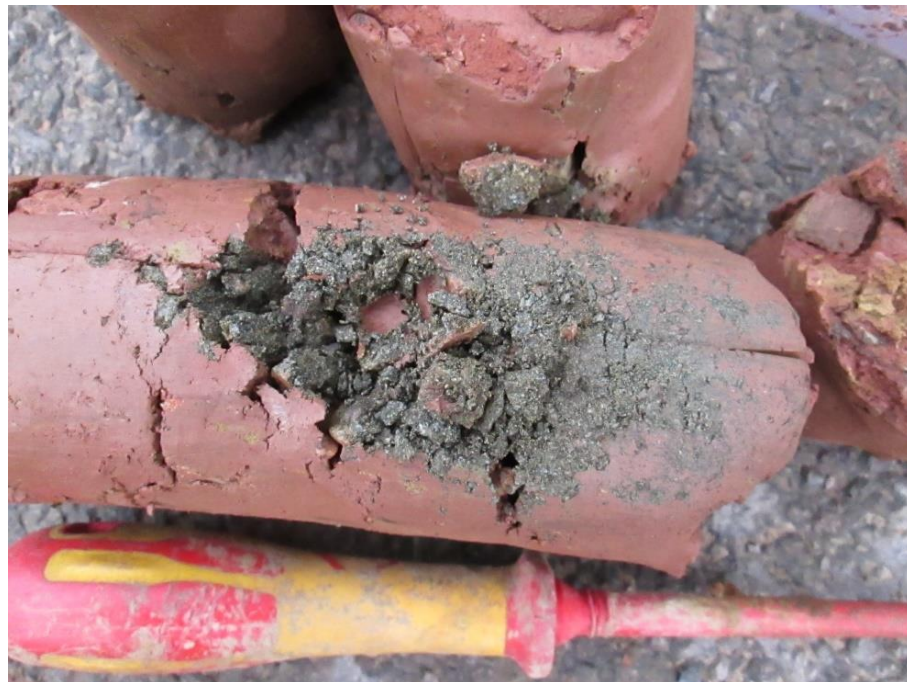
Figure 13 Pockets of Sand and Gravels in the Raglan Mudstone Formation

The gravels in the Raglan Mudstone Formation in WS1 were found to be very wet upon retrieval from the hole between 3mbgl to 3.30mbgl. Occasional dark grey pockets of sand and fine gravels were observed as shown in Figure 13.

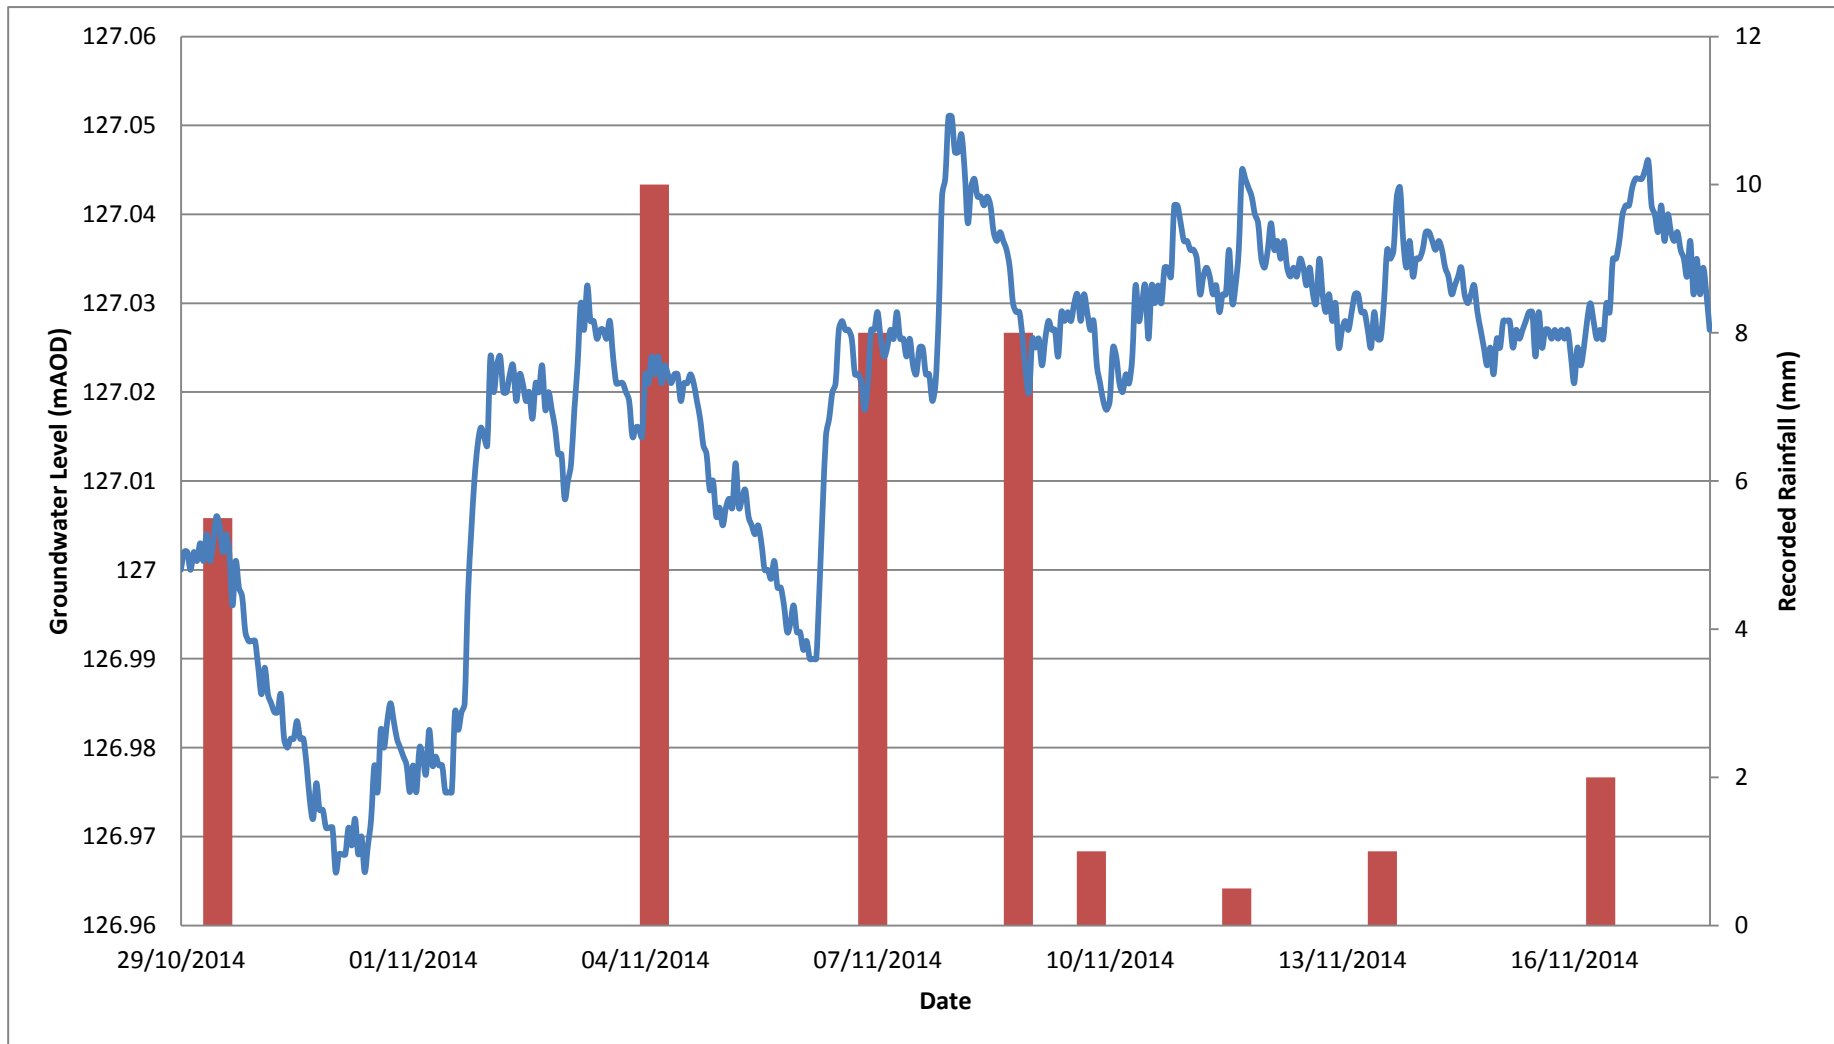
Figure 16 WS3 Groundwater Level Hydrograph (29/10/2014 – 18/11/2014)

In addition to the groundwater monitoring rounds, a level logger (pressure transducer) and barometric pressure logger were installed within WS3 on the 29th October until the 18th November 2014 to record the groundwater level within the borehole at hourly intervals. The variation in groundwater level in WS3 during the monitoring period is presented in Figure 16.

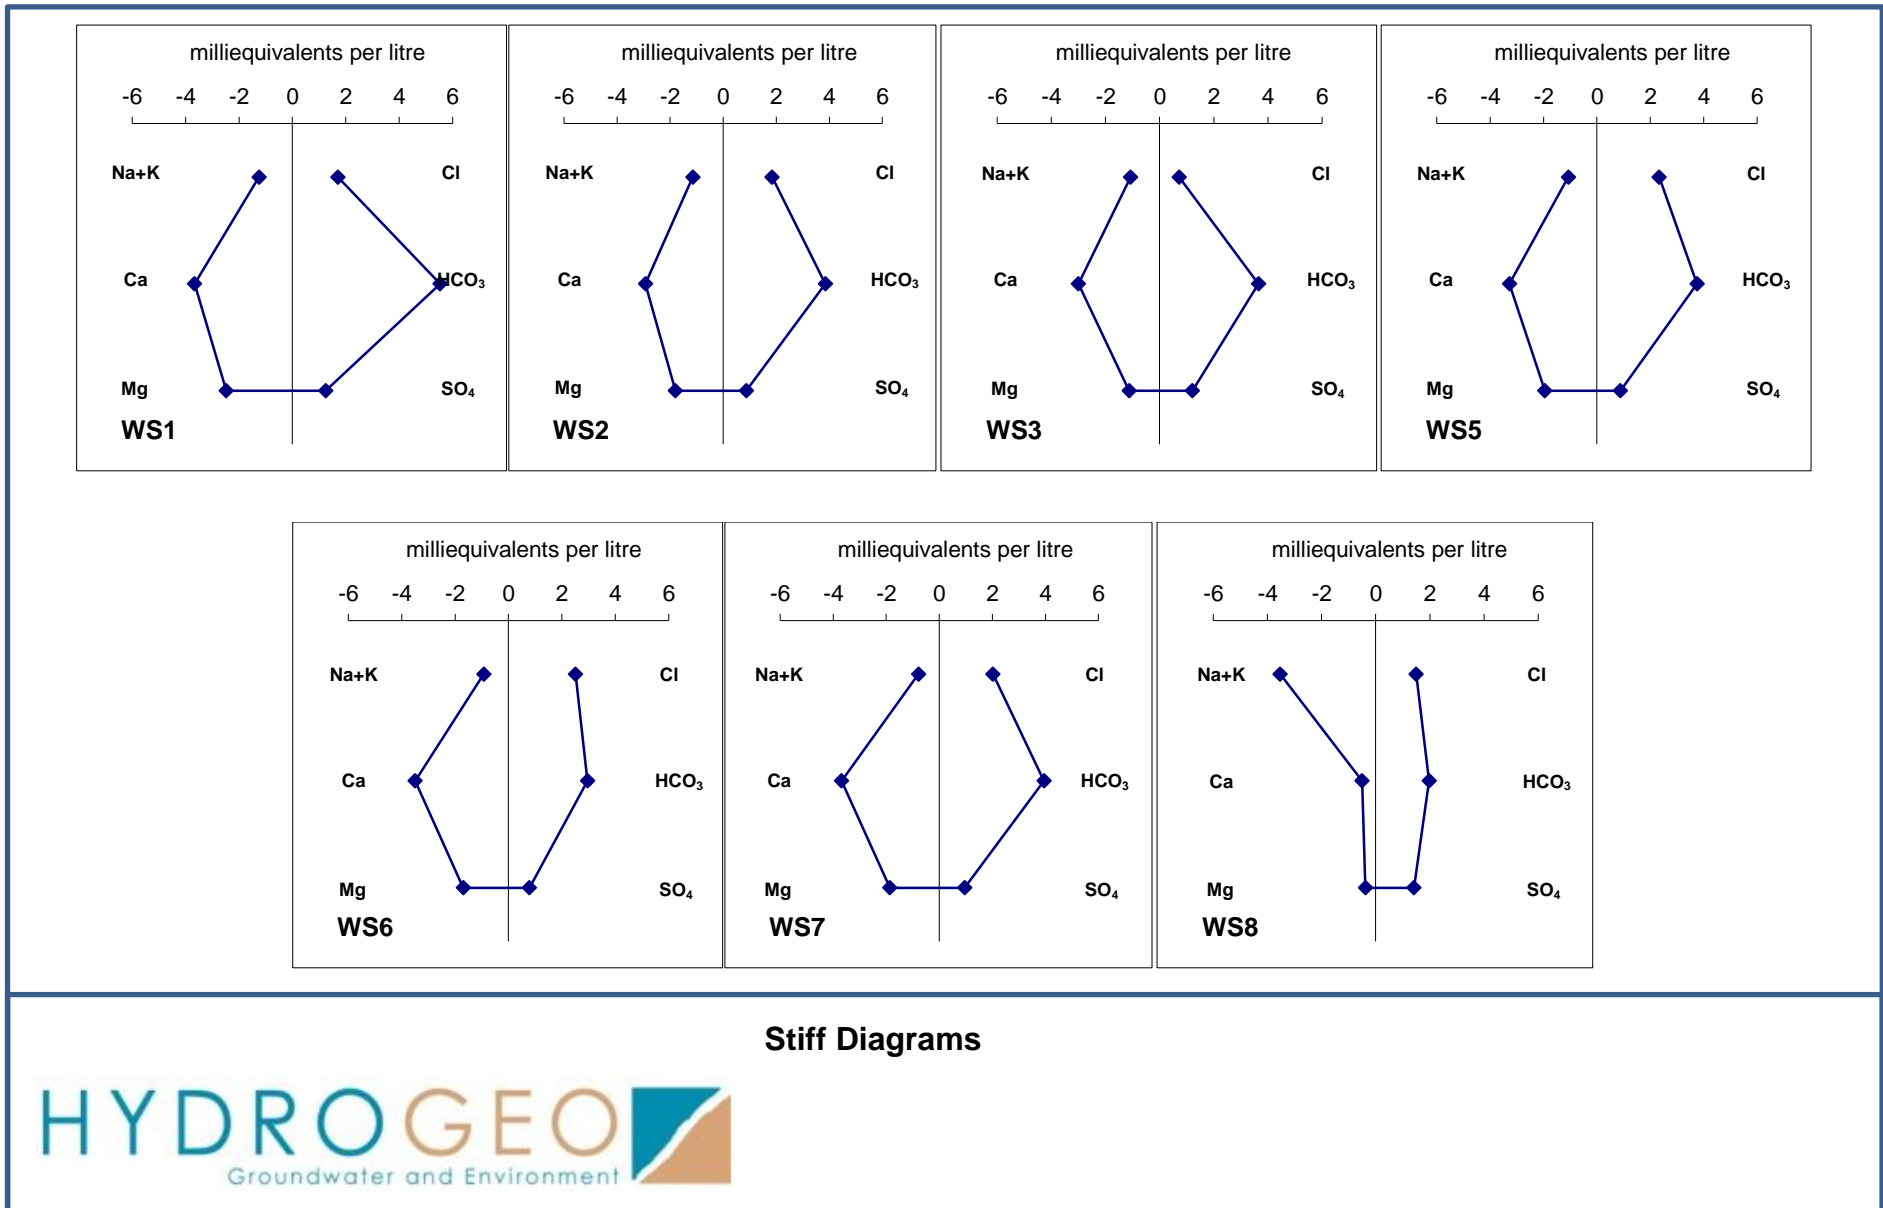
Figure 17 Stiff Diagrams

Stiff diagrams have been plotted for the groundwater samples to graphically compare the concentrations of major anions (Bicarbonate, Sulphate & Chloride) and cations (Calcium, Magnesium, Sodium & Potassium) to investigate the provenience of the water samples, shown in Figure 17.

The largest anion-cation charge balance error (CBE) was calculated in WS1 (-7.11%) compared to the smallest CBE in WS6 (-4.48%). The larger charge balance error calculated in WS1 is likely to be due to the larger amounts of dissolved species present within the sample or some other dissolved species which have not been analysed for are largely present within the sample.

The highest concentrations of dissolved ions in groundwater at the site were in sample WS1. This would suggest that groundwater at this part of the site is derived from recharge over a greater distance in comparison to groundwater in the southern area of the site, which is derived from local recharge (as discussed in section 5).

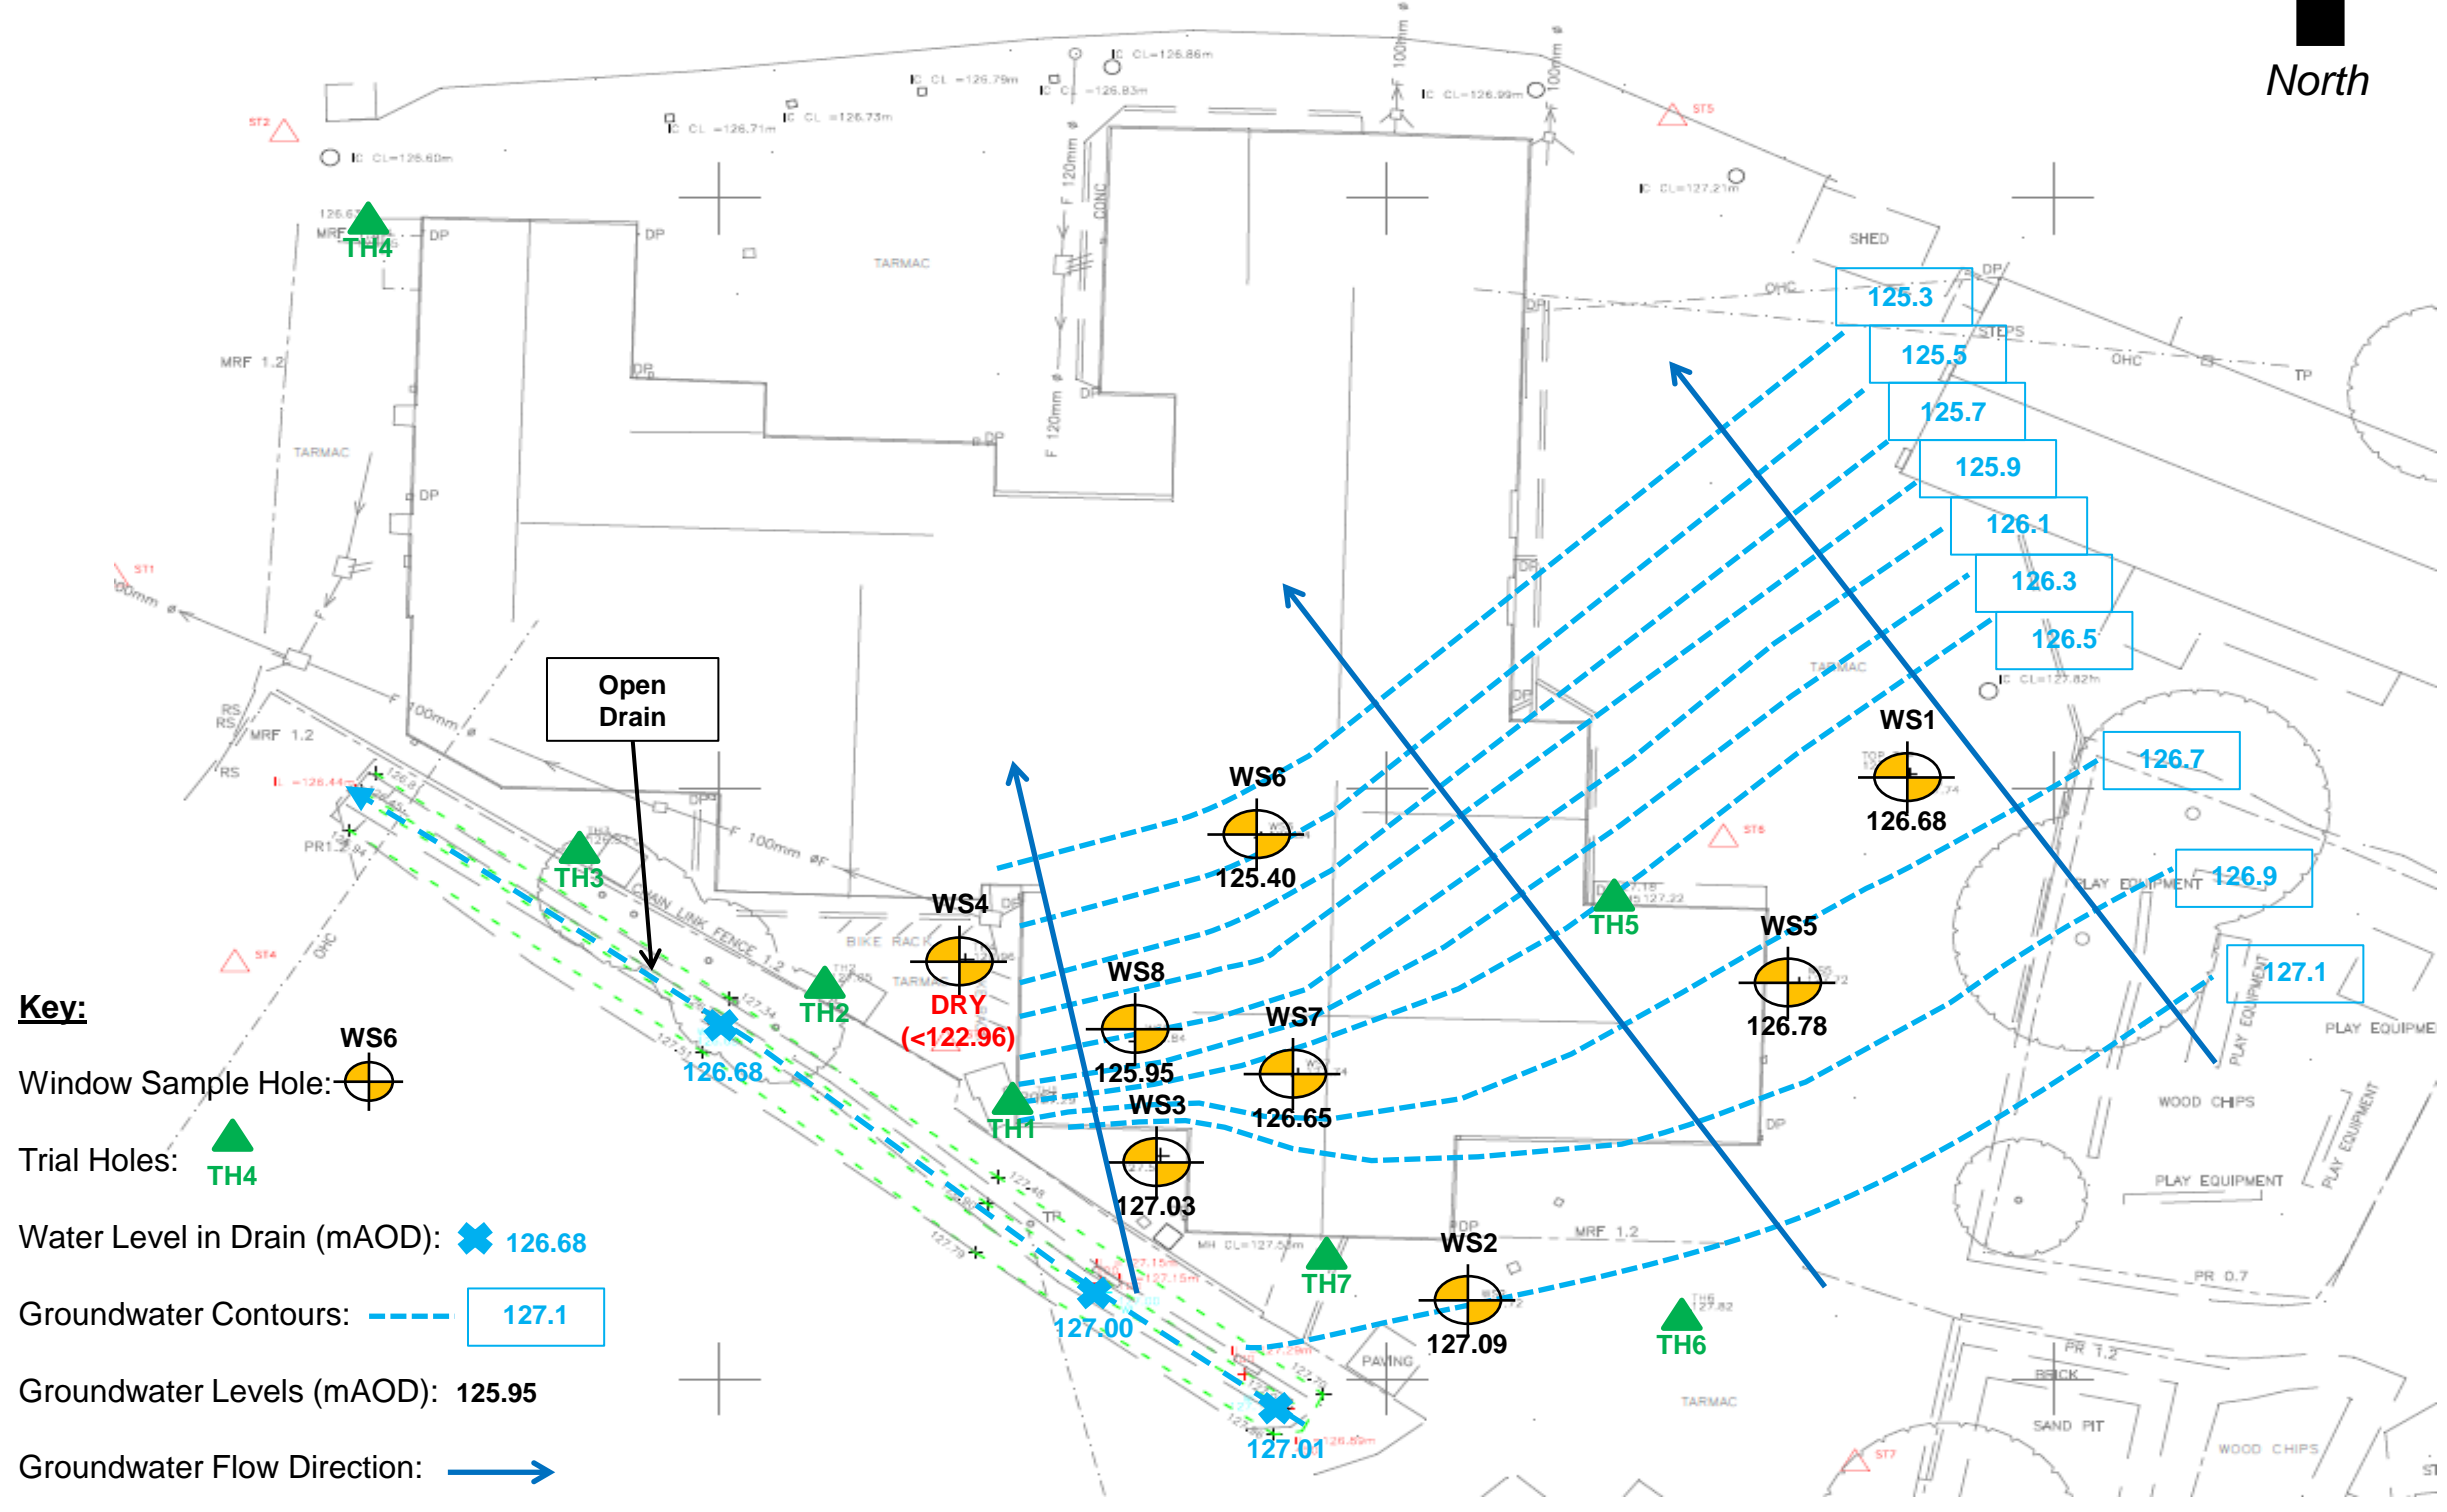
Client: Herefordshire County Council
Project: HYG124 Colwall C of E Primary School
Date: 28/11/2014 Checked: CB Ref: Drawing - 001

The exploratory Windowless Sample locations and locations of the trial holes TH1-TH7 are shown in Figure 5 and in Drawing 001. The boreholes were installed with 50mm diameter monitoring standpipes, with the upper 1m plain with a bentonite seal surround (with the exception of WS8), with the lower part of the boreholes slotted with a filter sock and gravel filter. Stopcock covers were concreted in at each point flush to ground surface.

The groundwater levels recorded during the 3 no. monitoring rounds are summarised below in Table 4-4, and an inferred groundwater level contour plot for groundwater levels on the 22/10/2014 is presented in Drawing 001. A Hydrograph is also presented in Figure 13 which depicts the groundwater levels over the 3 no. monitoring periods.

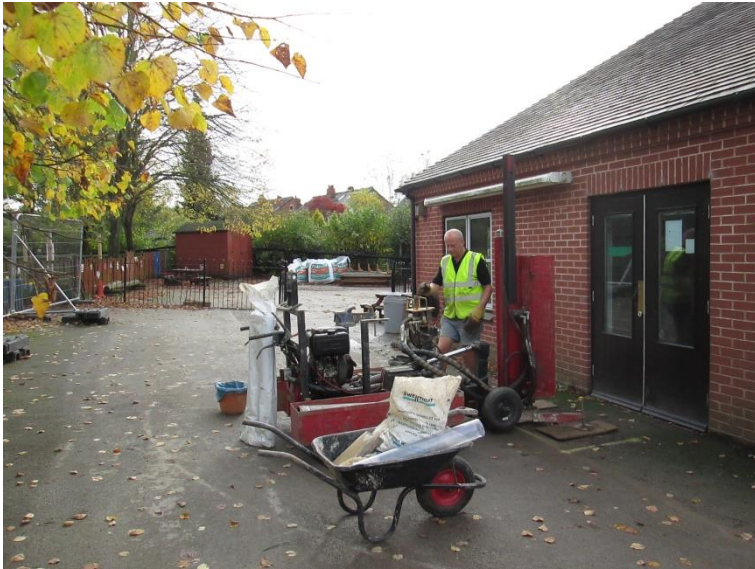
Photo depicting the 'Competitor' Windowless Sampling Rig drilling WS5 within the current car-parking compound, around the perimeter of the school building.

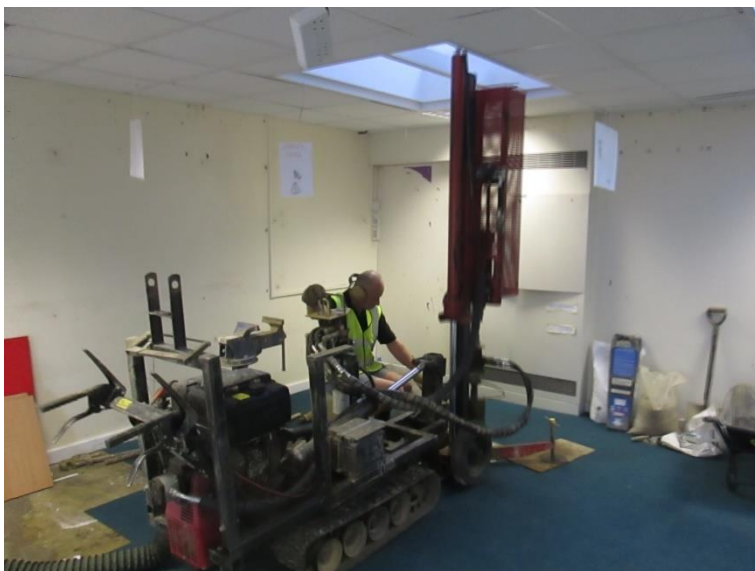
Photo showing the drilling of WS6 within one of the classrooms in the school building. The concrete floor was cored out prior to the commencement of the drilling using a concrete corer attachment.

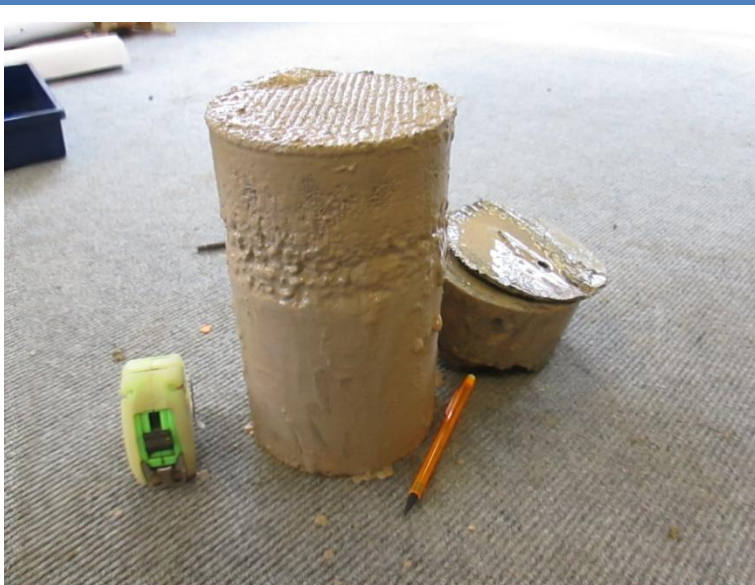
Representative photograph depicting a concrete core from the coring of WS7 within the school building. The concrete was found to be 0.18 metres thick within WS6, 0.32 metres in WS7 and 0.30 metres thick in WS8.

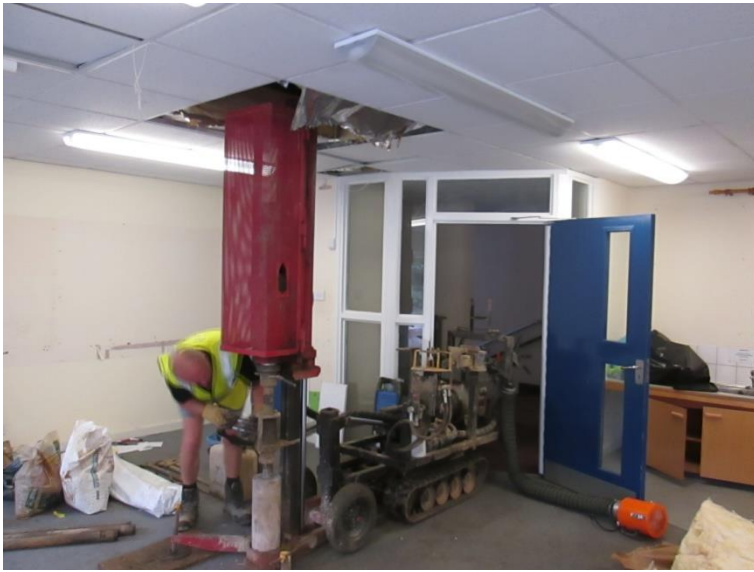
The photo shows the drilling rig set up in one of the classrooms to the east of the school building. The ceiling panels within the classroom and also within the staff room (WS8) had to be removed to allow for the clearance of the rig mast (3 metres) to drill the holes.

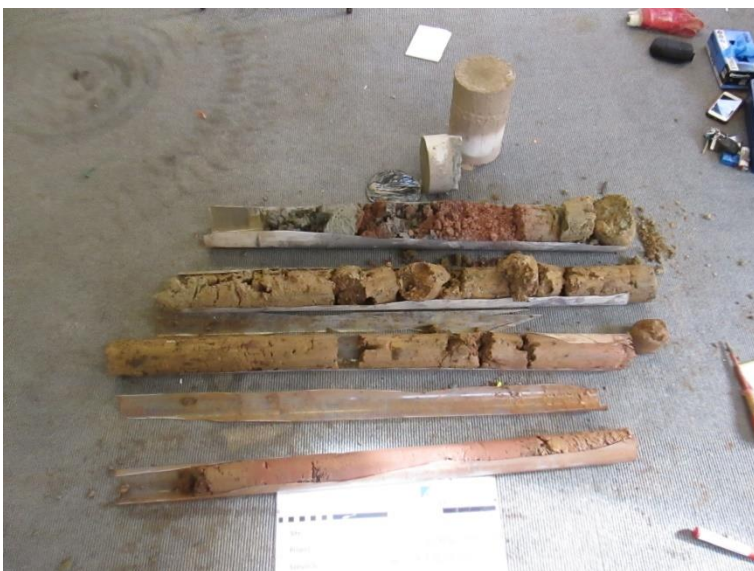
Photo depicts a representative retrieved sample run of the made ground and shallow geology encountered during drilling down to 4mbgl in WS7.
